INSPECTION REPORT
ARECIBO AERIAL TRAMWAY
ARECIBO, PUERTO RICO
AUGUST 6 TO 10, 2012

INSPECTION DATES: August 6 to 10, 2012

REPORT DATE: August 15, 2012

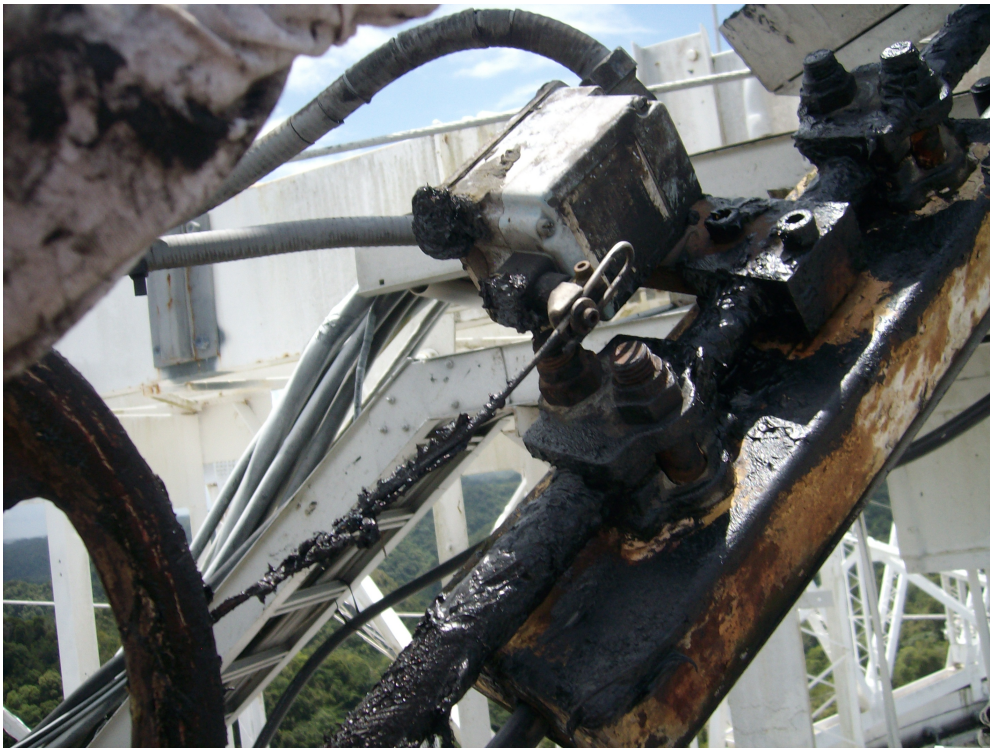
2.2.1.5 Wiring All electrical wiring should be in accordance with the designer's specifications and applicable codes. One of the upper station travel limit switches is mounted in the wrong place and has an incorrect type of actuator arm (wire type) (See Photo 1.) This switch is a backup travel switch for the east travel switch but is not functional in its present condition. Also there is a circuit wired into the system and shown on the electrical schematic which energizes relays "Cable Car Path Up" and "Cable Car Path Down" but these relays have been removed.

Photo 1 – Incorrectly located travel switch at upper terminal.

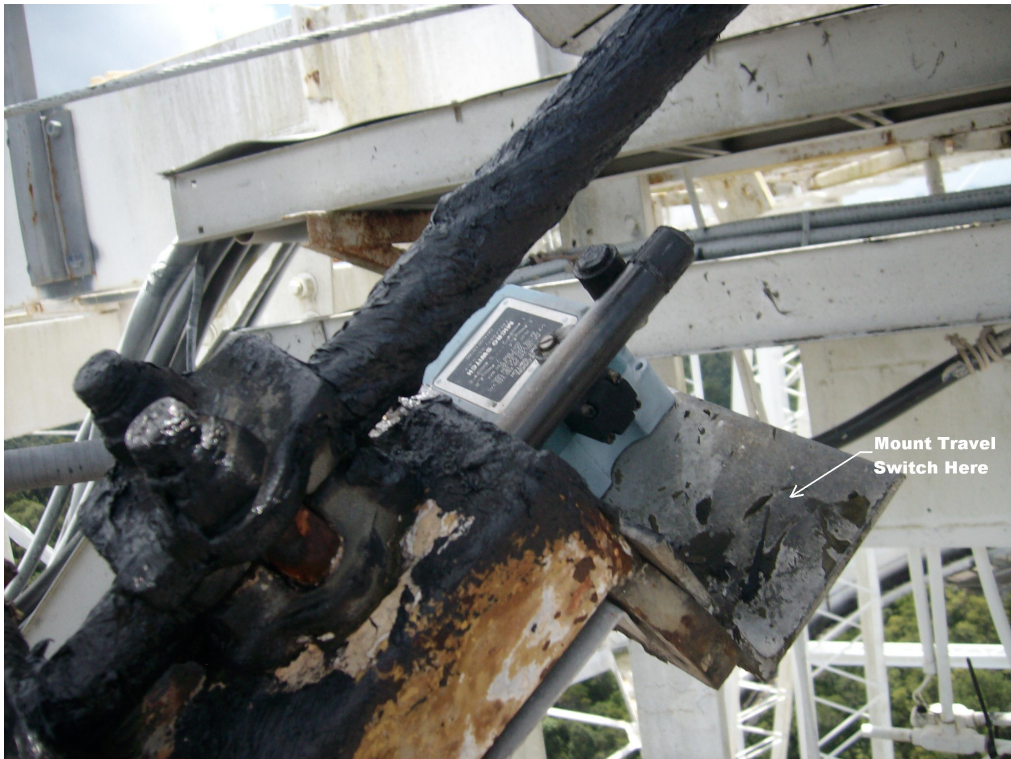
Photo 2 – Location to mount incorrectly located travel switch.

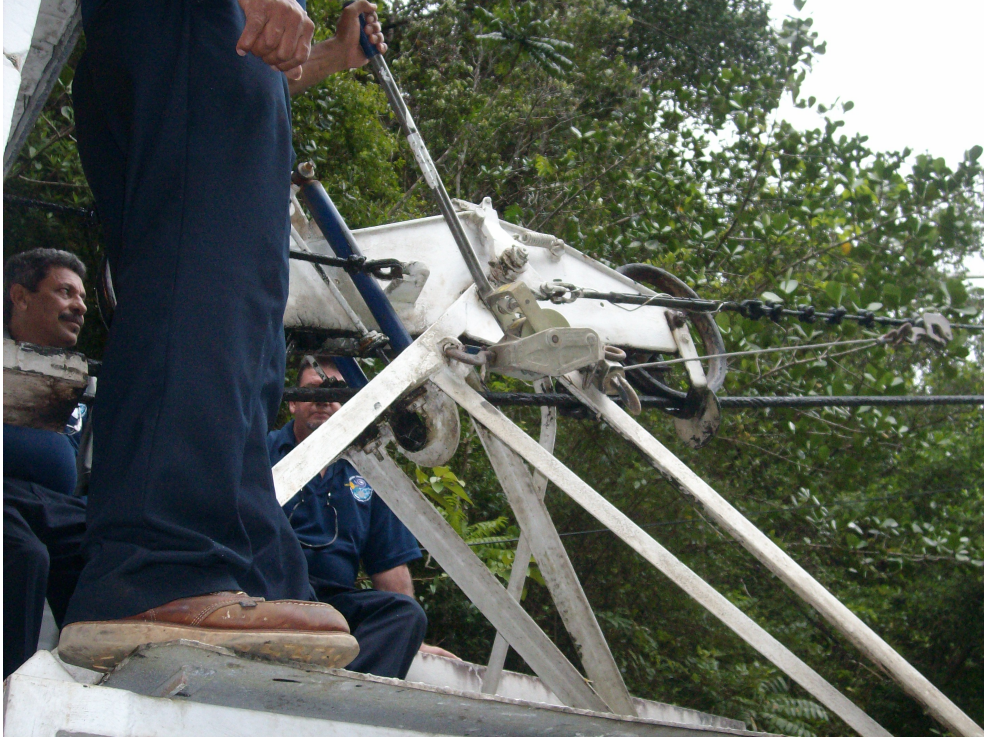
slow down in either direction and there was no slippage of the haul rope in the drive sheave. Successfully tested automatic application of the track rope brake by slacking off the haul rope at the car with a lever hoist. (See Photo 3.) Disassembled and inspected brake pads and disks of Sterns service brake. (See Photo 7.)

Photo 3 – Performing slack rope test of track cable brake.

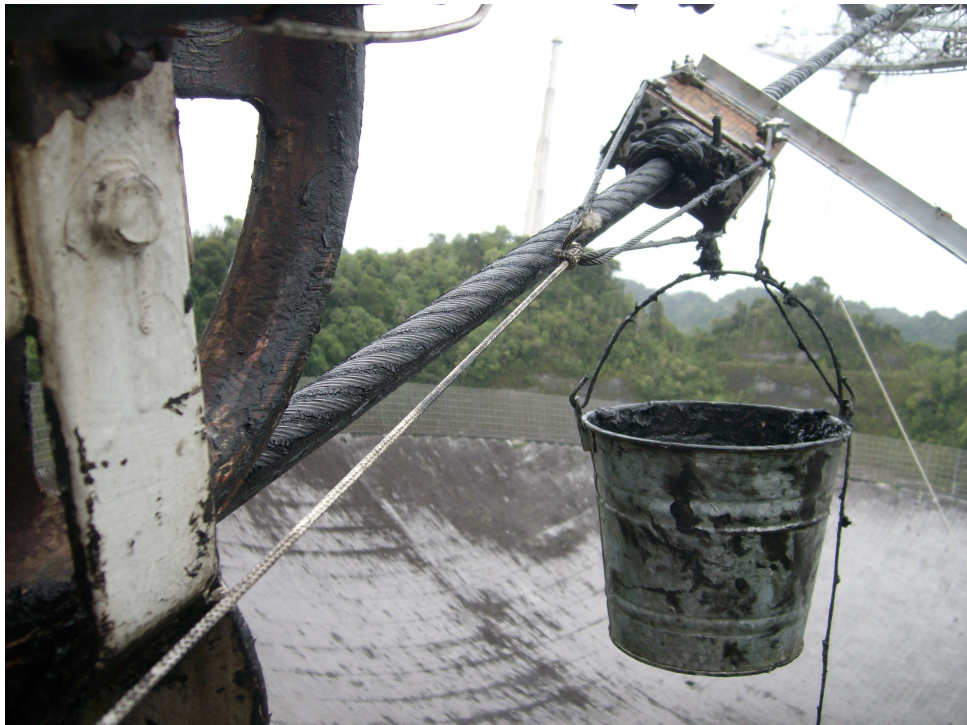
Wednesday, August 8 Removed excess grease from the track rope with a groove cleaning apparatus (See Photo 4) so that the rope could be visually inspected. The groove cleaning apparatus was pulled from the top station to the bottom by the car which was moved by gravity and hand crank in order to limit the speed and force of the groove cleaner. Inspected track rope from the roof of the car and ½ of the haul rope from the lower terminal. (See Rope Inspection Reports.)

Photo 4 – Removing excess grease from track rope with groove cleaner.

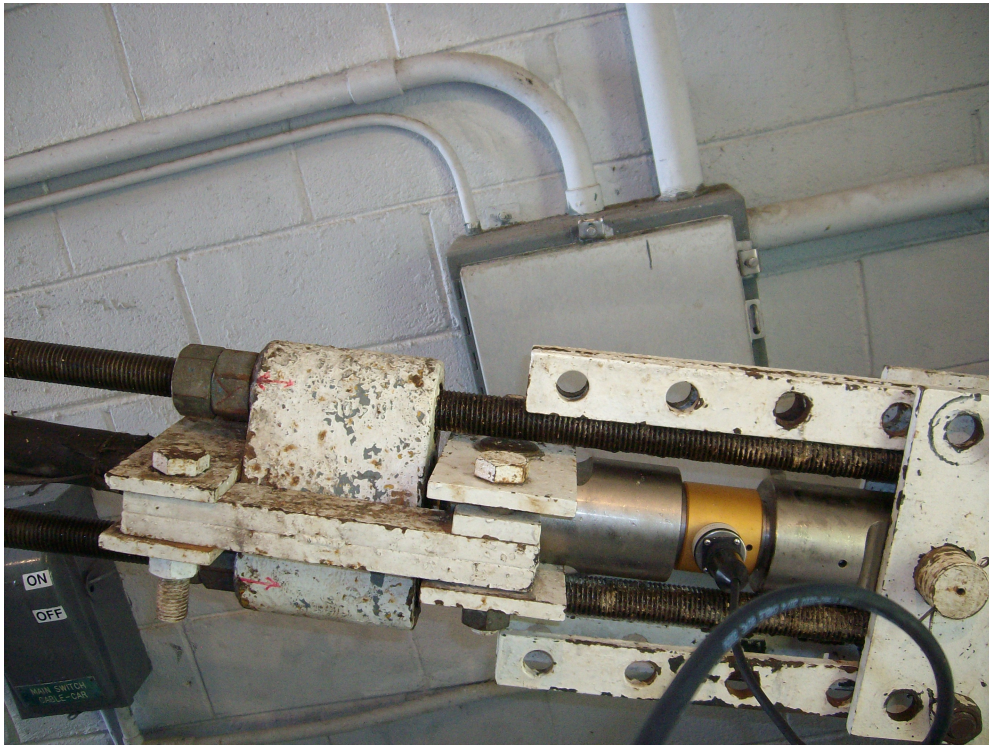
Inspected travel limit switches in lower terminal including wiring connections. Arecibo staff measured tension in the track rope at 5,700 lbs (See Photo 5) and haul rope at 535 lbs at a temperature of 90 degrees F. Tested track cable brake again by taking car to mid-span with 2 people on board and stopping the car. The track cable brake was then applied. The motor was disconnected from the electrical power source and the Sterns service brake was released manually. The car then rolled downhill due to the force of gravity. The track cable brake clamps on to the track rope but does not grip tightly enough to slowdown or hold the car. (See Photo 8.)

Photo 5 – Measuring track rope tension.

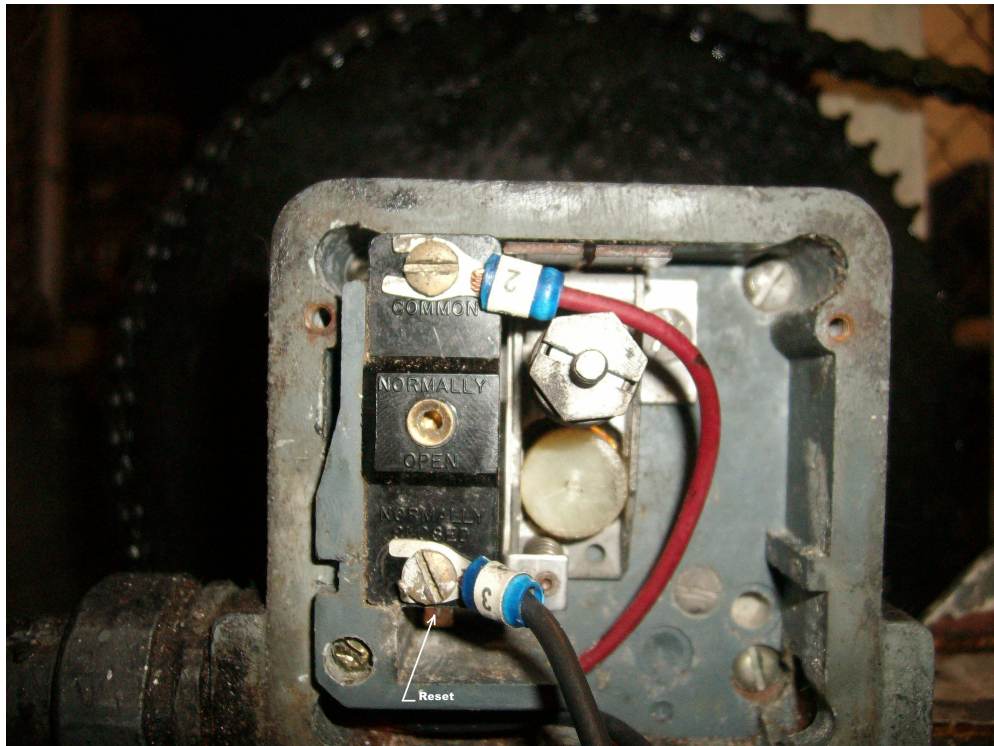
Friday, August 10 Inspected travel limit switches in upper terminal including wiring connections. Tested the over speed sensing switch by disconnecting the drive chain and turning the sprocket manually. The sensing switch opened its contact upon sensing the over speed. The switch was then reset (See Photo 6) and the drive chain was put back on the sprocket.

Photo 6 – Over speed sensing switch showing manual reset location (below microswitch).

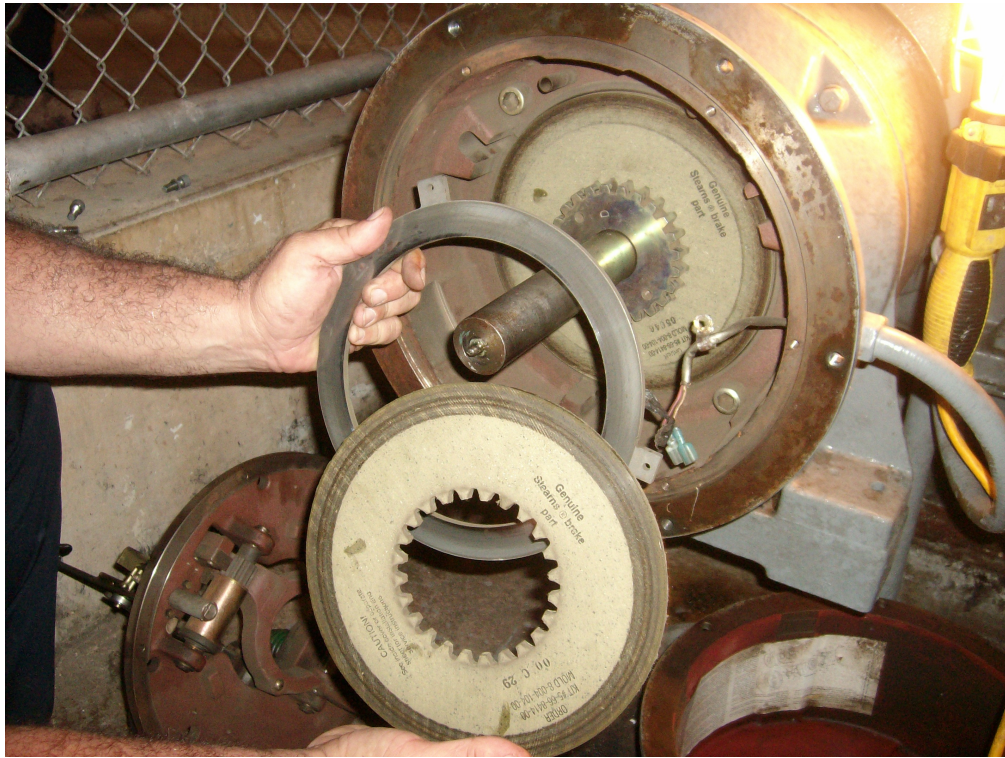
Photo 7 – Inspecting the Sterns service brake.

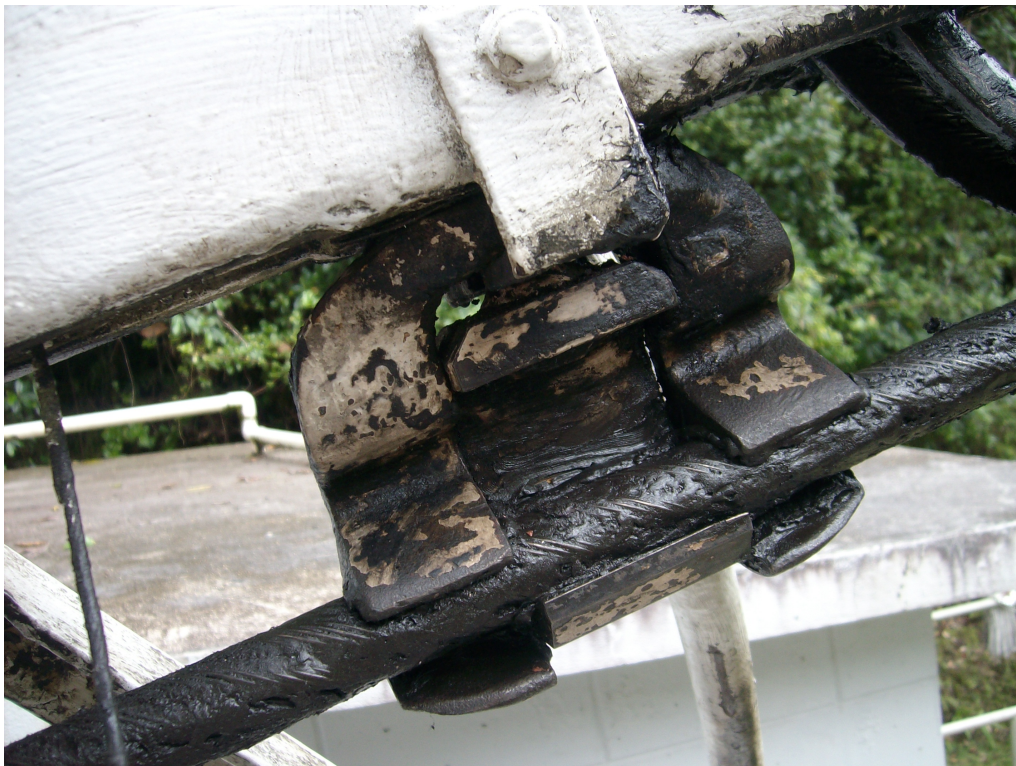
2.1.4.3.2. Track Cable Brakes The track cable brake should be capable of stopping and holding a fully loaded carrier at the point of maximum gradient. The track cable brake was tested and found to be unable to hold the car at mid-span with 2 people in the car, no electric power to the drive motor and the service brake manually released.

Photo 8 – Grip jaws of track rope brake clamp on to track rope but do not stop or hold

car.

1. Mount a sign in the car stating “4 passengers and 1000 lbs or 455 kg max. total weight”.
2. Install an automatic stop device that will be actuated in case the automatic speed control fails to reduce the tramway speed during terminal approach.
3. Repair the track cable brake so that it is capable of stopping and holding the fully loaded car at the point of maximum gradient.
4. Move the upper terminal travel switch with the wire actuator to the location opposite (west of) (See Photo 2) the east travel limit switch and replace the actuator arm with the same type (roller arm) that is mounted on the east travel limit switch.
5. Correct the electrical schematic to show that the “Cable Car Path Up” and “Cable Car Path Down” relays have been removed.
6. Order and install a new track rope since the existing track rope diameter is reduced to 94% which is the ANSI minimum.
