CONDITION OF STEEL CABLE AFTER PERIOD OF SERVICE

By S. Leigh Phoenix,¹ Herbert H. Johnson,²
and William McGuire,³ F. ASCE

ABSTRACT: The condition of the interior of a 3-1/4-in. steel cable after approximately 20 yrs in service is described. The cable studied was one of 21 bridge strands that support a very large radio telescope. It had suffered minor surface wire breakage and was replaced for testing and dissection to provide information needed for judging the condition of the entire cable system, and ensuring long-term satisfactory operation of the telescope. Very little information has been published on the condition of cables after a period of service. The paper is presented in the interest of partially filling this gap in the information needed for estimating the service life of steel structures.

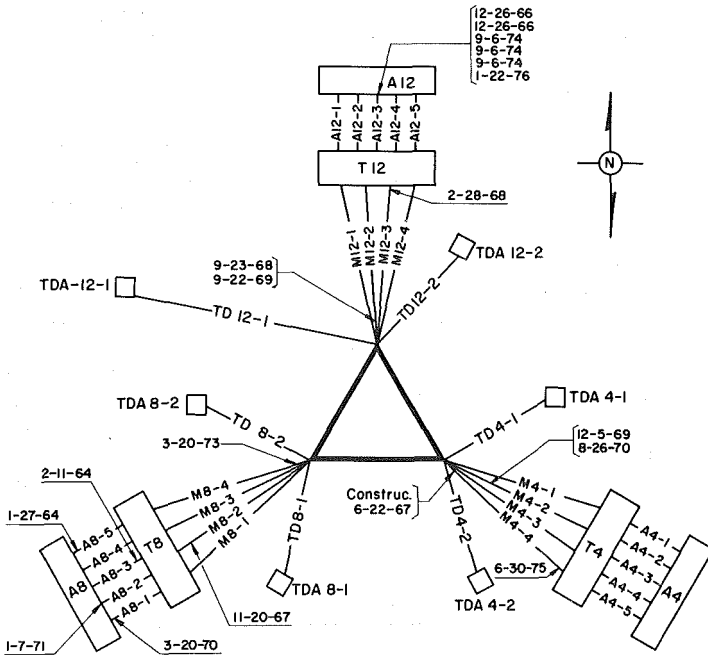
Wire Breaks.—Fig. 5 is a chart of the wire breaks and their dates of discovery from the period of construction to the time of replacement (1981) of the cable of interest here (A12-3). All of the breaks occurred near the point where the wires enter a socket.

The cable with the largest number of breaks (six) was the center backstay (A12-3), as shown in Fig. 5. Breakage occurred at roughly a constant rate from 1972 to 1978. Broken ends of several of the wires were studied. Analysts mentioned some possible evidence of both stress corrosion and corrosion fatigue, but the conditions of the fracture surfaces at the times

FIG. 5.—Summary Chart of Wire Breaks in Cables

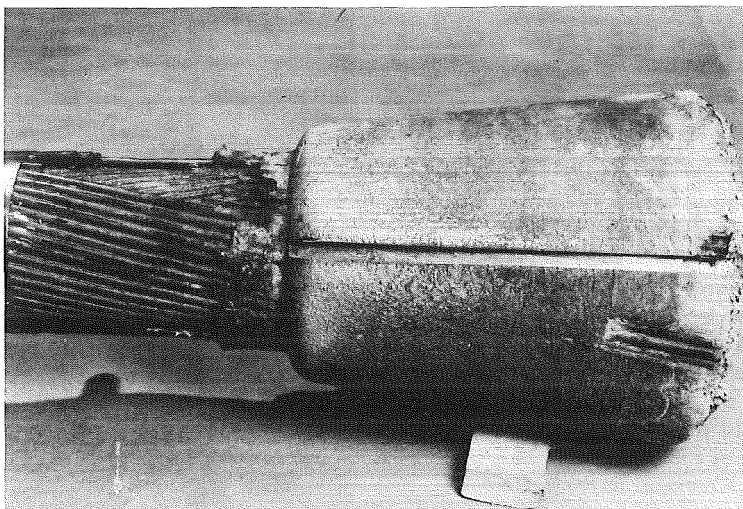
Lower Socket.—The above experiments were repeated for the lower socket. However, in this case the steel basket on the lower socket was cut off to relieve the internal transverse compressive stresses in the zinc (Fig. 7) caused by socket seating (wedging action in the tapered basket) during cable pretensioning. The basket was then securely bolted back on. The proof-test procedure described earlier was applied to the wires in row 1, which we recall already had six adjacent broken wires (Fig. 7). The five wires opposite the break region of the strand (180° around the

FIG. 7.—Lower Socket without Jacket Showing Degraded Zinc Collar and Wire Break Region (Note Saw Cut from Jacket Removal Process)

Most of the wires survived this initial proof-test; however, a few wires near the region of the breaks slipped at loads substantially below the 137 ksi proof-load. This slippage was viewed as evidence of poor bonding between these wires and the zinc. It is likely that these wires would not have slipped in service under the transverse compressive stresses described above. Two wires were not proof-tested. As will be evident later, one of these would probably have failed the 137 ksi proof-load test.

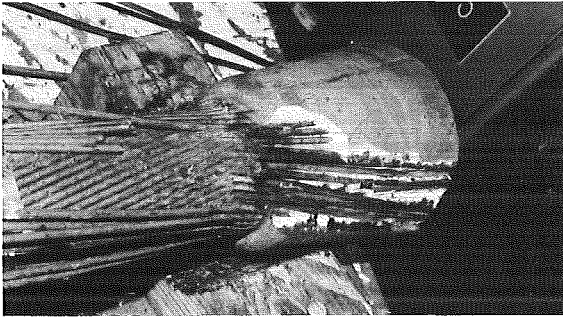
As with the upper socket, the lower socket was dissected by chipping the zinc from between the wires. It was first noticed that a "collar" of zinc existed around the cable at the socket face (Fig. 7), being thinnest in the area of the six wire breaks. It was again observed that no zinc existed on the wire surfaces from a point about 1 in. (25 mm) above the socket face to points well into the socket itself (Fig. 8). Considerable corrosion was found in this region at the collar. During dissection it was found that the zinc was easier to remove than in the upper socket, and that the wires of row 1 were splayed out closer to the surface (basket). The four wires adjacent to the break region in the counterclockwise direction (looking from the tower) were easily tapped out and had a com-

FIG. 8.—Wire Appearance In Lower Socket Break Region (Note Absence of Zinc)

pletely black surface with no zinc wetting. The ends of the wires at the deepest point in the socket were actually exposed to the outside of the zinc mass over about the last 1.5 in. (38 mm), and showed granular rust and dirt.

The six broken wires of the break region were easily tapped out longitudinally. They were not wetted by or bonded to the zinc, but were totally enclosed by zinc and 80% black. The next few wires in the clockwise direction were more difficult to remove, and showed some wetting to the zinc. In fact, the wetting seemed most complete in the few wires diametrically opposed to the six breaks. Proceeding in the clockwise direction, the wetting again diminished and the wires were again less well bonded to the zinc.

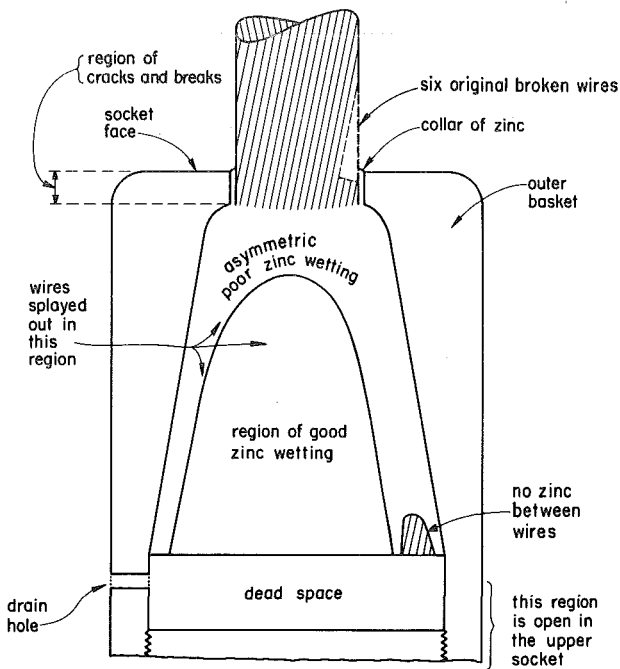
In rows 2 and 3, poor wetting was observed directly under the break region; however, wetting was much better elsewhere around the circumference. Regions near the exit point or face of the socket were not well wetted. Specimens from rows 4 and 5 were generally well wetted deeper into the socket except under the break region. Grease was found on the wires outside of the socket region and some spots of red rust were noticed at the socket entry point. Rows 6, 7, and 8 were uniformly wetted around the circumference in the lower half of the socket. The upper half of the socket region near the exit point showed the wires again to be black on the surface. Fig. 9 illustrates some of the observations about the lower socket.

FIG. 9.—Schematic Diagram of Lower Socket Region

flanking the original six breaks in the outer row and the wires directly underneath the break region tended to be poorly wetted (Fig. 9). Water appears to have seeped between these wires to the base of the socket where corrosion and its products were found. The resulting chemical activity may have contributed to the wire cracking and breakage.

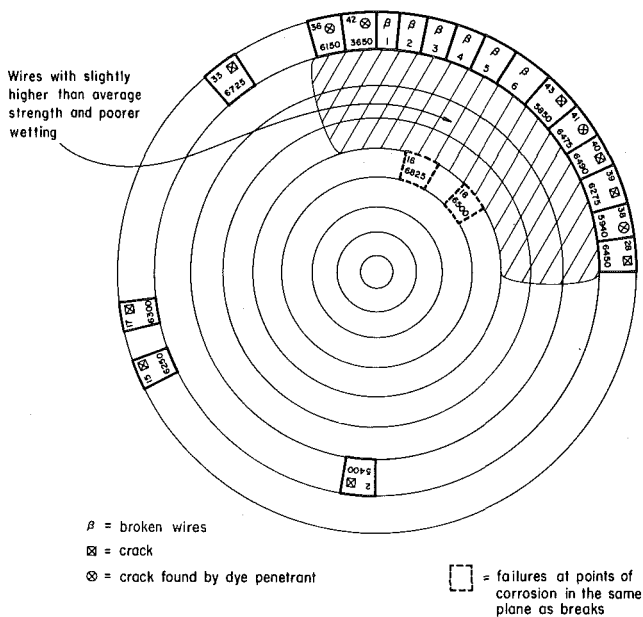
Cracked Wires from Lower Socket.—In all, 11 wires from row 1 and one of the wires from row 2 failed at preexistent surface cracks. All of these failures were at surface cracks which protruded into the steel less than 0.025 in. (0.1 mm). These cracks were easily seen on the fracture surface with an optical stereo microscope. The cracks tended to be perpendicular to the surface and to the wire axis, but sometimes formed an angle with the surface. All cracks appeared to have existed for some time, and showed surface corrosion. A microprobe analysis of one of the cracks revealed the element zinc. This zinc was not thought to be galvanizing but rather some zinc compound washed into the crack. The

FIG. 10.—Map of Broken and Cracked Wires in Lower Socket; Failure Loads of Cracked Wires are Shown in Pounds (230 ksi = 6,730 lb) (Note: Wires in Each Layer are Numbered in Order Tested)

The cause of these cracks is not known, but they usually appeared in regions of substantial corrosion or pitting. Only four of the cracks were large enough to be detected by Zyglo and dye-penetrant techniques. The mildest crack was in a wire which failed at the normal value of 230 ksi (1.59 GPa). The most severe crack was in a wire which failed at 125 ksi (861 MPa), a strength slightly above the working stress. Stains on some of the crack surfaces indicated growth over time; however, it is not known whether this growth was influenced by the installation of air dryers. It is likely that these surface cracks were caused by the same factors which led to the six adjacent breaks of Fig. 7.

Fig. 10 shows a map of the cracked wires. Also shown are their failure loads in pounds. [The wire diameter for rows 1–7 was 0.193 in. (4.9 mm), and for row 8 and the center wire was 0.206 in. (5.2 mm).]

5. In effect, a region of "damage" was found in the lower socket surrounding the six adjacent breaks (Fig. 10). Here we found several cracked wires, a region of poor wetting and bonding of the zinc, corrosion on the wires just under the socket face, degradation of the zinc collar, and the presence of moisture, at least in the early years of operation.
