Arecibo Telescope Collapse Forensic Investigation

Thornton Tomasetti

July 25, 2022

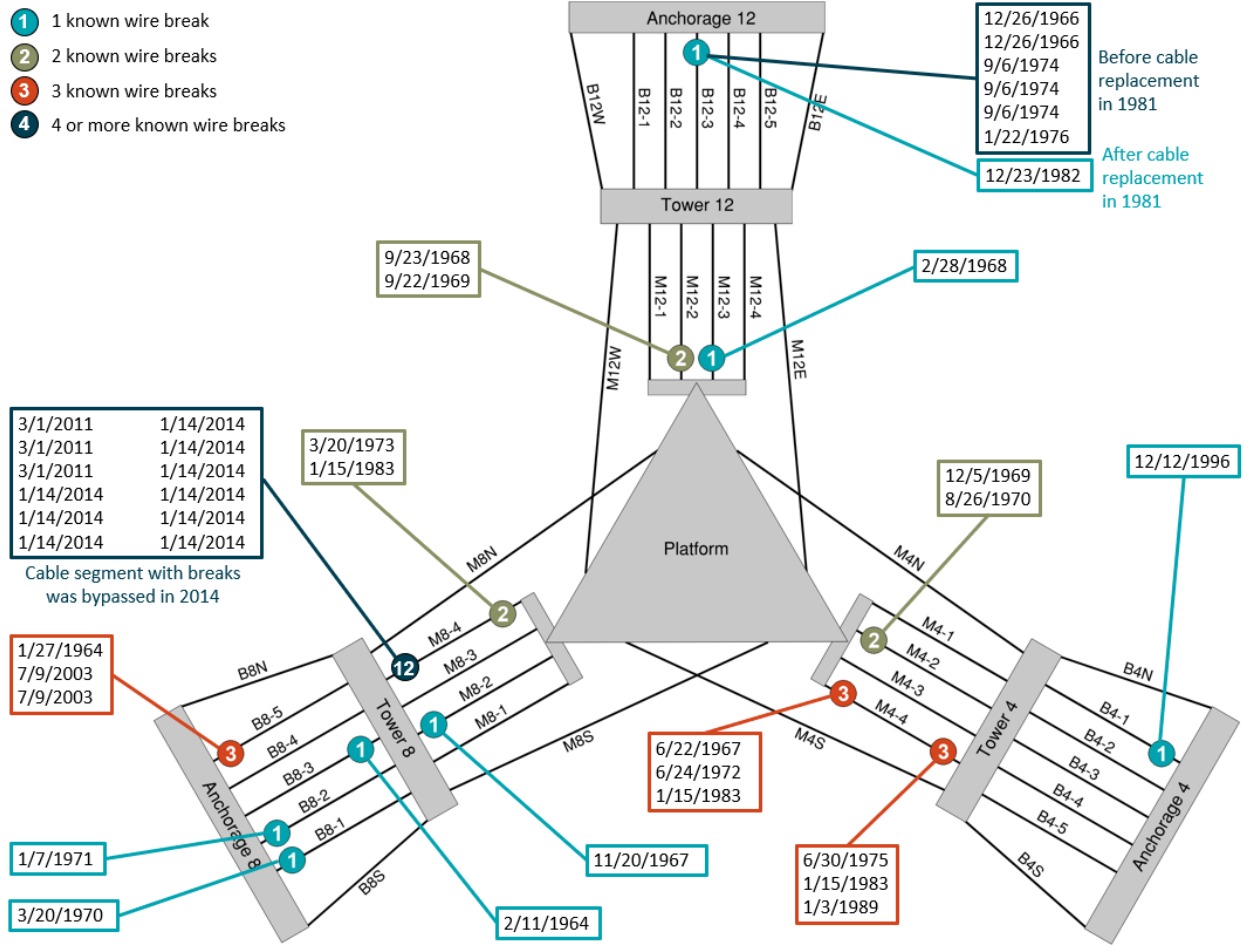
Figure 22: Wire break locations and report dates.

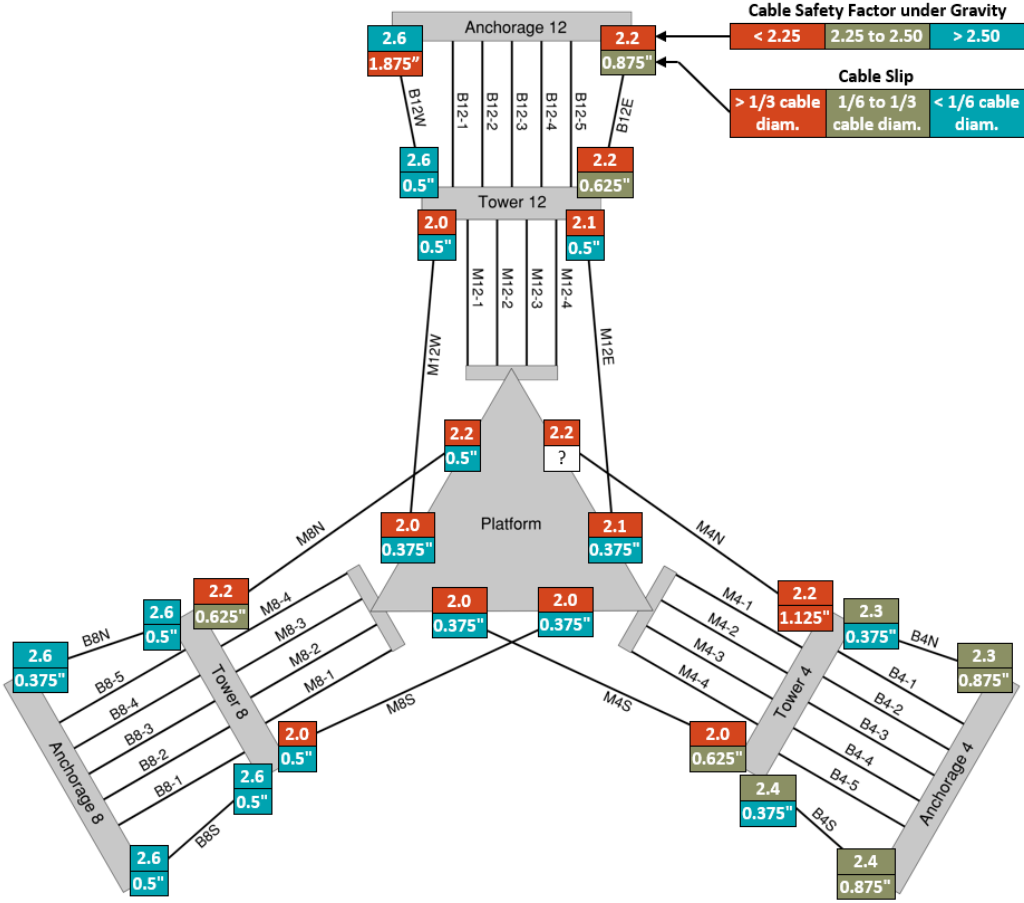
Figure 25: Cable safety factors and measured cable slips on auxiliary cable sockets.

The cable slips were measured at the tower and ground ends of the auxiliary cables after the first cable failure, and at the platform ends after the collapse (Figure 25). One-third of the cable slips exceeded the AASHTO limit of one-sixth of the cable diameter. The maximum cable slip was observed at the ground end of B12W, and had increased from 1.5 inches in May 2018 to over 1.75 inches in September 2020 (Figure 24).

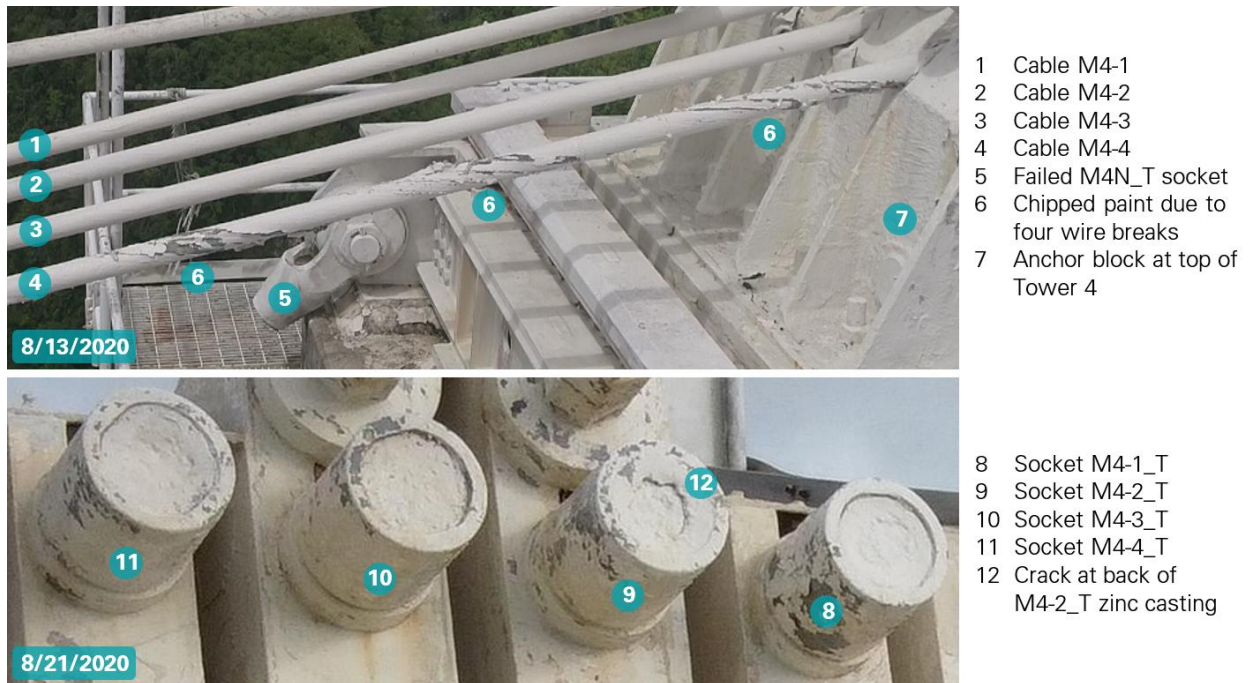
Figure 26: Damage on original M4 cables at top of Tower 4 after first cable failure
(photos: NAIC Arecibo Observatory, a facility of the NSF).

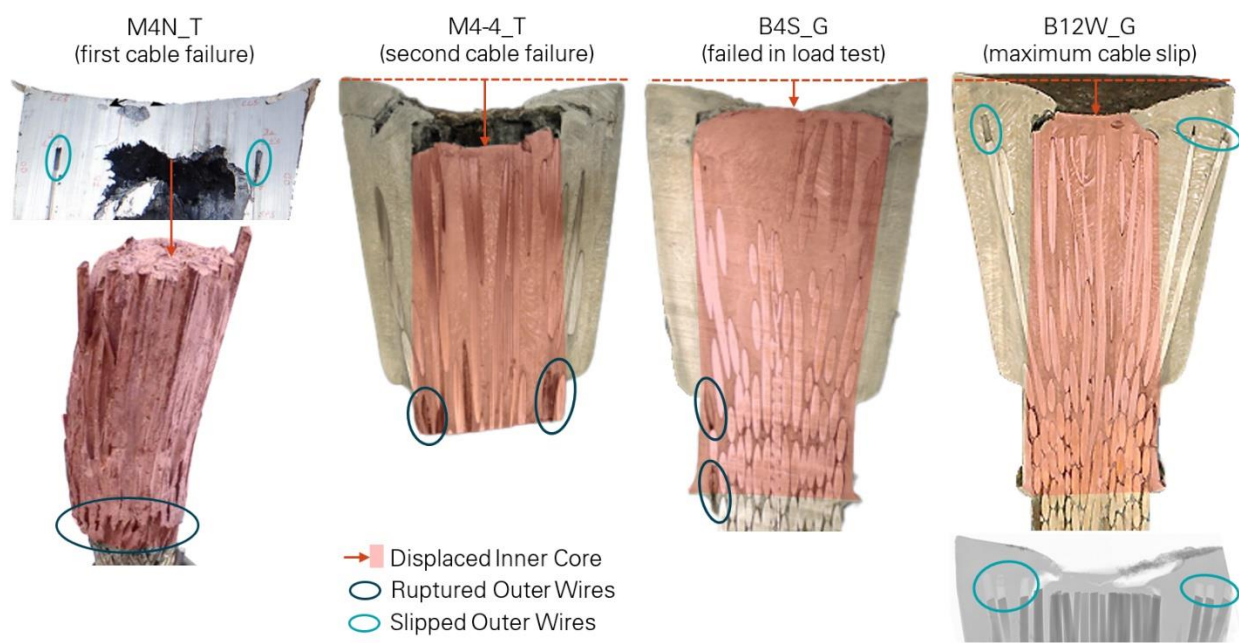
The inner core and the inner wires completely pulled out of the first socket that failed (M4N_T). In the second socket that failed (M4-4_T), the core remained in the socket after shifting significantly and the remaining wires ruptured outside of the core. As a result, the two failed sockets look different yet both failures started inside the socket with a displacement of the core and the rupture of outer wires (Figure 35).

Figure 33: Observations in distressed sockets (M4N_T photos: WJE¹⁶; B12W_G radiograph: Adrian Brügger, Columbia University - Oak Ridge National Laboratory; other photos: Socotec).

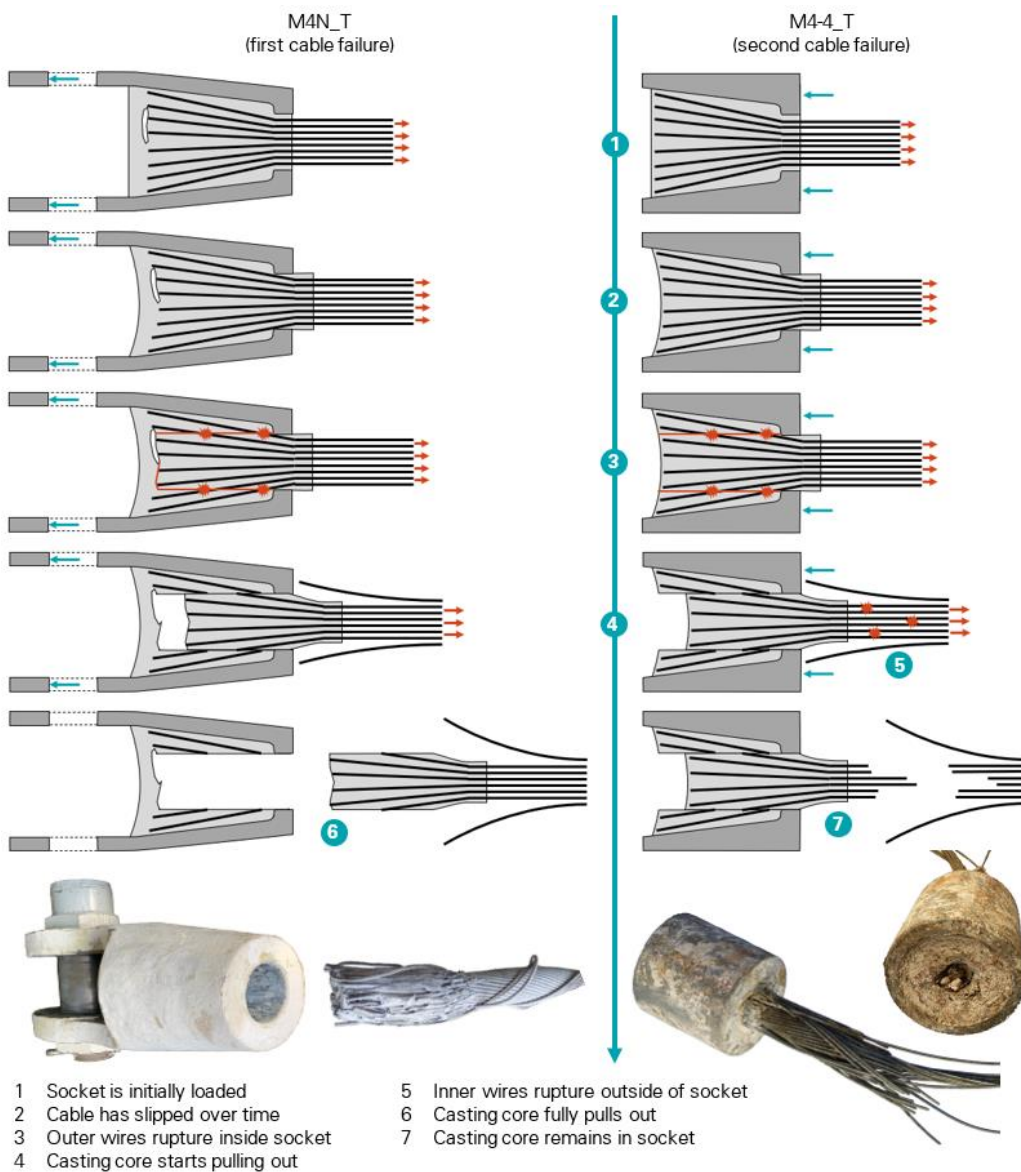
Figure 35: First two socket failures (M4N_T socket photo: NAIC Arecibo Observatory, a facility of the NSF; M4-4_T photos: Socotec).

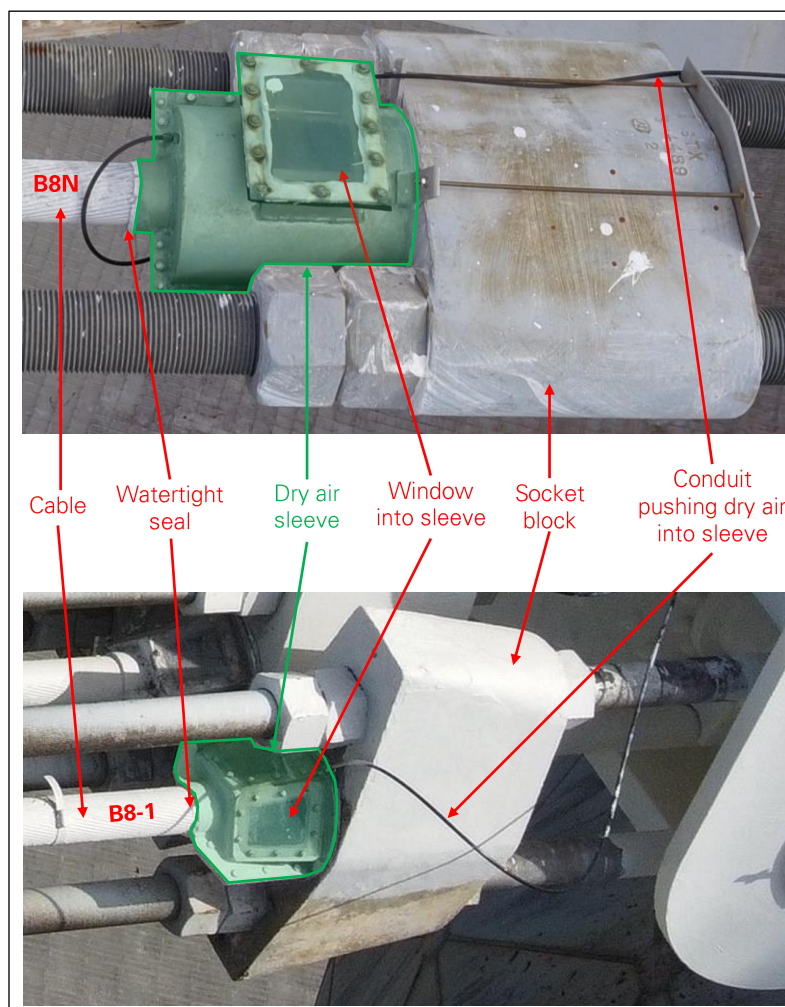
The maintenance and inspection documents include several reports, beginning in 2002, of condensation inside the dry air sleeves of some of the auxiliary cables (Figure 7 and Figure 8). The cause, extent and duration of the problem are not precisely known, although it affected backstays and main cables and persisted until at least 2011.

Figure 6: Moisture exclusion system on auxiliary main (B8N, top) and original main (B8-1, bottom) sockets in 2020
 (photos: NAIC Arecibo Observatory, a facility of the NSF).

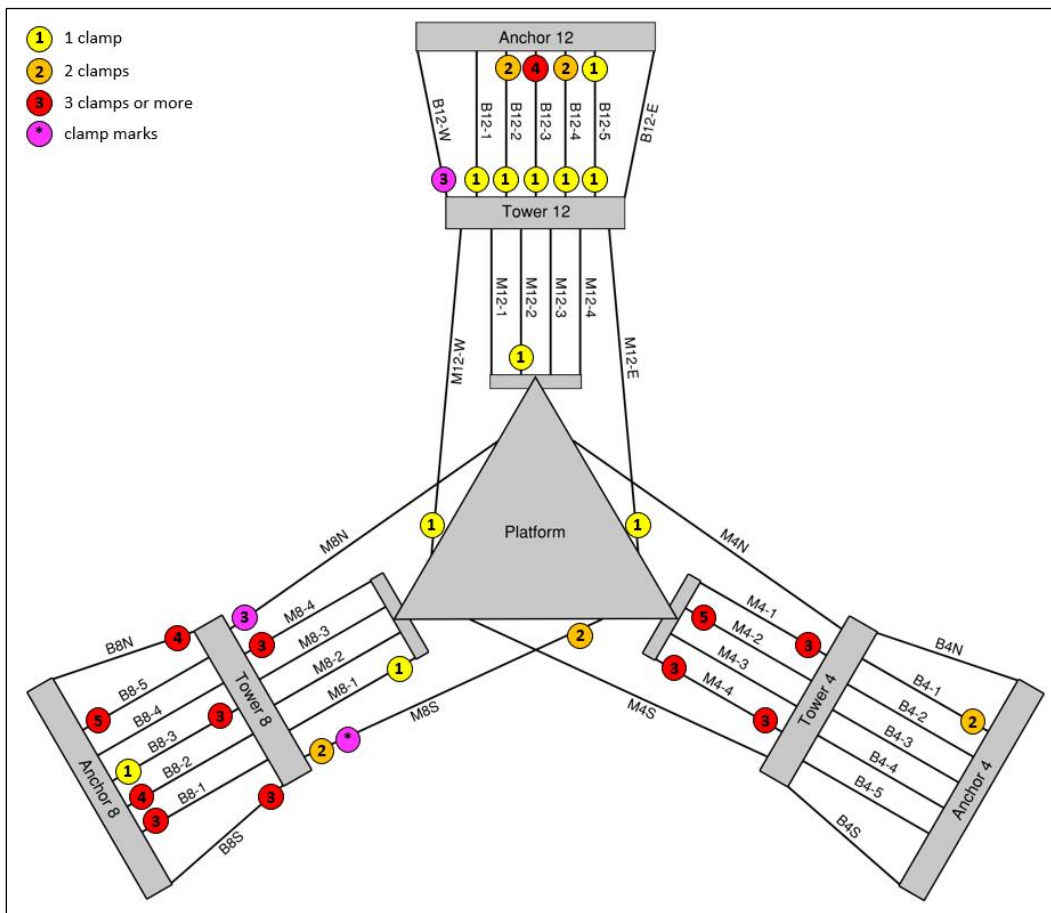
Figure 15: Cable clamps and clamp marks observed after first cable failure.

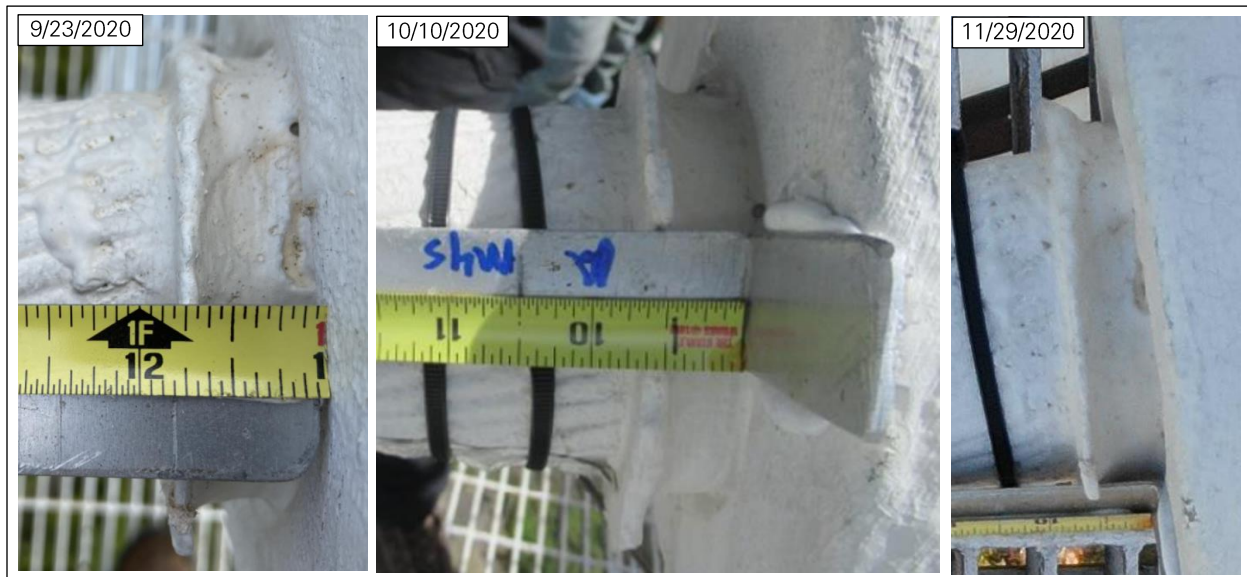
Figure 20: Cable slip at socket M4S_T
(left and center photos: WJE⁹; right photo: NAIC Arecibo Observatory, a facility of the NSF).

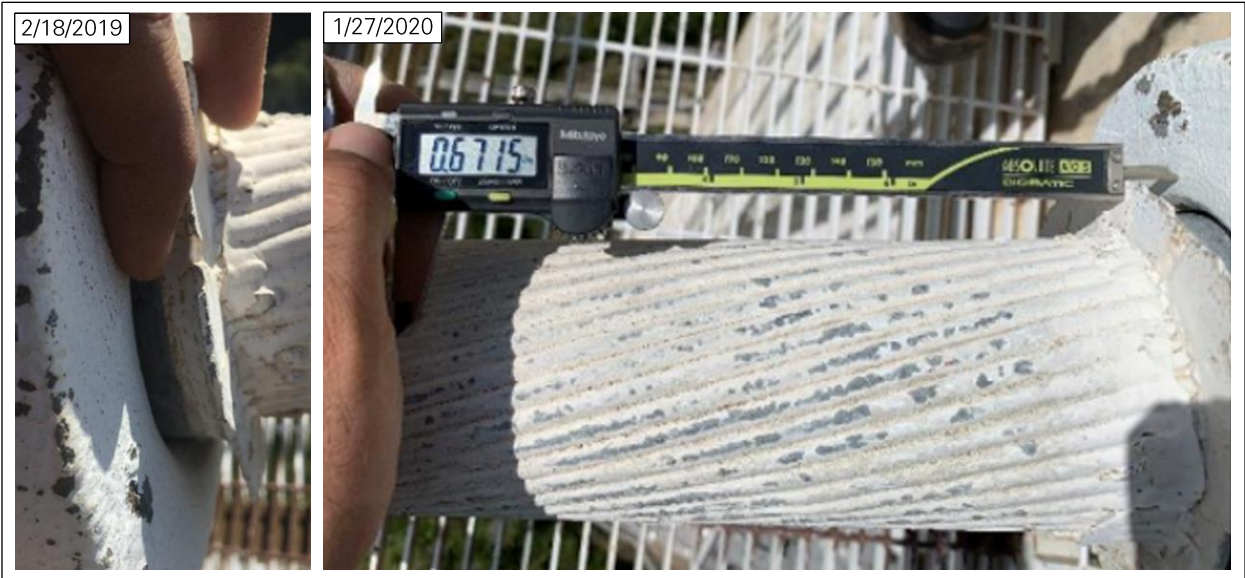
Socket M12E_T

Figure 23: Cable slip at socket M12E_T
(photos: NAIC Arecibo Observatory, a facility of the NSF).

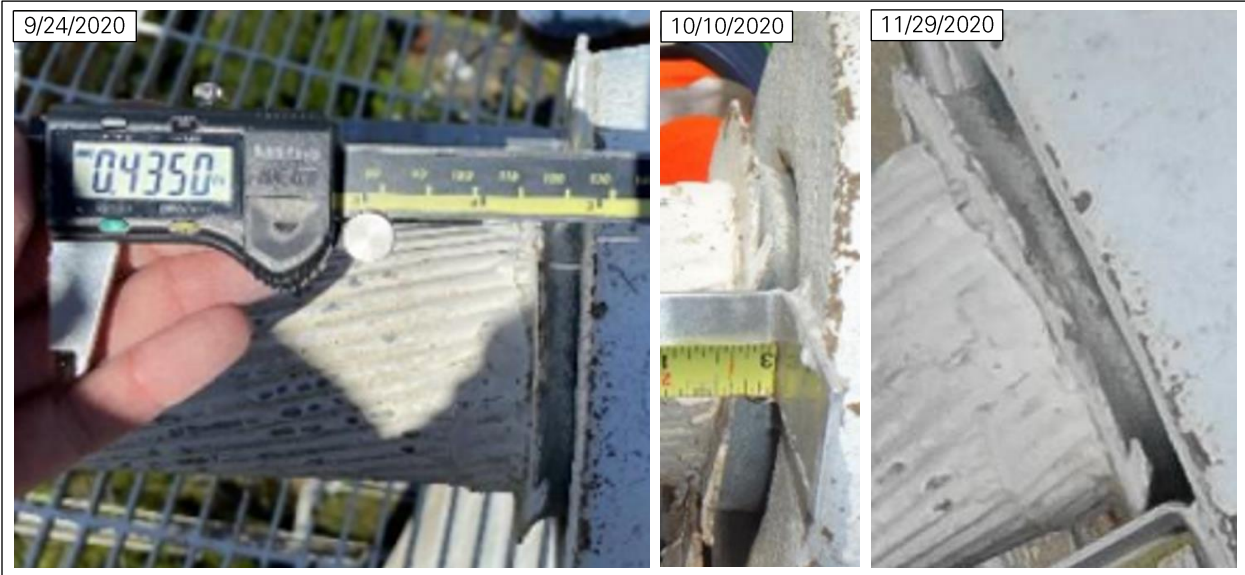
Figure 24: Cable slip at socket M12E_T
(left and center photos: WJE¹¹; right photo: NAIC Arecibo Observatory, a facility of the NSF).

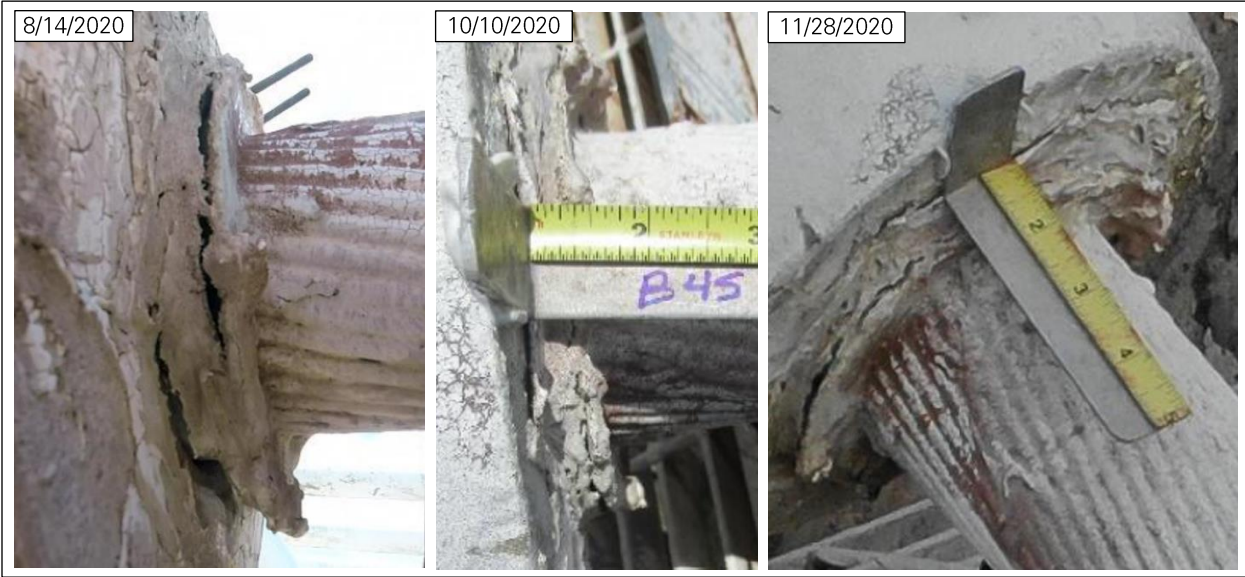
Socket B4S_T

Figure 33: Cable slip at socket B4S_T (left and right photos: NAIC Arecibo Observatory, a facility of the NSF; center photo: WJE¹³).

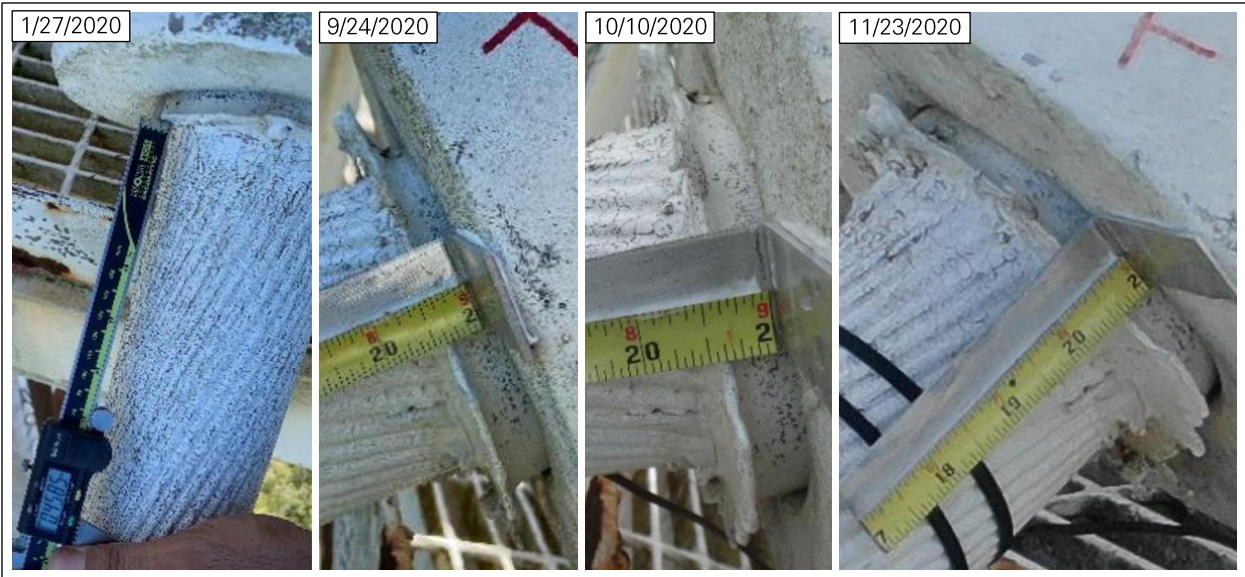
Socket B12W_T

Figure 37: Cable slip at socket B12W_T
(left and right photos: NAIC Arecibo Observatory, a facility of the NSF; center photos: WJE¹⁴).

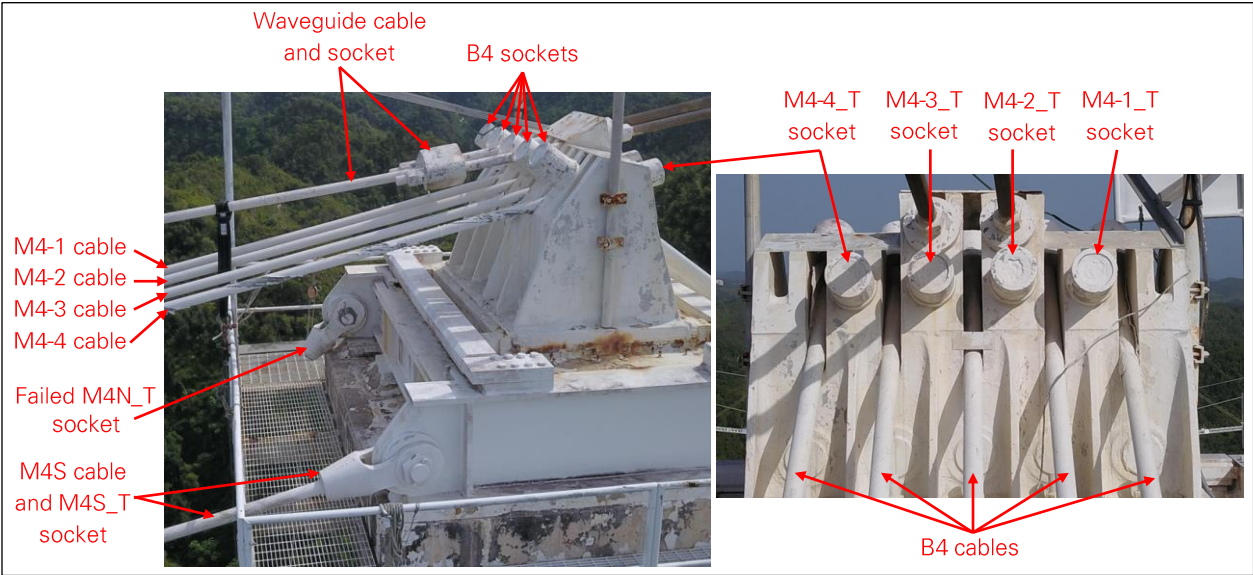
The structural damage observed between the cable failure and collapse consists of cable wire breaks, cable socket deformation, and full cable failures. Damage was only observed among the original main cables supporting the telescope’s platform from Tower 4 (the M4 cables), and most of the damage occurred near the top of Tower 4 (Figure 1).

Figure 1: Cables and sockets at top of Tower 4 after M4N failure, looking northeast (left) and northwest (right) (photos: NAIC Arecibo Observatory, a facility of the NSF).

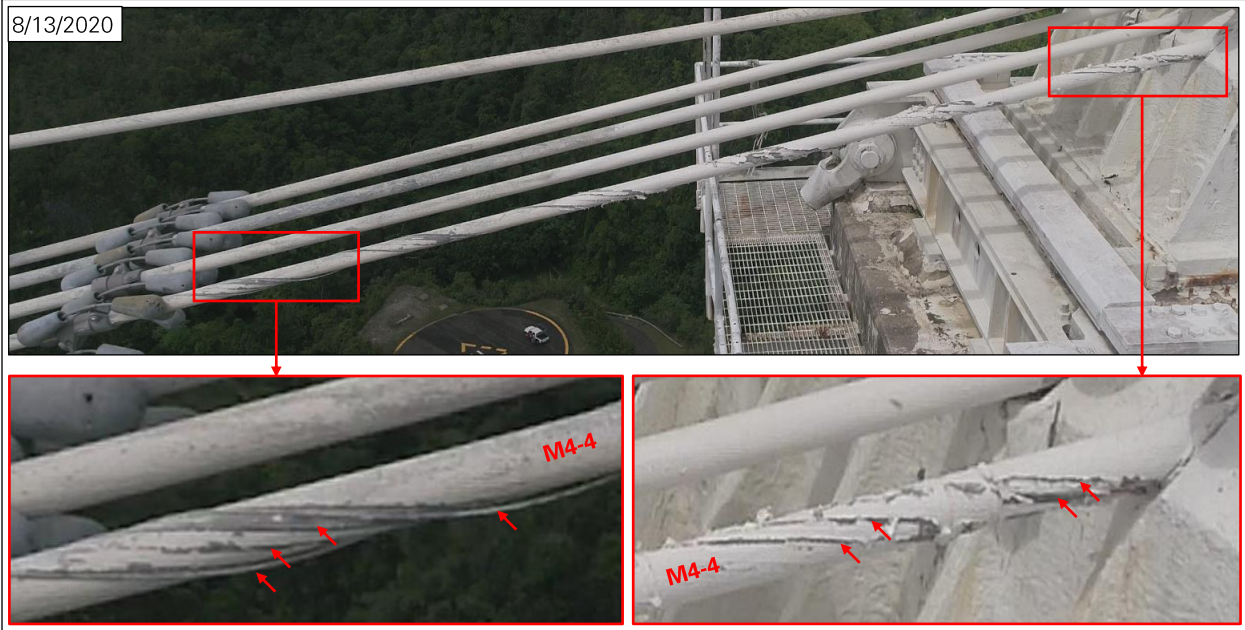
Shortly after the M4N failure, four wire breaks were observed in M4-4 near Tower 4 (Figure 4). No wire break was observed in any other M4 cable or near the platform (Figure 5).

Figure 4: M4 cables near Tower 4 on August 13, 2020. Four wires are broken in M4-4, and no wire is broken in the other three cables. (Photo: NAIC Arecibo Observatory, a facility of the NSF.)

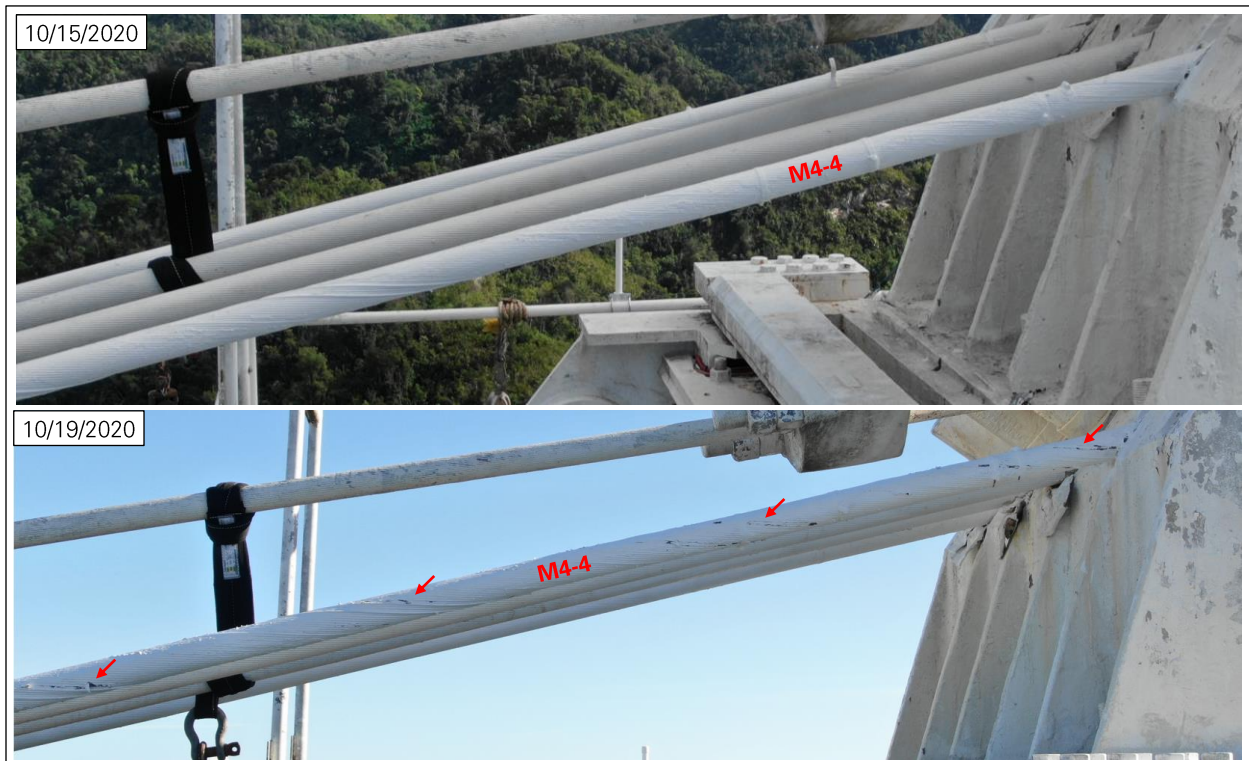
Figure 11: Broken wire movement in M4-4 on October 19, 2020
(photos: NAIC Arecibo Observatory, a facility of the NSF).

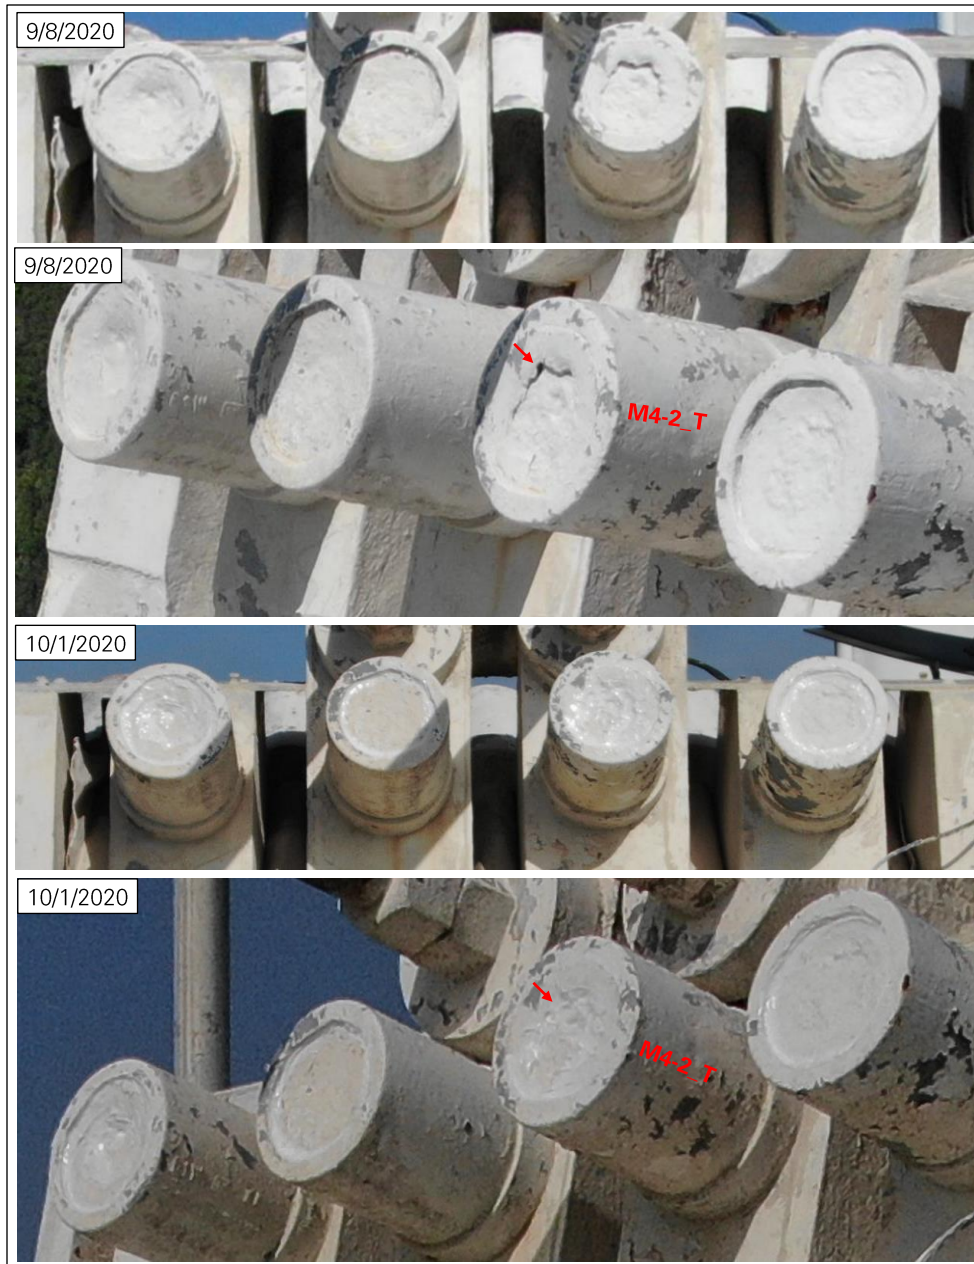
The crack in the zinc casting at the back of socket M4-2_T was sealed by October 1, 2020 (Figure 14). No significant change was observed on the sockets in October 2020 (Figure 15).

Figure 14: Sealant added at back of M4 sockets at Tower 4 by October 1, 2020
(photos: NAIC Arecibo Observatory, a facility of the NSF).

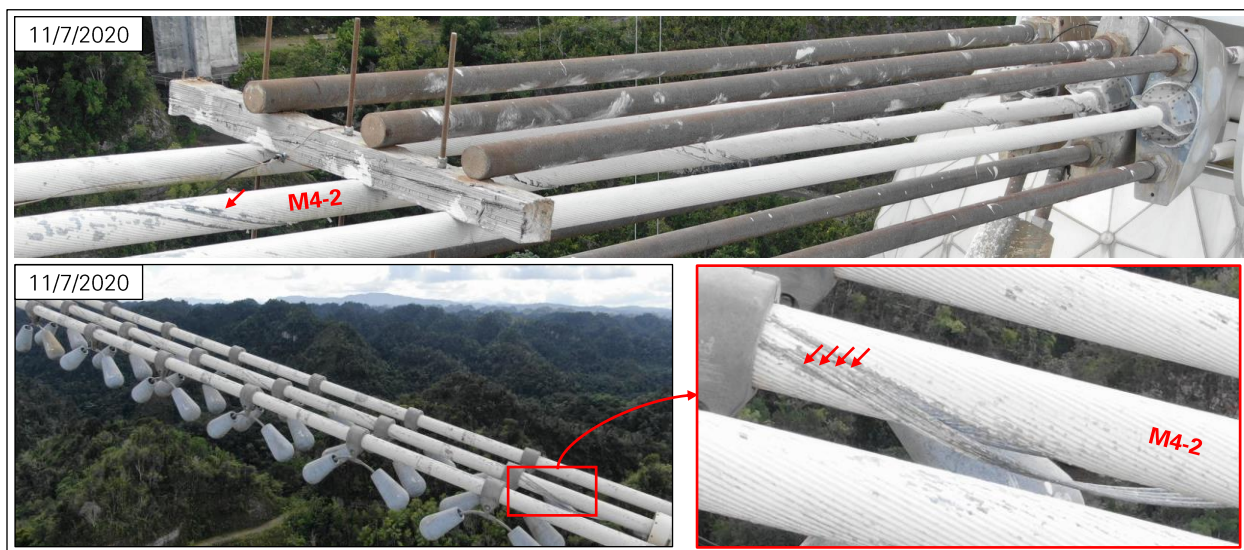
Figure 17: M4 cables near platform on November 7, 2020. Four adjacent wires are broken in M4-2.
(Photos: NAIC Arecibo Observatory, a facility of the NSF.)

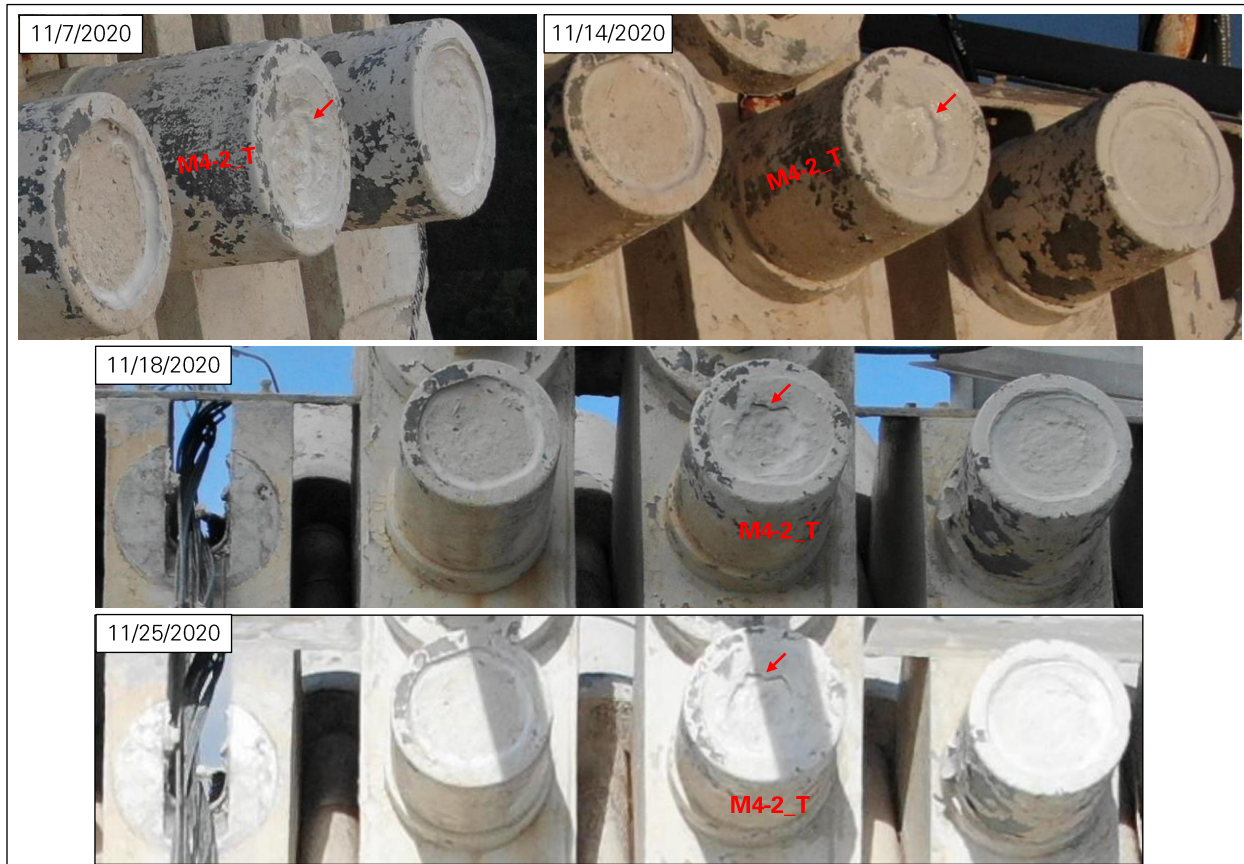
Figure 30: M4 sockets at Tower 4 after M4-4 failure. On socket M4-2, the central part of the zinc casting appears to move inwards, resulting in a new sealant crack. (Photos: NAIC Arecibo Observatory, a facility of the NSF.)

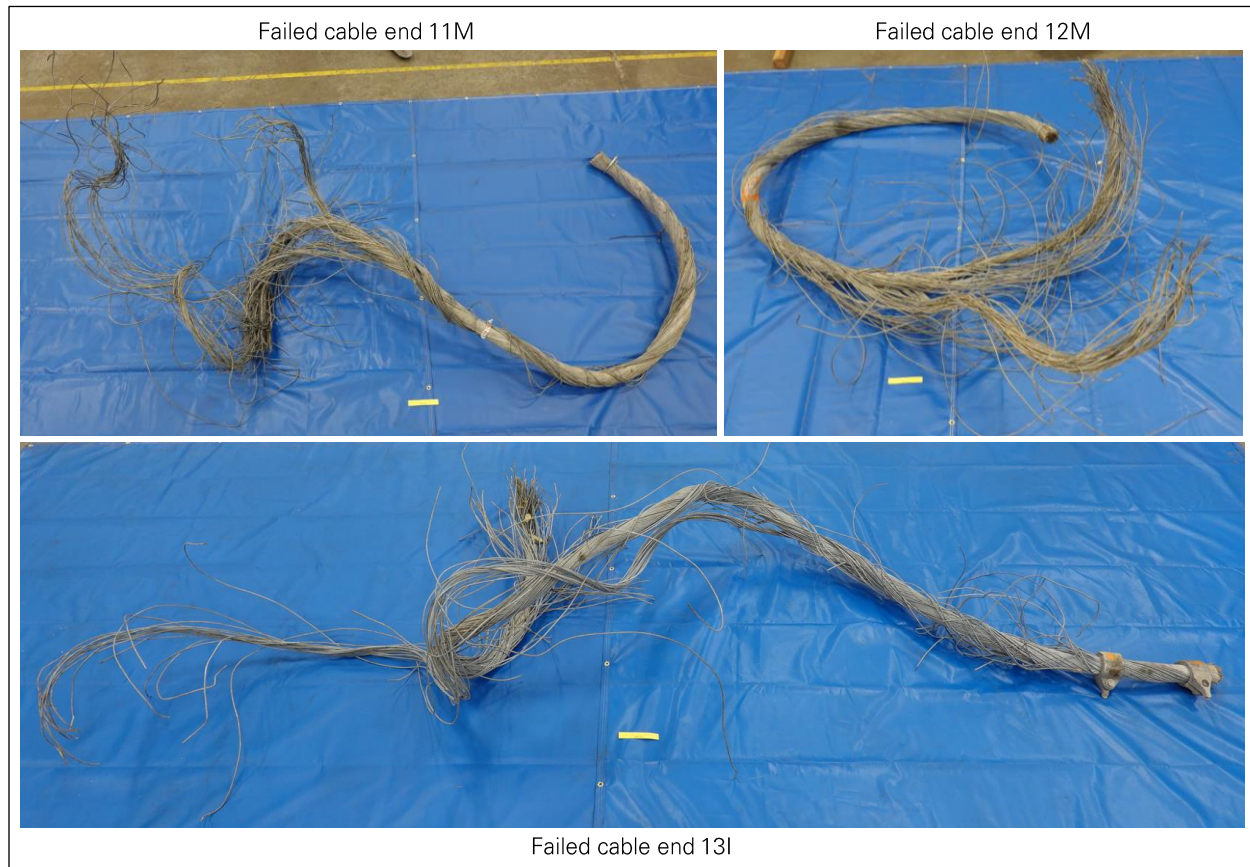
Figure 1: Failed ends of three M4 cables (photos: Socotec).

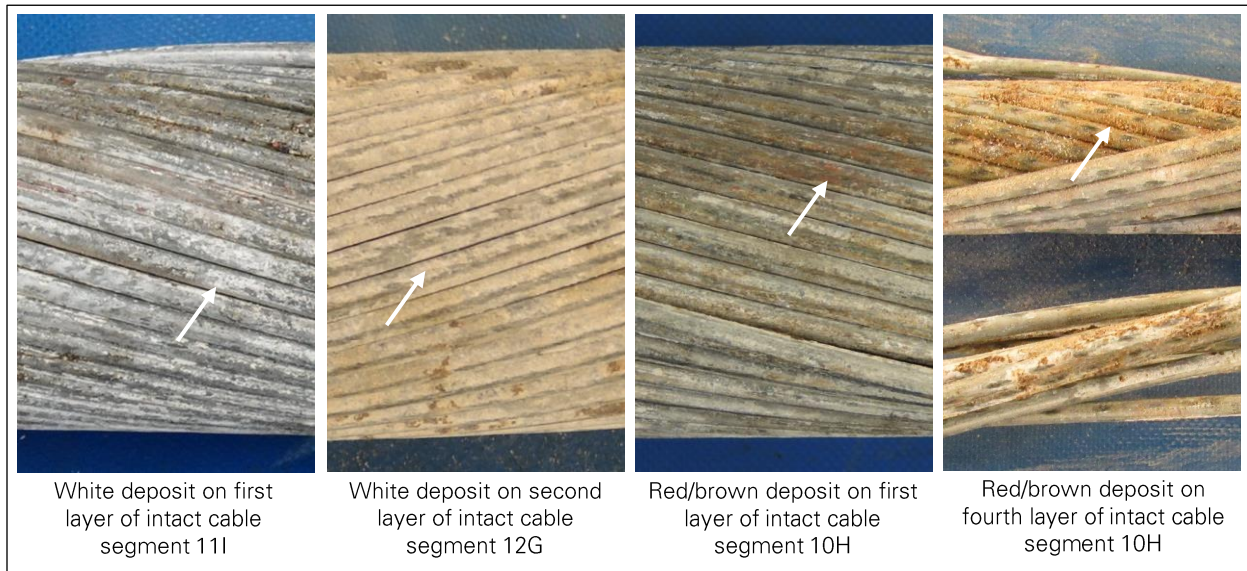
Figure 4: Corrosion deposits tested for chemical composition (photos: Socotec).

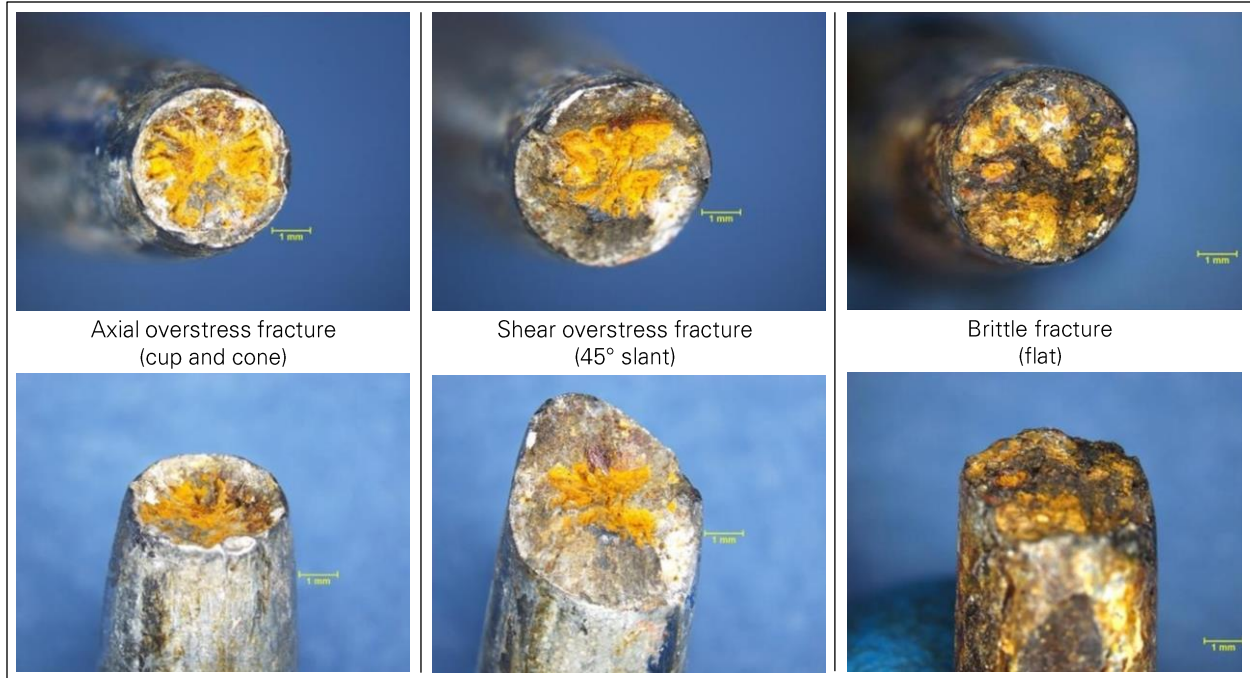
Figure 10: Representative images of axial overstress, shear overstress, and brittle fracture surfaces on wires of the failed cable ends (photos: Socotec).

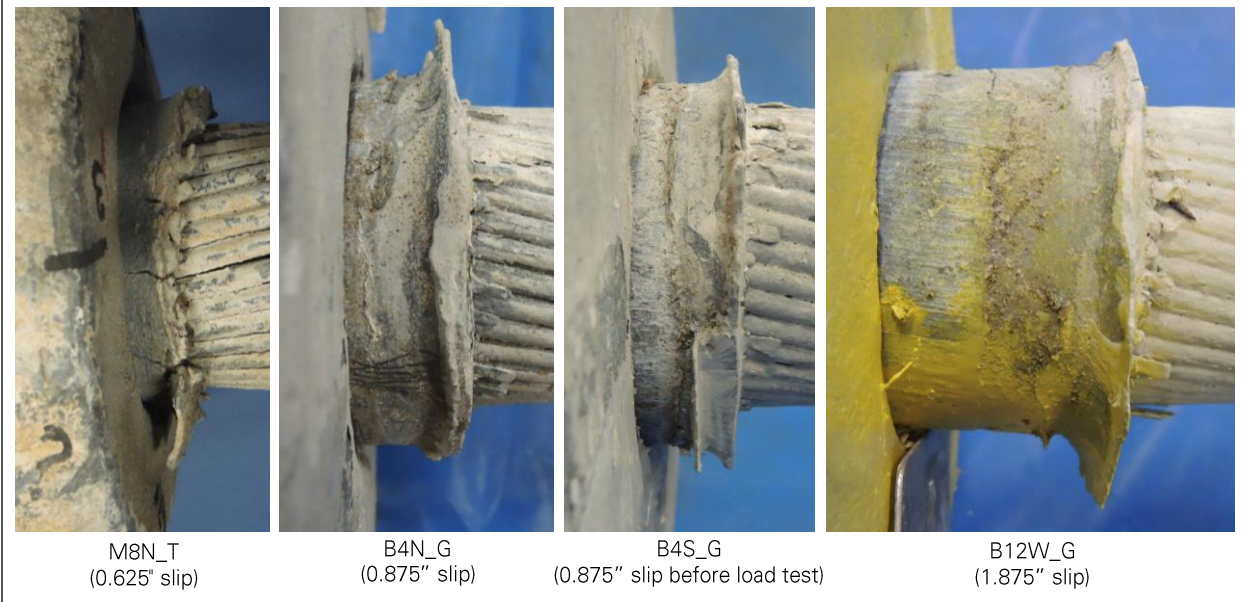
Figure 9: Cable slips observed on four auxiliary sockets (photos: Socotec).

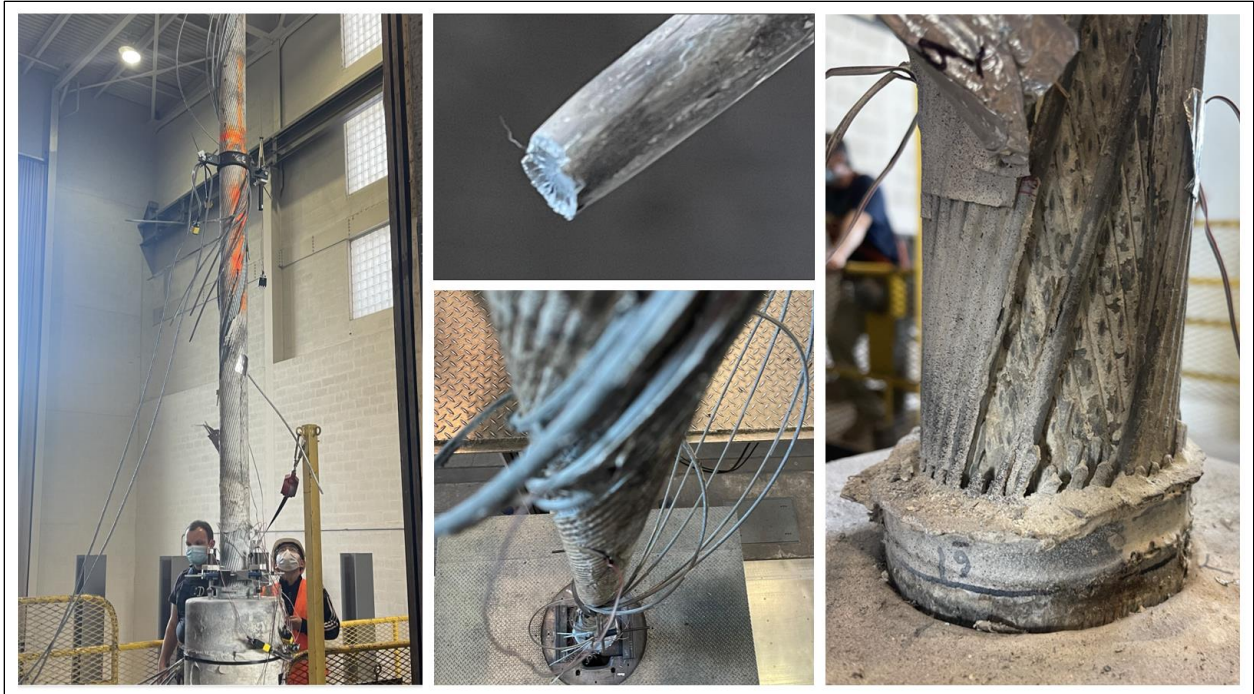
Figure 17: Specimen condition at end of load test.

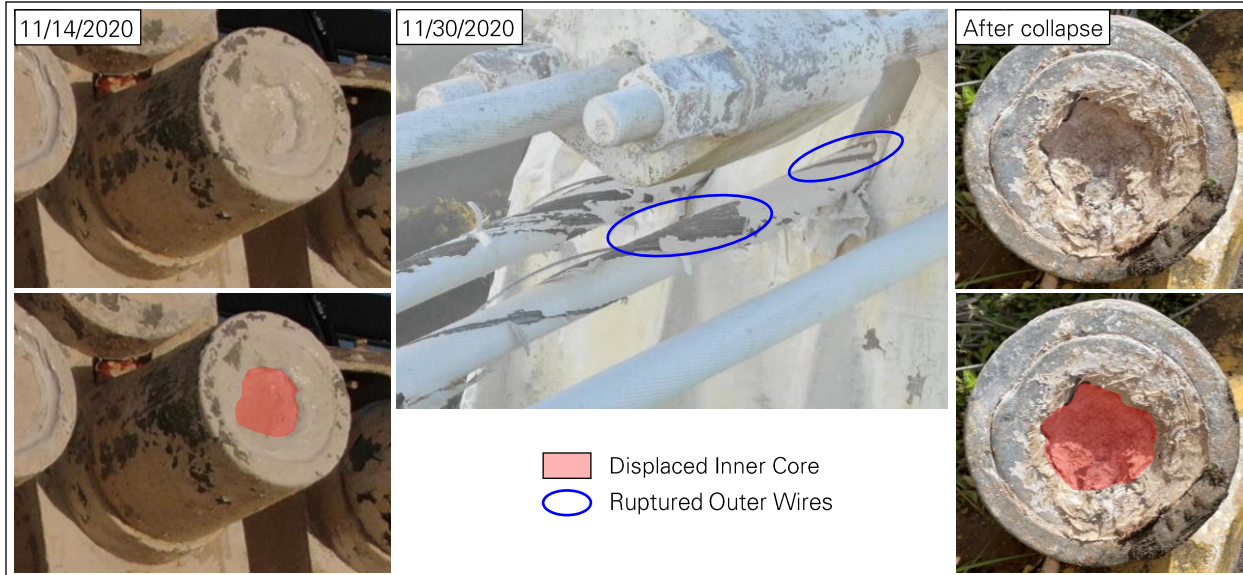
Figure 3: Displaced inner core and ruptured outer wires in socket M4-2_T before failure (left and center) and after failure (right) (left and center photos: NAIC Arecibo Observatory, a facility of the NSF).

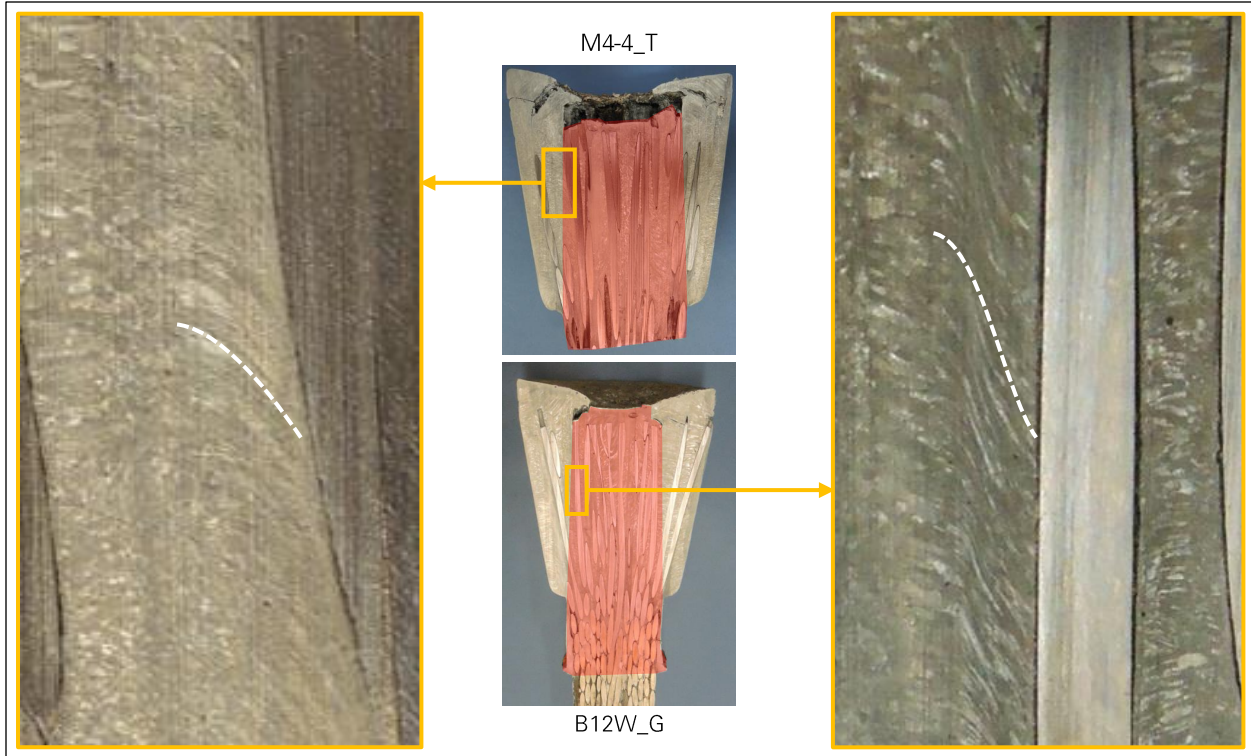
Figure 6: Zinc flow near surface of slipped core in sockets M4-4_T and B12W_G (photos: Socotec).
