Arecibo Telescope Collapse Forensic Investigation

Thornton Tomasetti

July 25, 2022

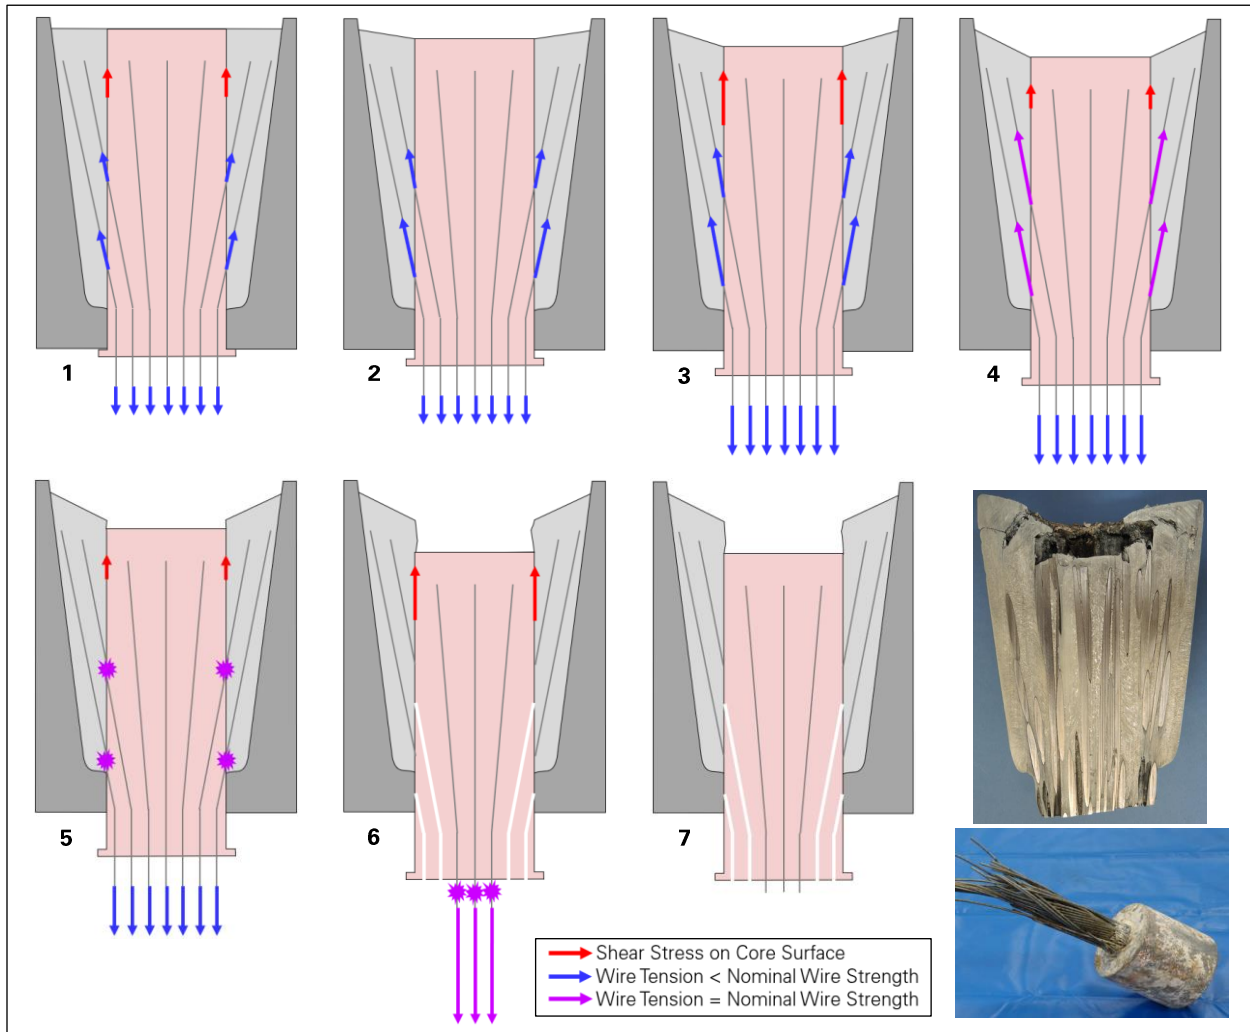
Figure 29: Behavior and failure of socket M4-4_T (photos: Socotec).

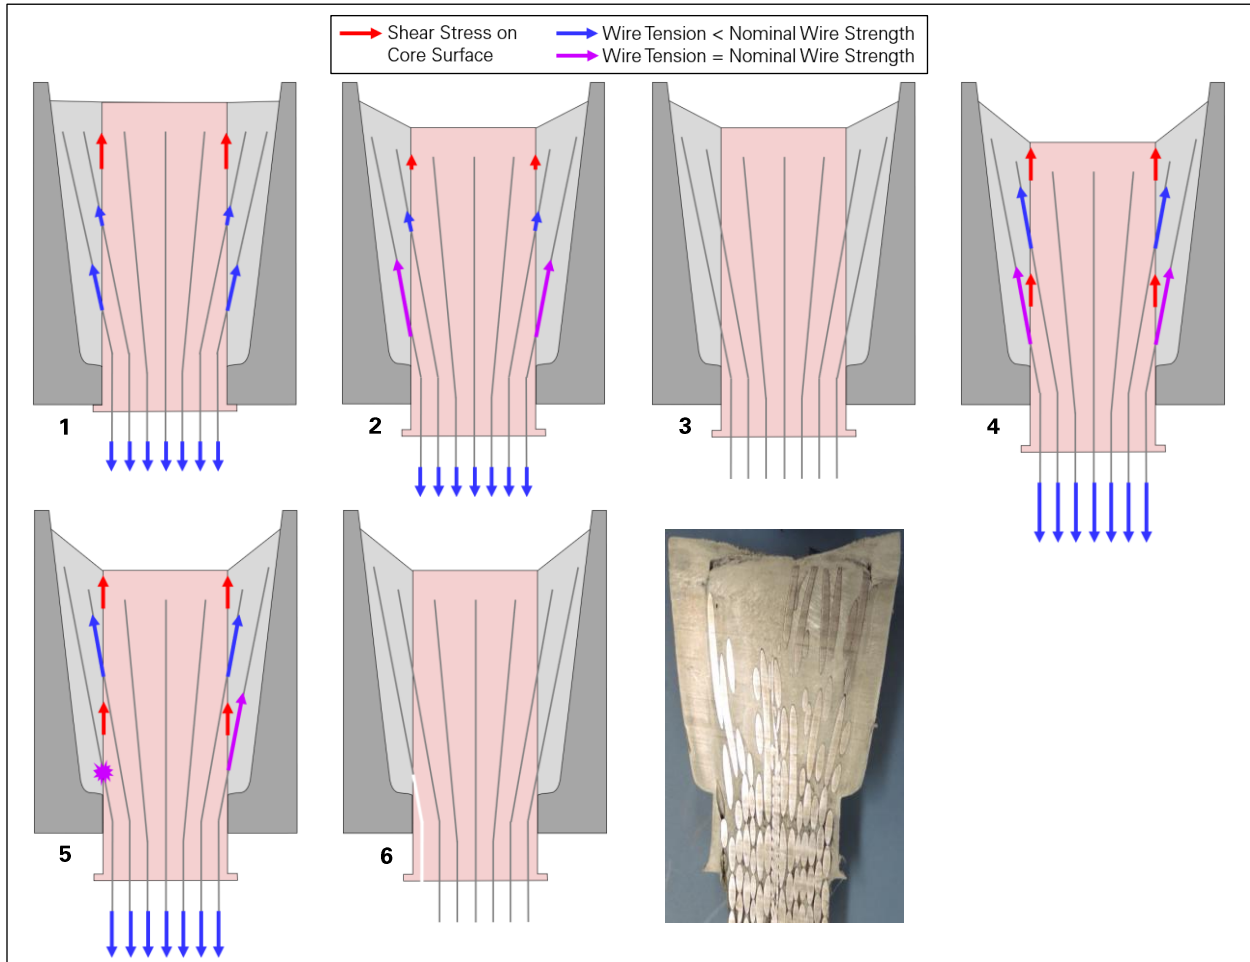
Figure 32: Behavior and failure of socket B4S_G (photo: Socotec).

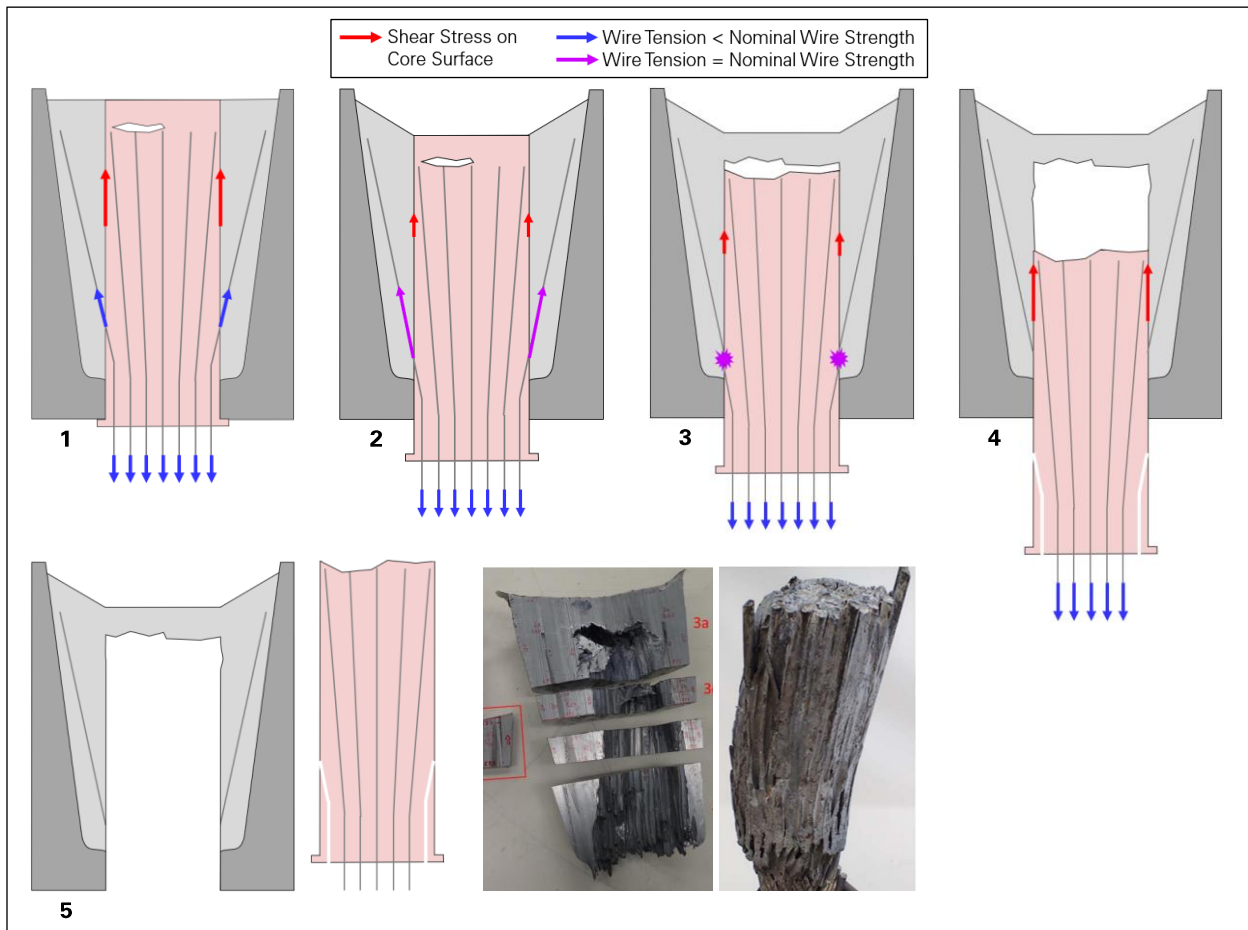
Figure 33: Behavior and failure of socket M4N_T (photos: WJE⁵).

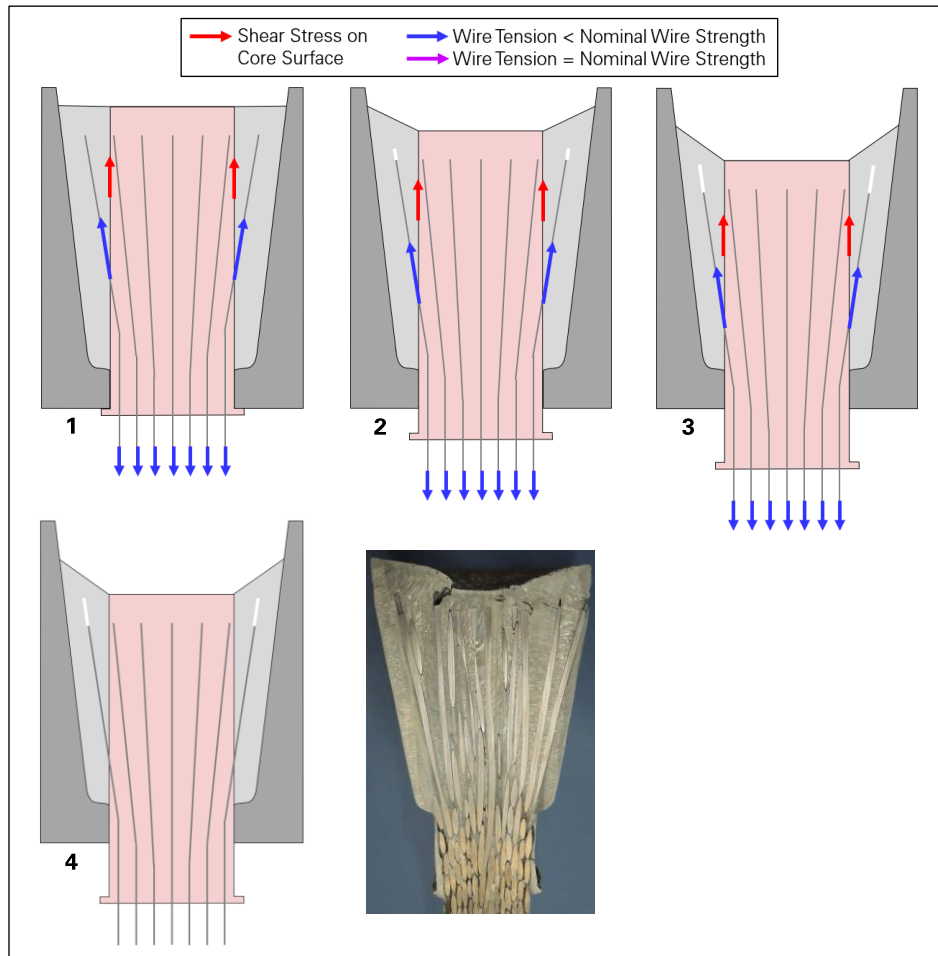
Figure 34: Behavior of socket B12W_G (photo: Socotec).
