# TN246

## Z180-Based Boards and Changes to the Serial EEPROM

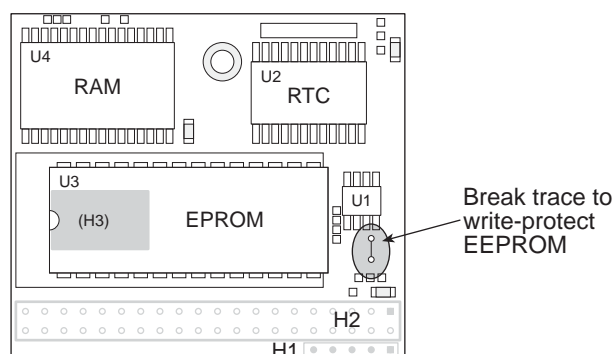
**Figure 1. Trace Location on CM71xx Boards**

For CM71xx boards, there is a trace that controls the write-protect status. See Figure 1 for the location of the trace.
