Arecibo Telescope Collapse Forensic Investigation

Thornton Tomasetti

July 25, 2022

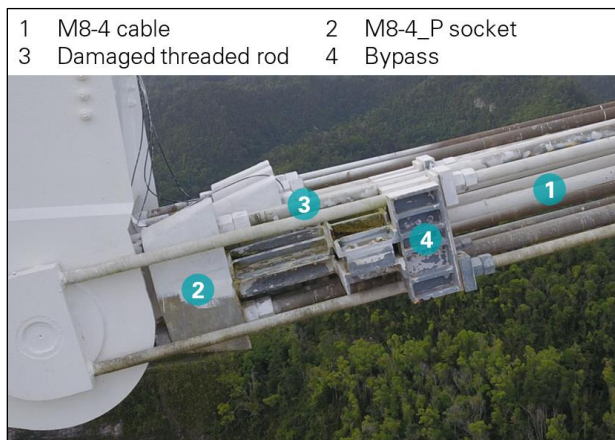
Apart from the second upgrade, three significant changes were made to the cable system. In 1981, one of the original backstays of Tower 12 was replaced after six wire breaks were discovered in the cable over time. Then in 1997, a threaded rod connecting the platform-end socket of cable M8-4 was accidentally damaged while implementing the second upgrade of the telescope. A structural bypass was installed to catch the socket should the damaged rod fail (Figure 11). In 2014, a splice near the tower end of the same M8-4 cable was bypassed after multiple wire breaks were discovered during an inspection (Figure 12).

Figure 11: Damaged rod bypass at platform end of cable M8-4
(photo: NAIC Arecibo Observatory, a facility of the NSF).

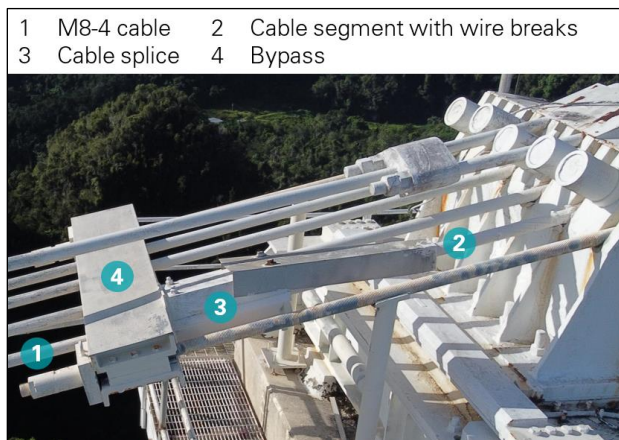
Figure 12: Cable splice bypass near tower end of cable M8-4
(photo: NAIC Arecibo Observatory, a facility of the NSF).

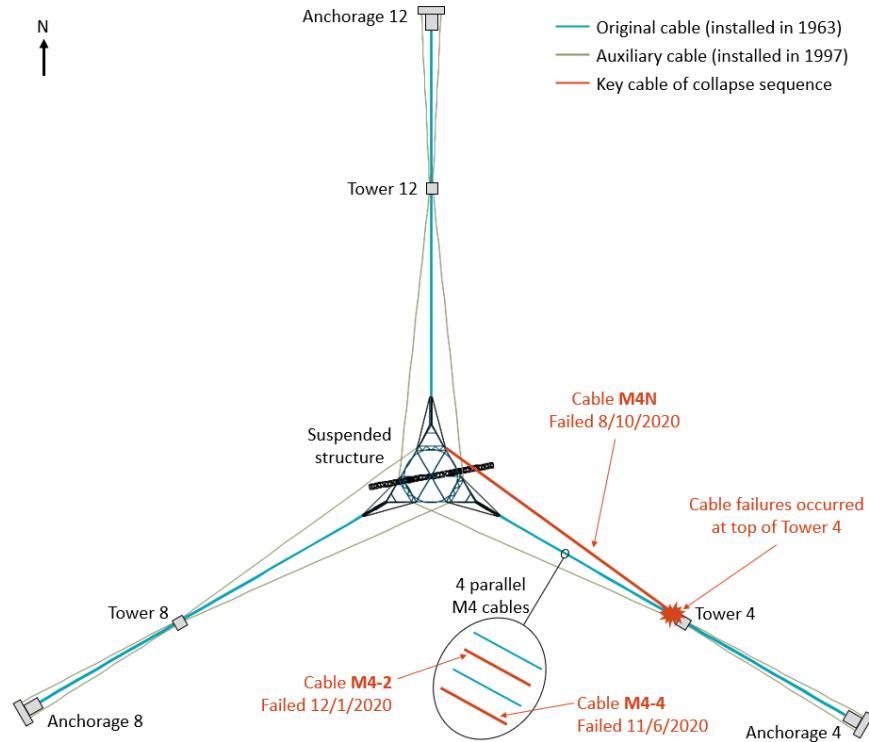
At 2:36 AM local time on August 10, 2020, cable M4N pulled out of its socket at the top of Tower 4 (Figure 18). This first failure occurred as the telescope was operating normally, with the azimuth arm rotating with respect to the platform and the Gregorian shifting along the bottom of the azimuth arm. There were no particularly strong winds or any significant earthquake during that night. The telescope continued to operate (azimuth arm and Gregorian movement) for approximately 20 minutes after the cable failure, before being stopped by the operator. Several wire breaks were observed three days later in adjacent cables at the top of Tower 4, and likely occurred when M4N failed (details in Section 3.2.1).

Figure 18: Cable failure locations.

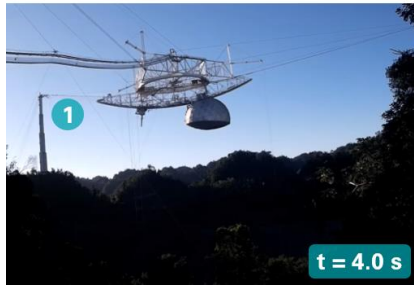
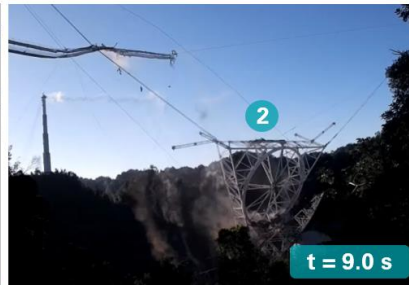
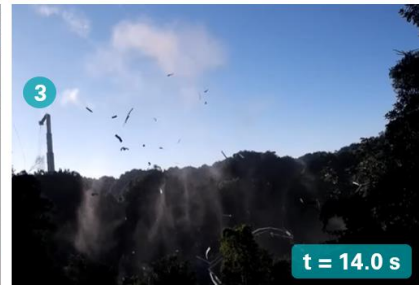
At 7:54 AM local time on December 1, 2020, cable M4-2 failed at its socket at the top of Tower 4, once again without any significant wind or seismic activity. This third cable failure was immediately followed by the failure of the remaining two original mains at the top of Tower 4, initiating the fall of the suspended structure. The suspended structure swung down while still connected to Tower 8 and Tower 12, and impacted a cliff face between these two towers. During the fall, the azimuth arm detached from the platform and fell through the reflector. Finally, the top of the three towers broke off and fell (Figure 19).

Figure 19: Telescope collapse sequence, looking south.
 (Still images of collapse video by NAIC Arecibo Observatory, a facility of the NSF.
 Intermediate still images are in provided Appendix E.)

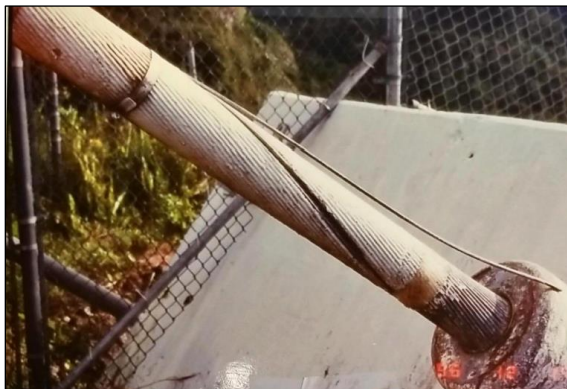
Each main and backstay cable is made of 126 to 216 steel wires, and individual broken wires were occasionally discovered near the cable ends throughout the structure’s life (Figure 20). A total of 40 wire breaks had been reported before 2020 (Figure 22). No more than three wire breaks were reported at each cable end, with two exceptions: six breaks at the bottom of a backstay cable, which was subsequently replaced, and 12 breaks near a cable splice (Figure 21), which was subsequently bypassed. Only the breaks that occurred in the outer layer of wires were visible and therefore counted.

Figure 20: Single wire break observed at ground end of cable B4-1 on 12/12/1996
(photo: NAIC Arecibo Observatory, a facility of the NSF).

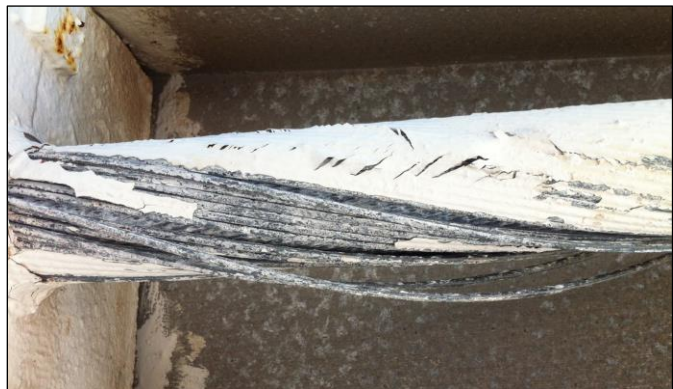
Figure 21: Multiple wire breaks observed at splice near tower end of cable M8-4 on 1/14/2014
(photo: NAIC Arecibo Observatory, a facility of the NSF).

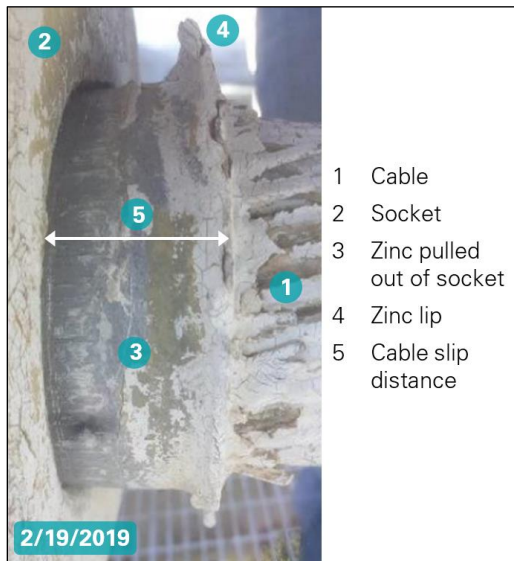
Before failing on August 10, 2020, the end of cable M4N had slipped by more than one inch outside its socket at the top of Tower 4 (Figure 23). This slip is approximately one-third of the cable’s diameter, and twice the AASHTO limit.

Figure 23: Last known cable slip (1.125 inch) at socket M4N_T, where first cable failure occurred (photo: NAIC Arecibo Observatory, a facility of the NSF).

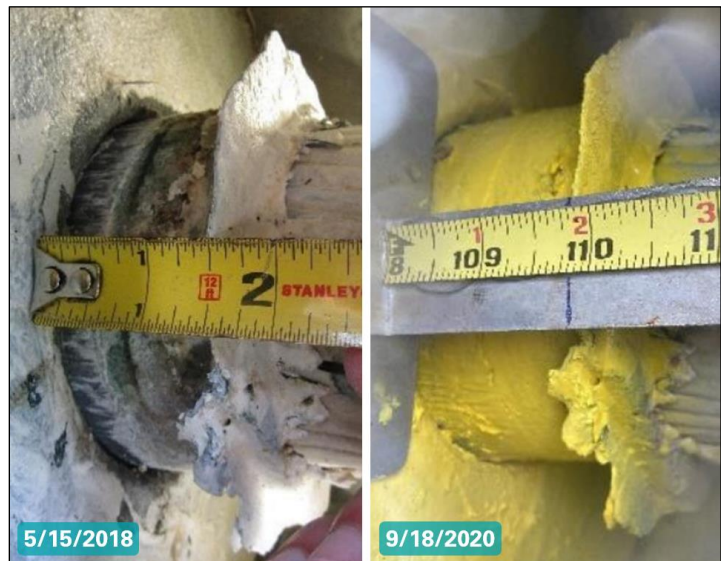
Figure 24: Cable slip increase measured at socket B12W_G (photos: NAIC Arecibo Observatory, a facility of the NSF).

The cable slips were measured at the tower and ground ends of the auxiliary cables after the first cable failure, and at the platform ends after the collapse (Figure 25). One-third of the cable slips exceeded the AASHTO limit of one-sixth of the cable diameter. The maximum cable slip was observed at the ground end of B12W, and had increased from 1.5 inches in May 2018 to over 1.75 inches in September 2020 (Figure 24).

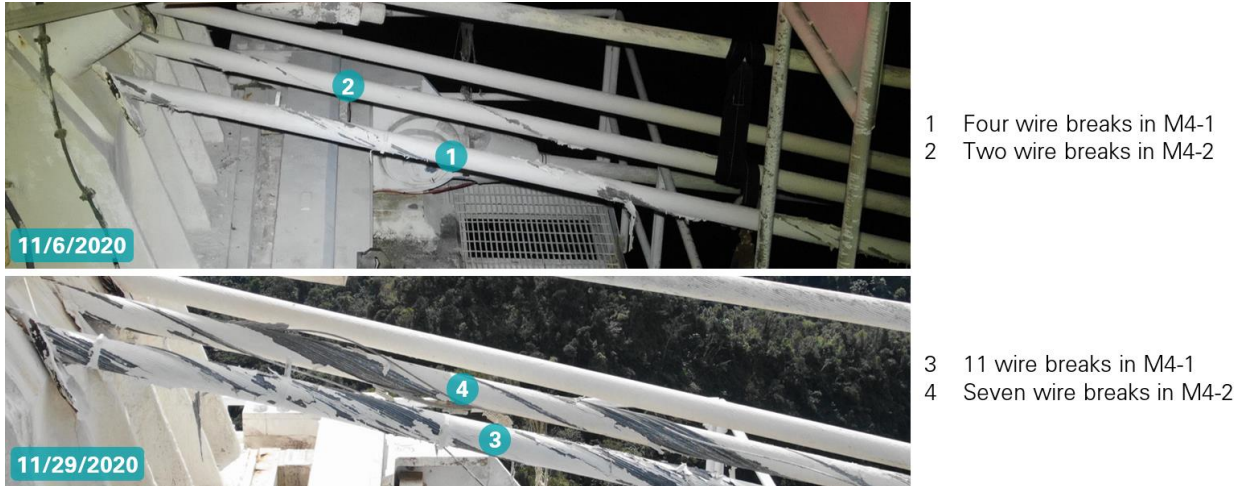
In the three weeks following the M4-4 failure, seven and five additional wires breaks were observed at the tower end of M4-1 and M4-2, respectively (Figure 27). The zinc casting of the M4-2 socket continued to deform with signs of crack movement at the back face of the casting (Figure 28).

Figure 27: Wire break development after second cable failure
 (photos: NAIC Arecibo Observatory, a facility of the NSF).

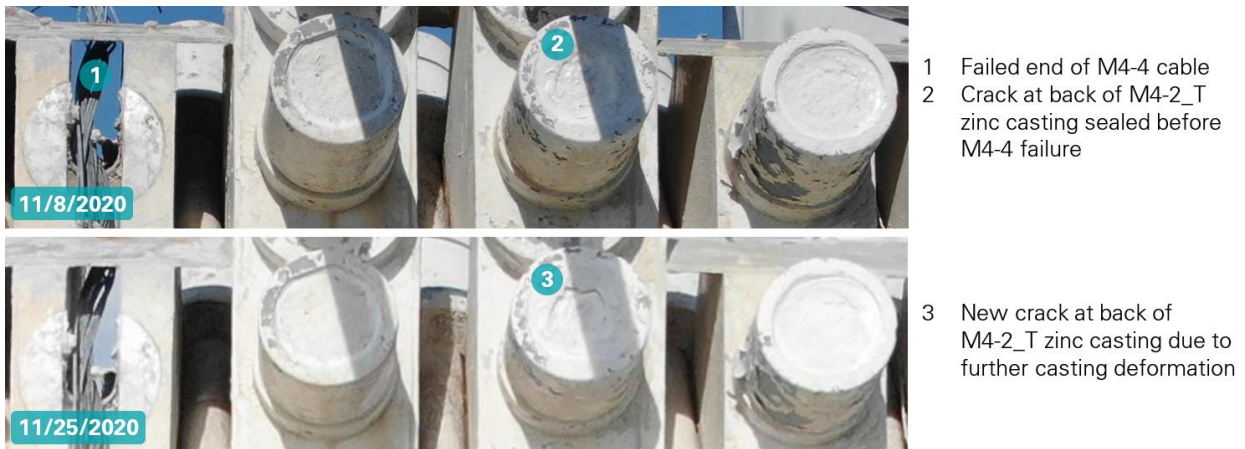
Figure 28: Evidence of socket casting core displacement after second cable failure
 (photos: NAIC Arecibo Observatory, a facility of the NSF).

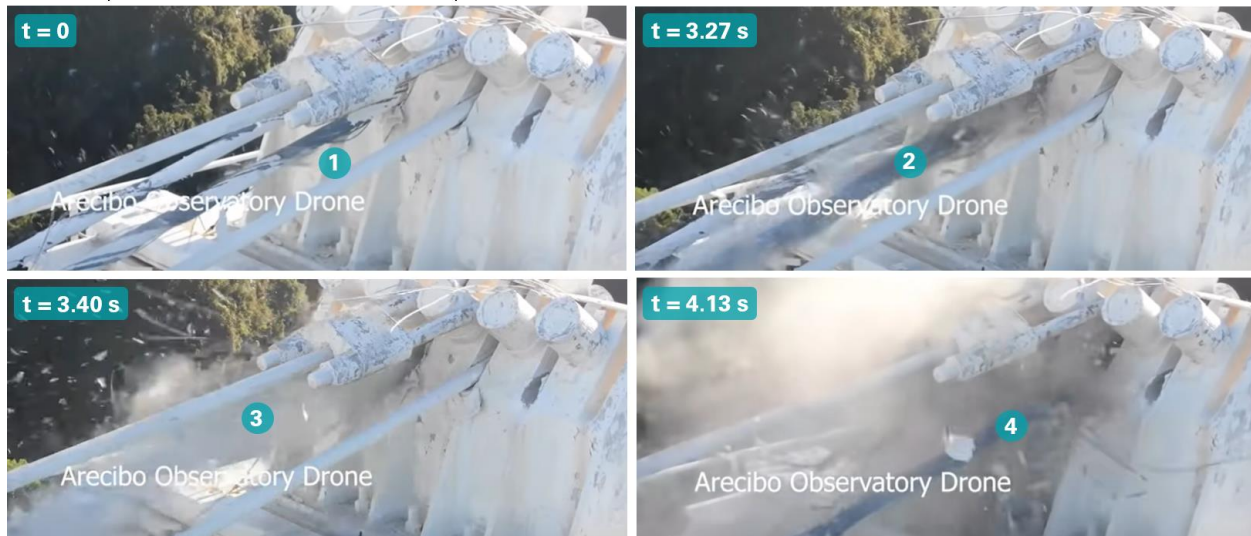
On December 1, 2020, the telescope collapsed immediately after the failure of cable M4-2 at the top of Tower 4, which was captured on a drone video (Figure 29). The video shows a wire break on M4-2, followed by the entire cable failure three seconds later and the failure of the remaining two M4 cables immediately after. After loss of support from Tower 4, the platform swung down away from Tower 4 and crashed into a cliff face between Tower 8 and Tower 12.

- 1 New wire break in M4-2
- 2 Complete failure of M4-2
- 3 Complete failure of M4-1
- 4 Complete failure of M4-3

Figure 29: Progressive failure of original main cables at top of Tower 4.
 (still images of drone video by NAIC Arecibo Observatory, a facility of the NSF.
 Intermediate still images are provided in Appendix E.)

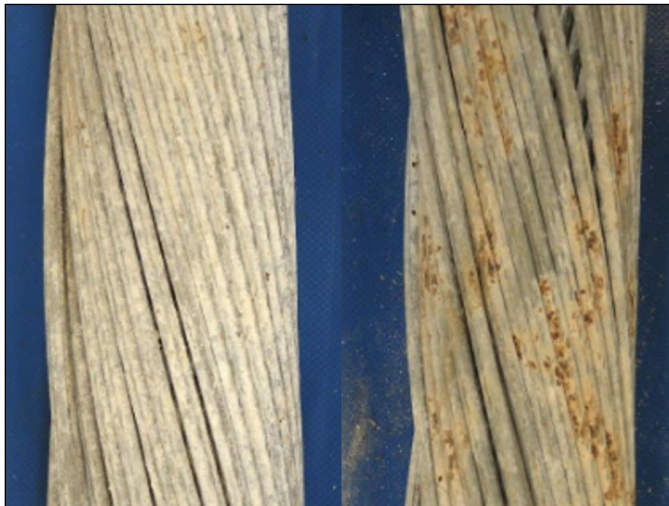
The original (1964) and auxiliary (1997) cables were in good general condition when the telescope collapsed. Several cable segments were taken apart to observe the condition of the inner layers of wires. As shown in Figure 30, moderate corrosion of the wires’ galvanizing zinc and superficial corrosion of the wires’ base steel was observed at some discrete locations. The remaining weight of galvanizing zinc was measured on wires taken from the outer layers of three original cables. After 57 years of service, more than 80 percent of the tested wires still had more galvanizing zinc than required for new Class A wires

Figure 30: Oxidation of galvanizing zinc (left) and wire steel (right) in second wire layer of an original M4 cable (photos: Socotec).

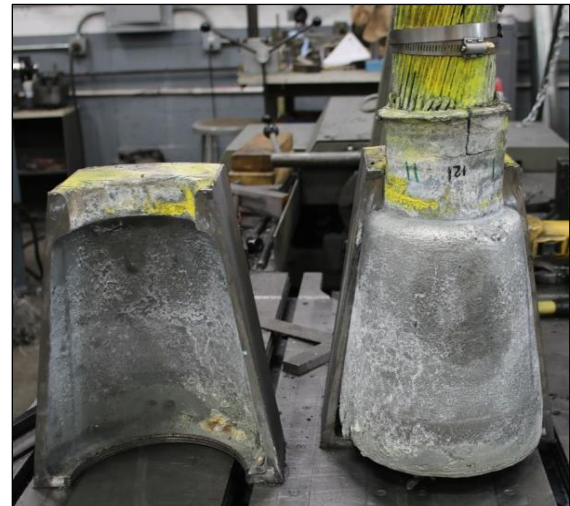
Figure 31: Surface corrosion of B12W_G socket casting (photo: Socotec).

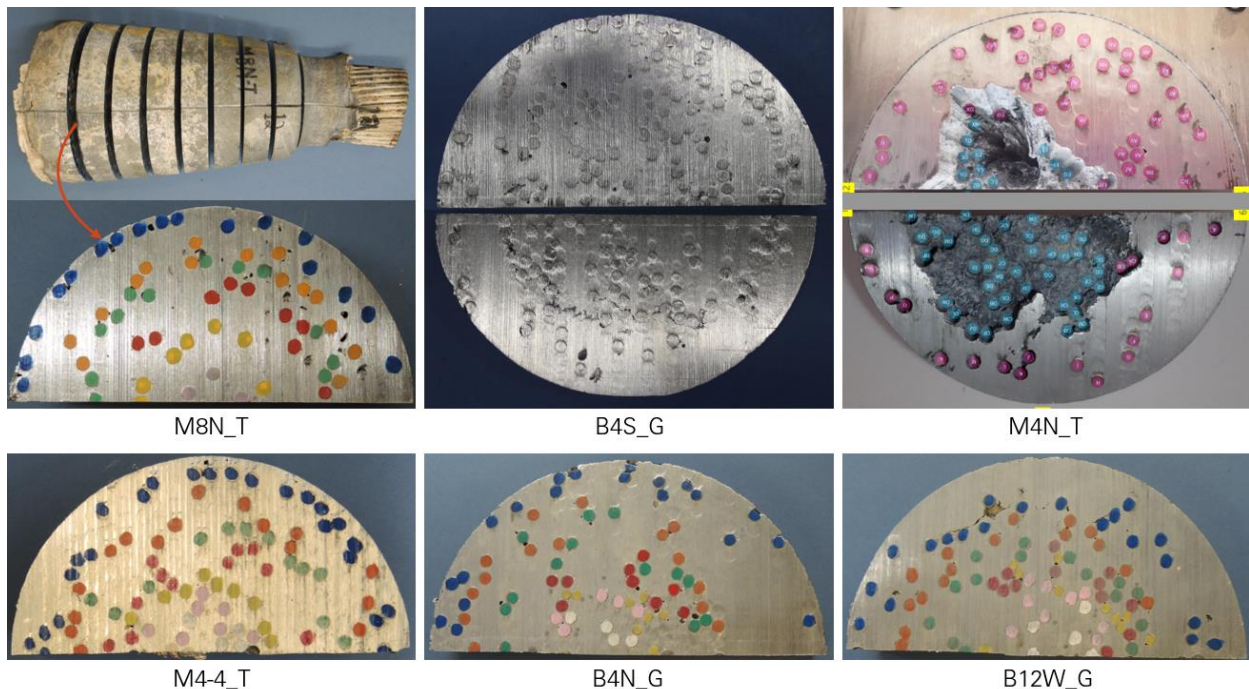
During socketing, the cable’s wires are spread out inside the socket to form a broom before pouring zinc. The casting of socket M4-4_T (second cable failure) and four auxiliary sockets (M8N_T, B4N_G, B4S_G, B12W_G) that exhibited different degrees of cable slip were cut in the transverse direction to observe the wire broom. As shown in Figure 32, the wire brooms are irregular, and differences in wire distribution between the center and perimeter of the casting can be observed. Additional observations and results on the wire broom geometry are provided in Appendix M.

Figure 32: Wire distribution at back of socket castings (M4N_T photos: WJE¹⁵; other photos: Socotec).

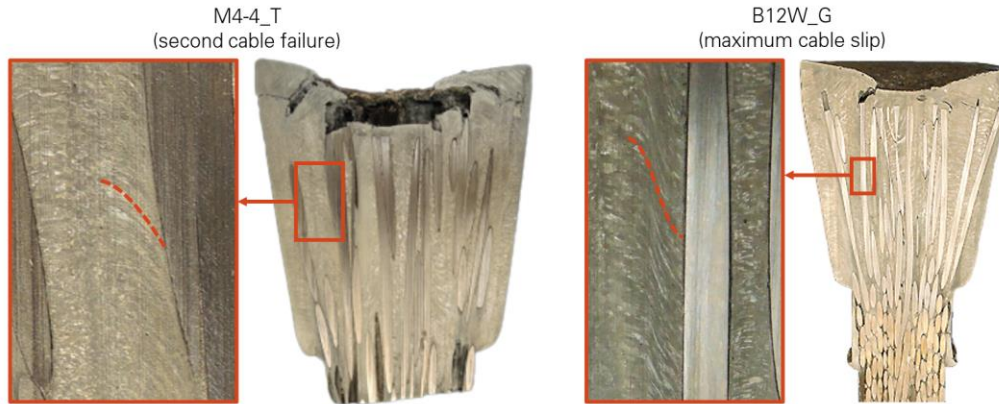
The surfaces of the longitudinal cuts of the socket's castings were macro-etched to observe the grain structure. Elongated deformation of the zinc grains was observed between wires near the surface of the displaced casting core (Figure 34).

Figure 34: Evidence of grain flow near surface of displaced core in socket zinc casting (photos: Socotec).

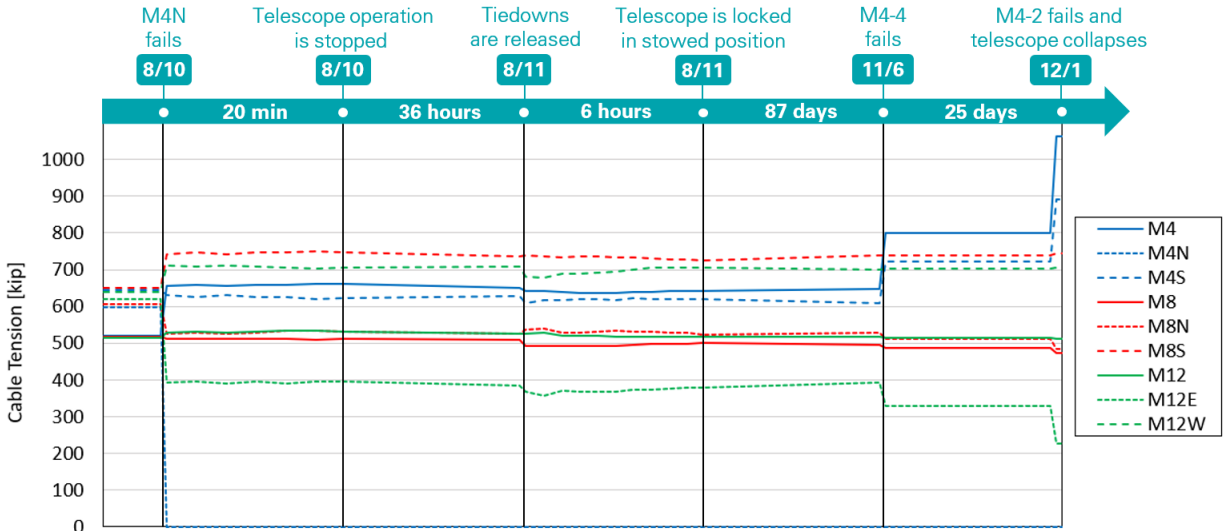
By comparing the position of the platform before and after the first cable failure (M4N), we determined that cable M4N carried a tension of 600 kip when it failed. This corresponds to a safety factor of 2.2. The M4N failure had a significant impact on the four original M4 cables, decreasing their safety factor from 2.0 to 1.6. After one of these cables failed (M4-4), the safety factor of the remaining three M4 cables dropped to 1.3. The collapse started with the failure of another M4 cable (M4-2). If the structure had stabilized after this third cable failure, the safety factor in the remaining two M4 cables would have been less than 1.0.

The M4N failure had a more significant impact on the redistribution of cable tensions than the M4-4 failure. Since M4N was an isolated cable, its failure resulted in an imbalance in the suspended structure. The suspended structure rotated to reach a new balance state resulting in increased and decreased tensions in the rest of the cable system. M4-4 ran in parallel with three other original M4 cables. As a result, when M4-4 failed, its tension was primarily redistributed to the three other M4 cables.

Figure 43: Tension in main cables between first cable failure and collapse.

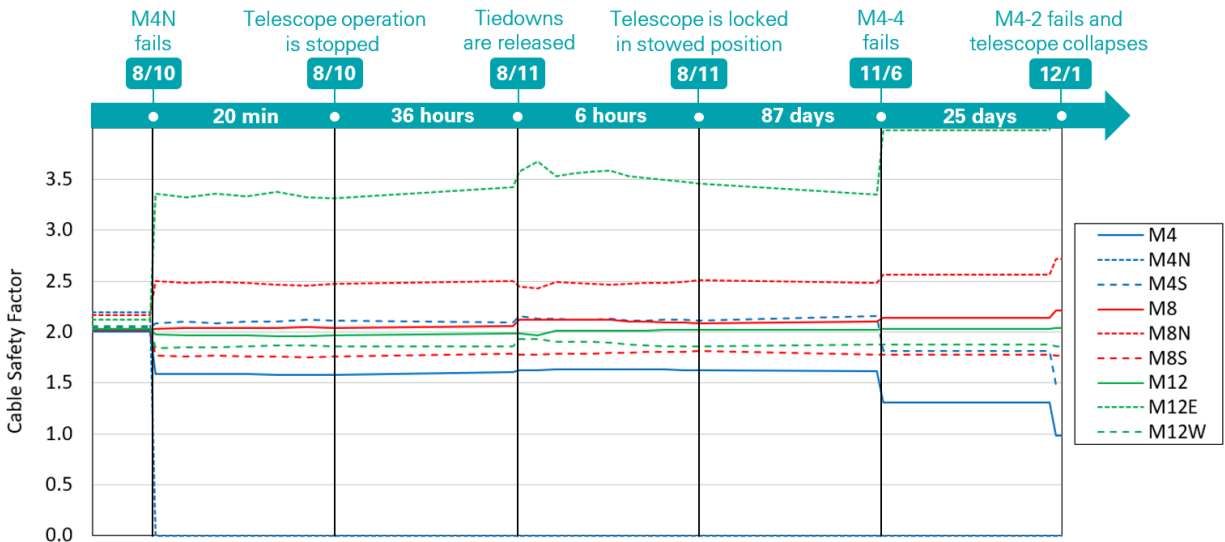
Figure 44: Safety factor in main cables between first cable failure and collapse.

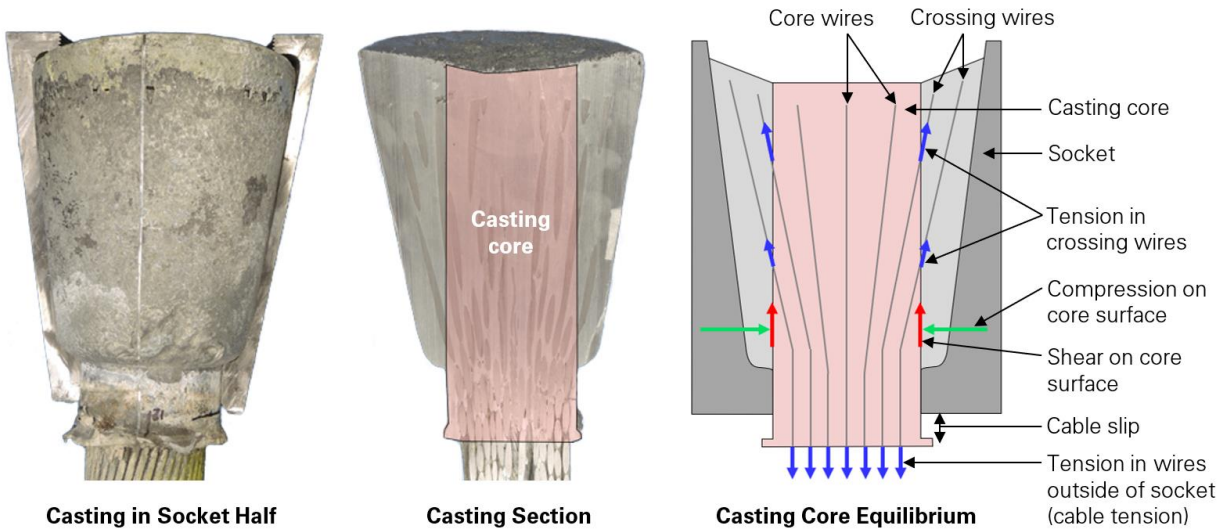
In a zinc-filled spelter socket, the cable tension is transferred to the socket through a zinc casting. In the telescope’s sockets that failed or exhibited the largest cable slip, we observed the displacement of a cylindrical *core* within the casting. If we consider the forces acting on this core (Figure 45), the cable tension is resisted by shear stress on the core surface and/or tension in the wires that cross through the

core surface. These wires are referred to as the *crossing wires*, and are typically part of the outer layers of the cable.

Figure 45: Equilibrium of socket casting core (photos: Socotec).

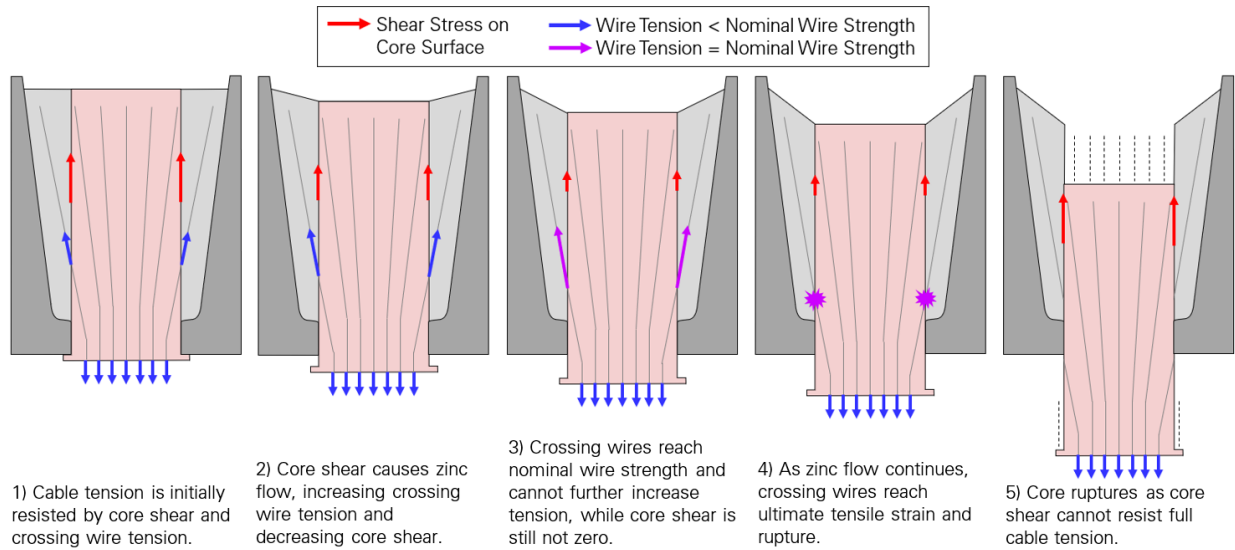
A socket where the crossing wires cannot resist the full cable tension is bound to fail, and the socket's failure mode depends on whether the crossing wires are fully or partially developed. If the crossing wires are fully developed (Figure 48), they continue to stretch near the core surface as the zinc continues to flow. Some of the wires rupture when they reach their ultimate tensile strain, which increases core shear and accelerates zinc flow, leading to more wire ruptures and, eventually, to *core rupture*. If the crossing wires are partially developed, they can slip in parallel with the core instead of rupturing, leading to *core flow-out* (Figure 49). In this case, the cable continues to gradually slip out of the socket. Complete slip-out or rupture of the core will eventually occur as the contact length between cable and socket decreases and/or the zinc's strain becomes too large. Macroscopically, the socket failure is more brittle when the crossing wires are fully developed, and more ductile when the crossing wires are partially developed. Actual sockets may include both fully and partially developed crossing wires and therefore exhibit intermediate behaviors and failure modes (Figure 50).

Figure 48: Case 2 – Core rupture when crossing wires cannot resist full cable tension and are fully developed.

Four of the six sockets that were analyzed failed or were in the process of failing. The failures of sockets M4N_T and M4-4_T occurred in the field and involved the rupture of multiple outer wires and a significant shift or complete pull-out of the core, which corresponds to core rupture (Figure 48, page 35). The load test of socket B4S_G was stopped after seven outer wires ruptured, indicating that the socket was on the brink of core rupture. Finally, socket B12W_G experienced a very large cable slip as its crossing wires slipped without fracturing, which corresponds to core flow-out (Figure 49 page 35).

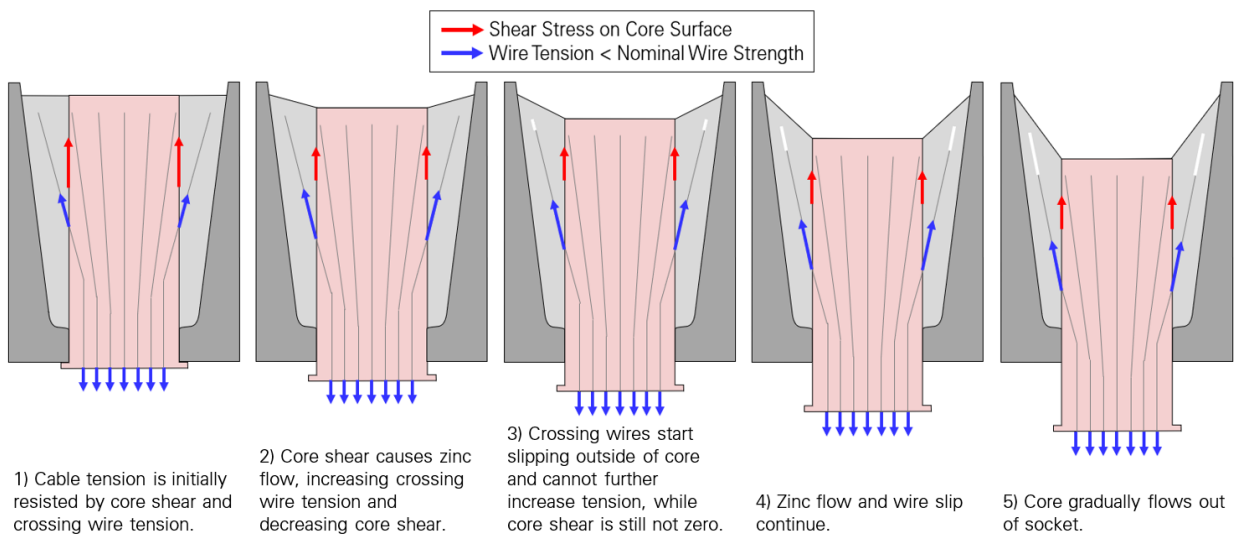
Figure 49: Case 3 – Core flow-out when crossing wires cannot resist full cable tension and are partially developed.

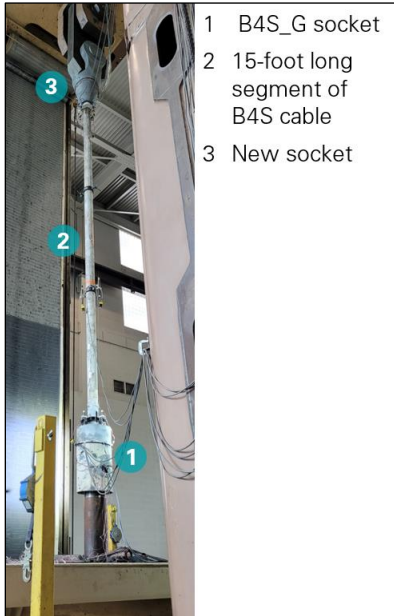
Socket B4S_G was recovered from the collapsed telescope with 15 feet of cable attached. The socket was generally in good condition, had no visible wire breaks, and exhibited an intermediate cable slip of 0.875 inch. The free end of the cable was cast in a new zinc-filled spelter socket, and the specimen was installed in a test frame (Figure 55).

Figure 55: Socket and cable specimen in load testing machine.

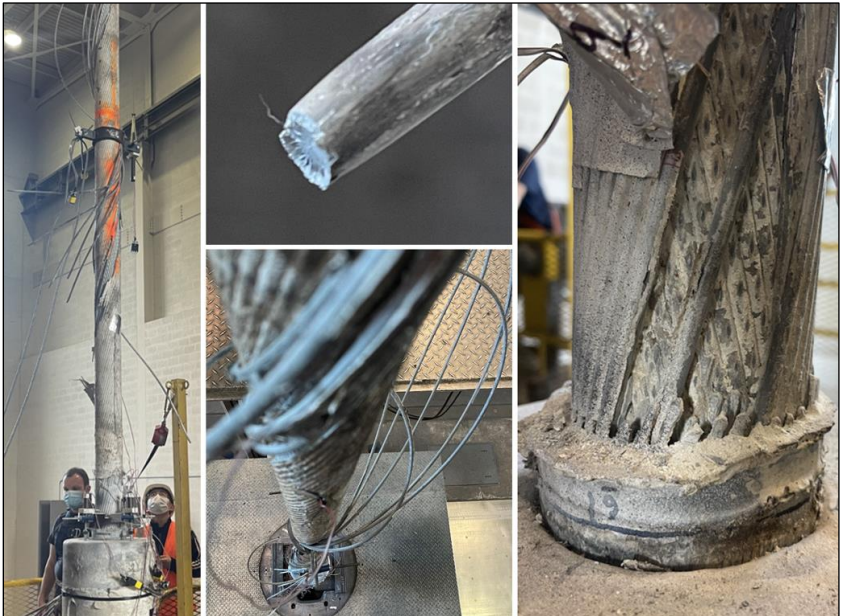
Over the course of four days, the specimen was initially loaded and held at 100, 125 and 150 percent of the cable’s service load of 675 kip for 20 hours, and a series of load cycles was applied at each load level (Figure 57). After unloading to half the service load, the load was increased until seven outer wires ruptured in socket B4S_G (Figure 56) and the specimen was unable to carry more load. The maximum tension reached was two percent greater than the cable’s Minimum Breaking Strength, such that the cable still met its design strength requirement after 25 years of service. No wire ruptures were observed at the new socket end.

Figure 56: Failed wires in B4S_G socket at end of load test.

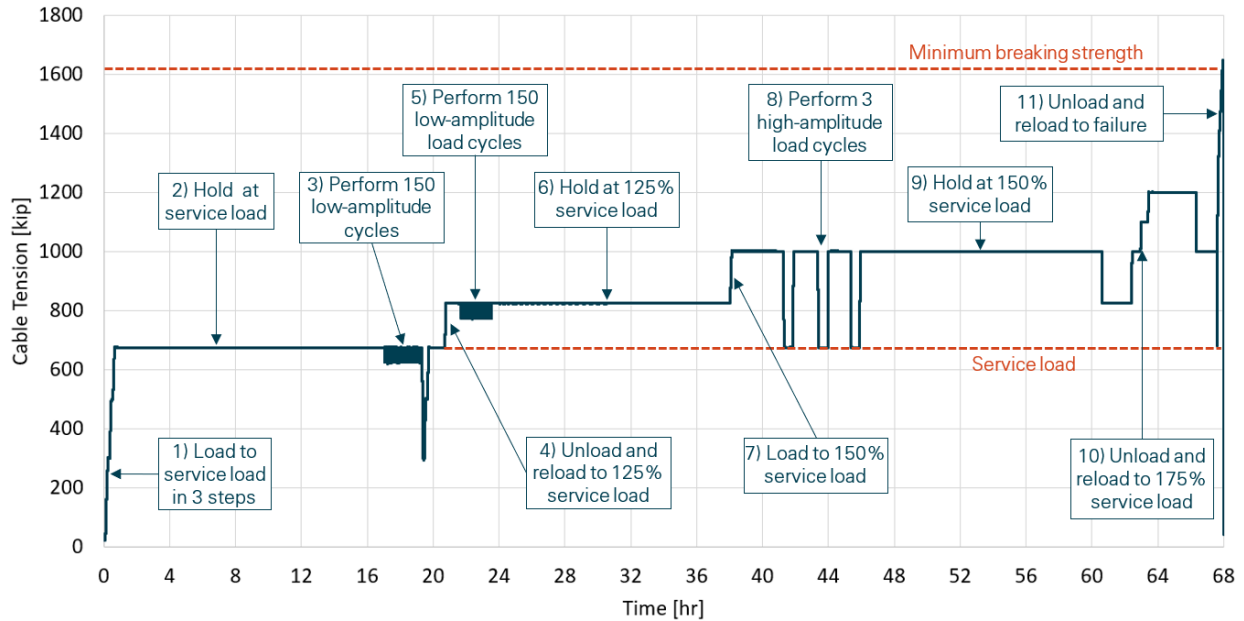
Figure 57: Loading time history of B4S_G socket test.

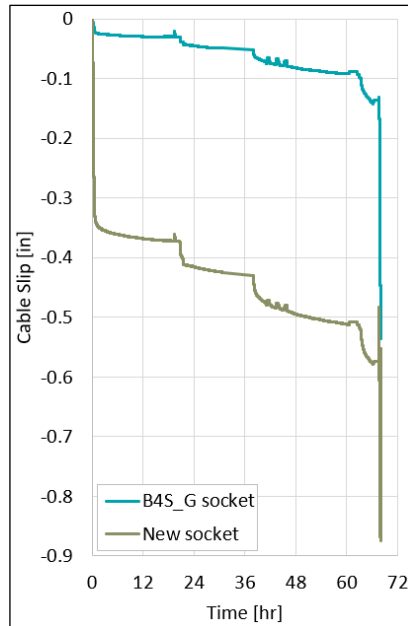
The zinc flow is non-recoverable, as was observed in the socket load test. The cable slip was monitored throughout the test with four displacement sensors at each socket (Figure 59). Plastic flow occurred in both sockets over the course of each hold, and the flow rate increased with the load. The cable slips resulting from the plastic flow were different between the new and existing sockets, although the cable tension was the same in both sockets. During the initial loading, the cable slip was more than 10 times larger at the new socket (0.35 inch) than at B4S_G (0.03 inch). This is due to the zinc casting of the new socket being wedged into the socket for the first time to achieve load transfer. When the load was increased to the next two levels, the additional cable slip remained larger in the new socket but the difference with B4S_G was less significant. For each load level, the cable continued to slip at both sockets while the load was held constant. This is evidence of time-dependent deformations occurring in the zinc castings. During the final loading to failure, the cable slip increased more at B4S_G (0.40 inch) than the new socket (0.27 inch). Considering the pre-existing slip of B4S_G (0.875 inch), the total cable slip at the end of the test was 1.375 inch at B4S_G, and 0.85 inch at the new socket. This is consistent with the socket behavior previously introduced (Figure 48 page 35), where a socket exhibits significant cable slip before failing. In addition, the total slip of 1.375 inch is relatively close to the last known slip of 1.125 inch at the first telescope socket that failed (M4N_T). The slip rate increased substantially in B4S_G once the cable tension exceeded 75 percent of the Minimum Breaking Strength, and it was clear that the cable was pulling from the socket.

Figure 59: Average cable slip per socket.

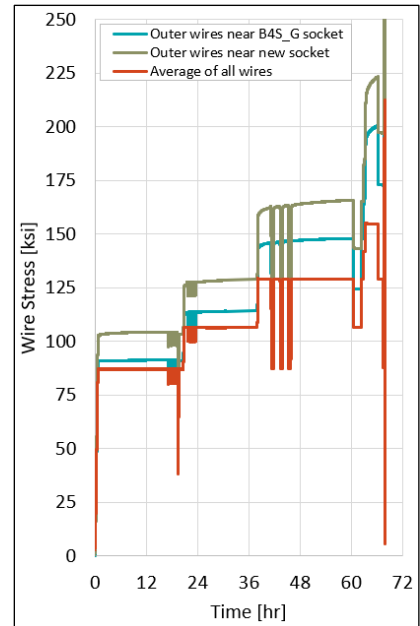
The stress in several outer wires near both sockets was monitored throughout the test with strain gages, while the average cable stress is known from the applied load (Figure 60). Under each increased load, the stress in the outer wires increased disproportionately more than in the inner wires. The outer wire stress is higher than the average cable stress at both sockets, and the difference is generally consistent with the measured cable slip. This is consistent with the socket behavior previously introduced (Figure 47 to Figure 50, pages 34 to 36), where the cable slip causes the tension to increase in the outer wires.

Figure 60: Outer wire stress vs. average cable stress.

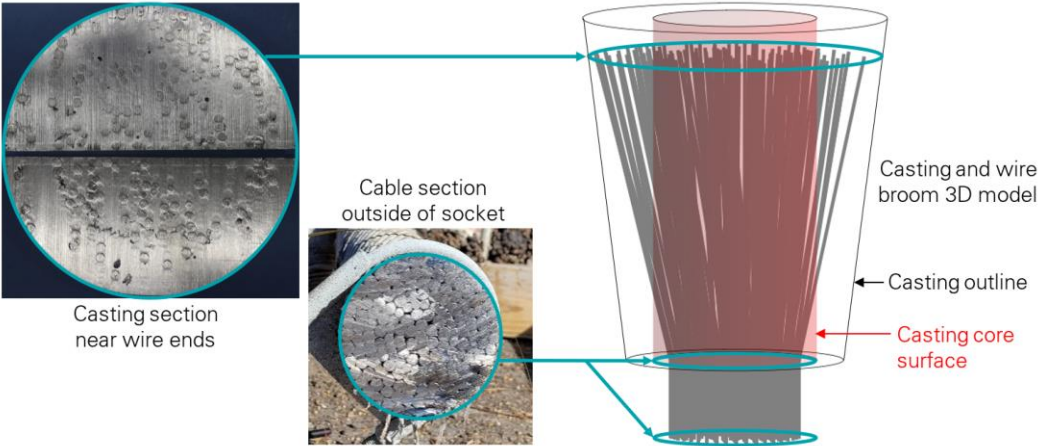
The wire broom geometry must be known to calculate the capacity of the crossing wires. The wire broom geometry was revealed from transverse cuts in the casting of six telescope sockets (Figure 61,

Figure 61: Construction of broom geometry from cable and casting sections (casting section photo: Socotec).

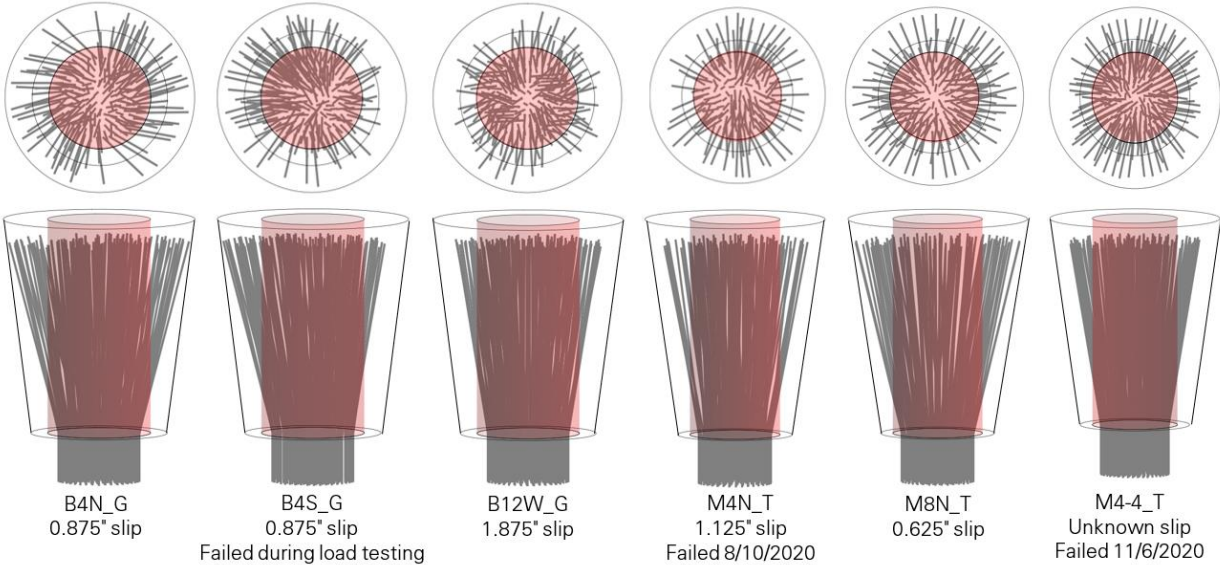
Figure 62), which include three failed sockets and three other sockets exhibiting different cable slips. The wire broom geometry of socket M4N_T (first cable failure) is provided in WJE’s investigation report,¹⁸ and the other five sockets were cut open at Socotec’s laboratory.

Figure 62: Wire broom geometries considered.

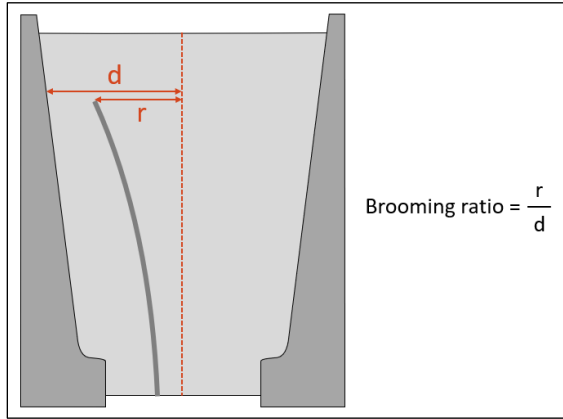
To characterize the broom geometry, we define a wire’s *brooming ratio* as the wire’s distance to the central axis (r) divided by the casting’s radius (d) in the plane containing the wire ends (Figure 63). For the five auxiliary sockets considered, the cable slip decreases as the average brooming ratio increases (Figure 64). This result is a first general correlation between wire broom and cable slip, which was further investigated.

Figure 63: Definition of brooming ratio.

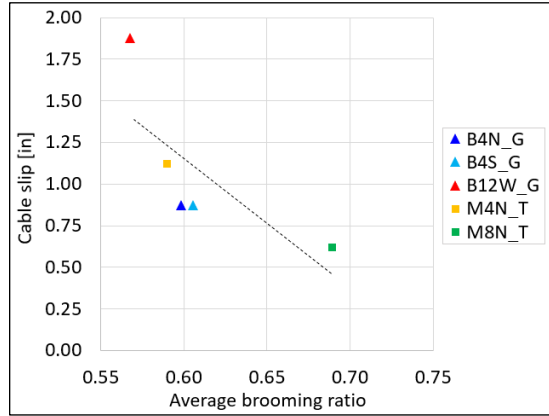
Figure 64: Cable slip vs. average brooming ratio for five auxiliary sockets.

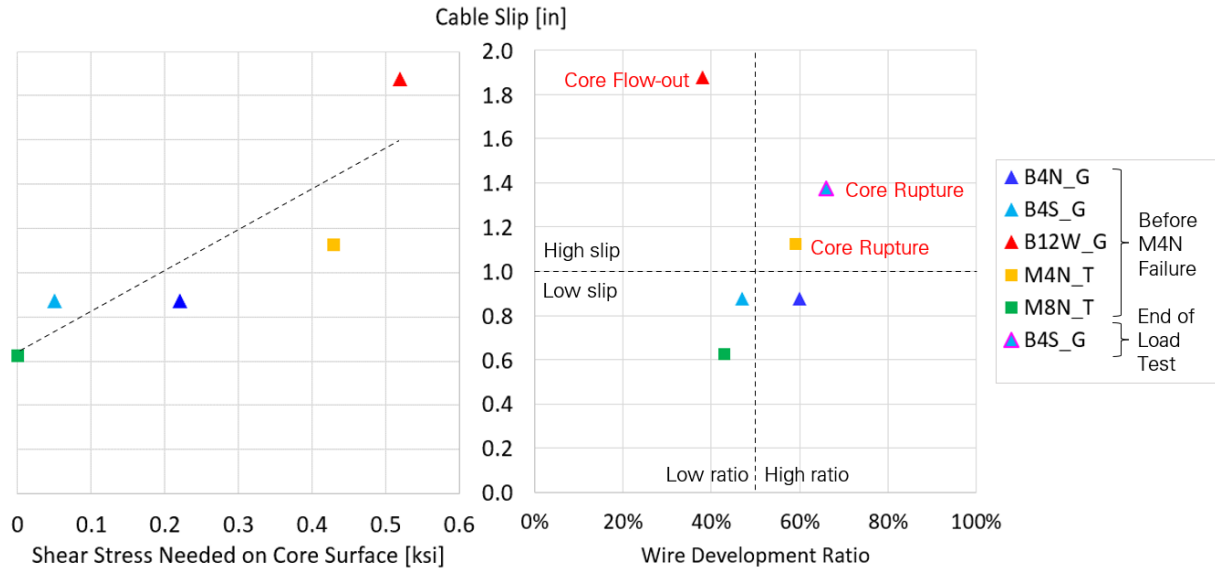
Under gravity loads, the cable slip increases with the shear stress needed for the five auxiliary sockets (Figure 65 left). In addition, when the first cable failed, the shear stress needed in socket M4-4_T increased from zero to the largest stress (0.7 ksi) among all considered sockets as the M4 cables experienced a 30 percent increase in tension. Socket M4-4_T failed three months later, and fracture

The three sockets exhibiting core rupture had a larger wire development ratio (59 to 66 percent) than the socket exhibiting core flow-out (38 percent) (Table 6, Figure 65 right, and Figure 66). This result is consistent with the socket behavior previously introduced (Figure 48 vs. Figure 49, page 35): fully developed wires lead to core fracture, while partially developed wires lead to core flow-out.

Figure 65 summarizes the observed socket behavior: if shear stress is needed on the core surface to resist the full cable tension, the zinc flows and causes cable slip over time. When the cable slip becomes too large, the socket fails in core rupture or core flow-out depending on whether the crossing wires are primarily fully developed or partially developed.

Figure 65: Correlation between core shear stress, wire development ratio, cable slip, and socket failure.

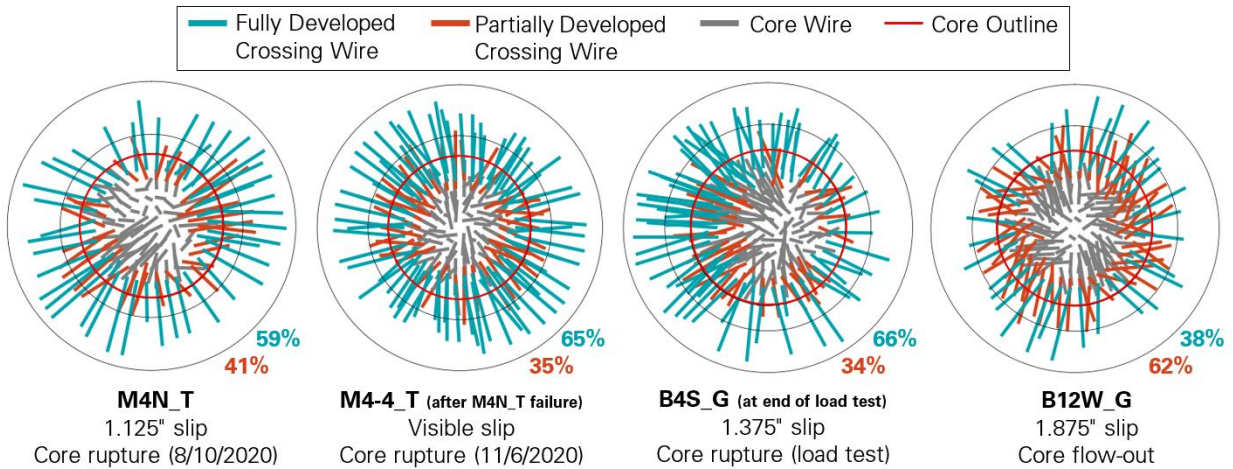
Figure 66: Fully and partially developed crossing wires in failed and failing sockets.

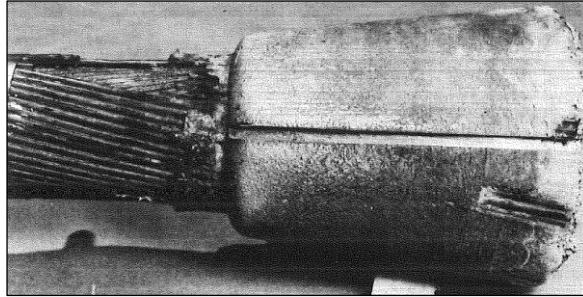
Figure 11: Zinc casting at ground end of cable B12-3 replaced in 1981 (photo: Phoenix, Johnson, and McGuire⁴).

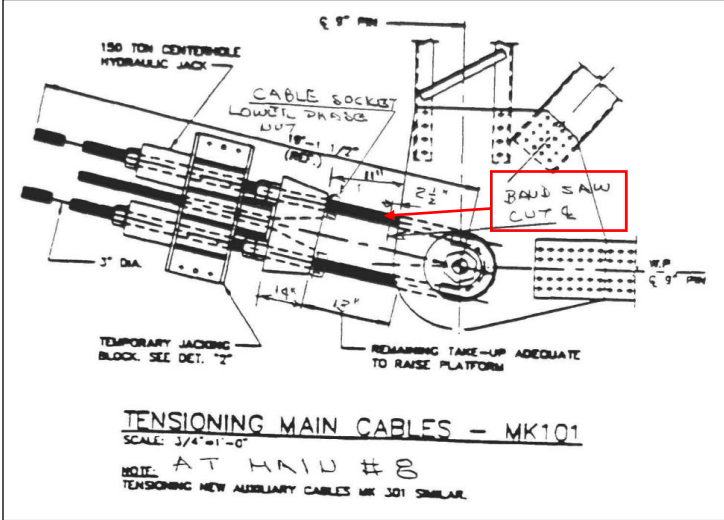
On 1/31/1997, a threaded rod connecting the socket of cable M8-4 to the platform was damaged as contractors were cutting a nut that prevented the installation of a jack required for a cable tensioning operation¹¹ (Figure 16). The damage consisted of several cuts on the surface of the rod (Figure 17), raising concerns about potential crack propagation through the rod. Fracture Analysis Consultants

analyzed the damage and a rod sample, and concluded that the rod remained fit for service¹². However, a structural bypass was installed to catch the socket in the event that the damaged threaded rod fails.

Figure 16: Location of threaded rod damage on M8-4 connection to platform (image: NAIC Arecibo Observatory, a facility of the NSF).

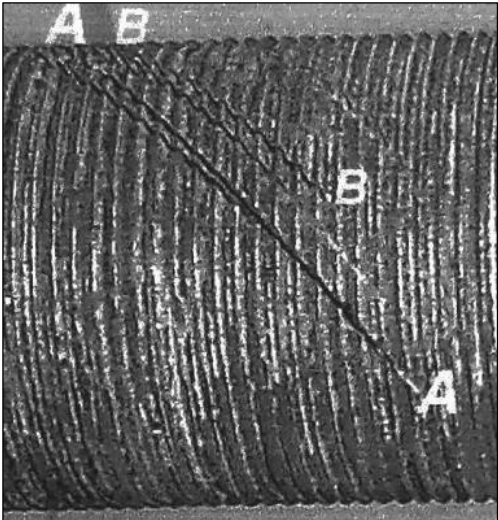
Figure 17: Cuts in M8-4 hairpin (photo: Fracture Analysis Consultants¹²).

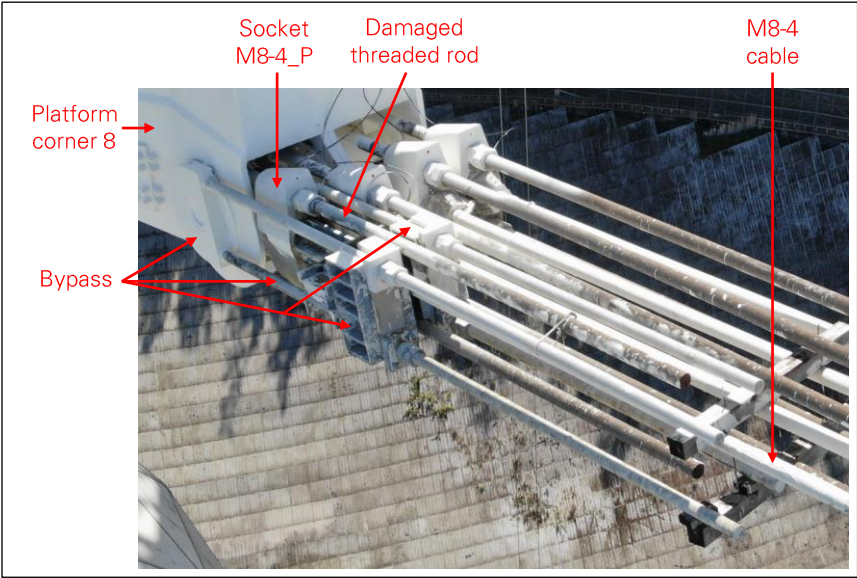
Figure 18: Bypass on socket M8-4_P (photo: NAIC Arecibo Observatory, a facility of the NSF).

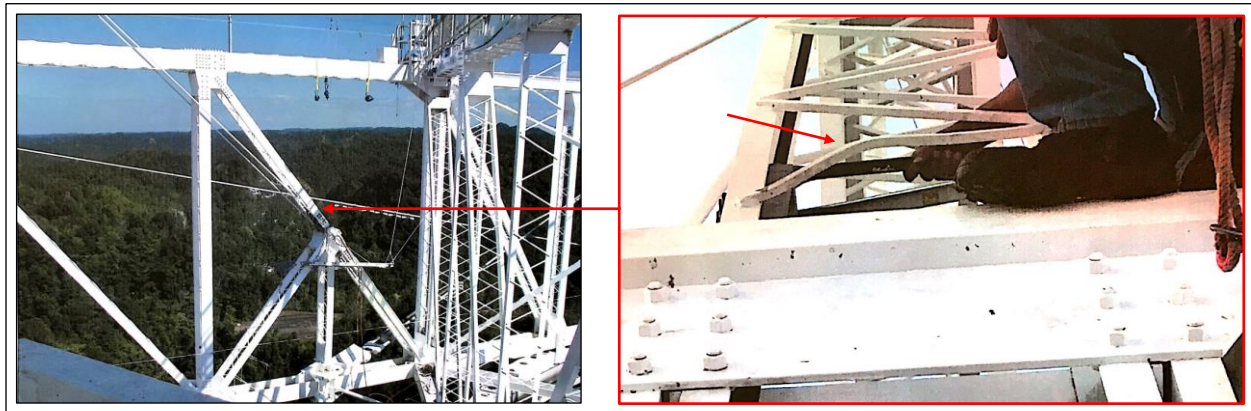
On 2/3/2010, local damage was discovered on a diagonal truss member of the platform (Figure 19), near the east backstay of the corner 12 tiedown outrigger. After re-analysis of the structure, AW prescribed the reinforcement of the damaged member and 23 other platform truss members, adding 14 kip of steel to the platform.

Figure 19: Damaged truss member lacing near outrigger 12 east backstay connection to platform on February 5, 2010. (photos: NAIC Arecibo Observatory, a facility of the NSF).

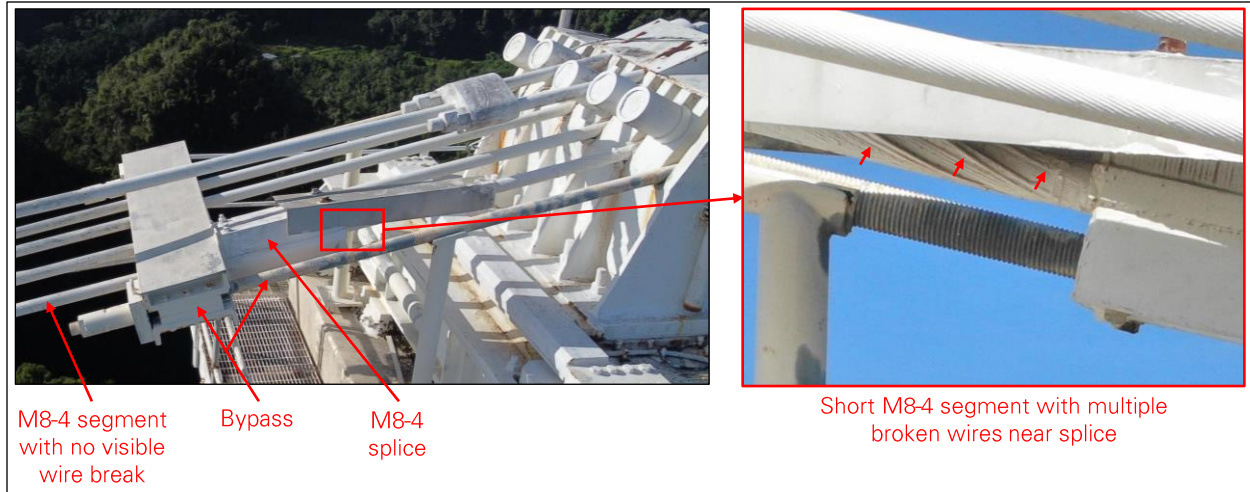
Puerto Rico was hit by an earthquake of magnitude 6.4 on 1/13/2014, and the next day the AO staff discovered several broken wires near the splice in cable M8-4. Cable M8-4 had been spliced near the top of Tower 8 during construction of the telescope in the 1960s, possibly because it was fabricated too short. After inspecting the splice, AW determined that the short segment of cable between the splice and the tower had at least 12 broken wires and was at risk of failing. AW designed a bypass system that connects the splice to the tower with a beam and a pair of threaded rods, which was installed in March 2014¹³ (Figure 20). AW described the bypass as a temporary solution and recommended that the M8-4 cable be replaced. Preparations to replace M8-4 were being made when the M4N cable failed in August 2020.

Figure 20: M8-4 splice bypass (photos: NAIC Arecibo Observatory, a facility of the NSF).
