Arecibo Telescope Collapse Forensic Investigation

Thornton Tomasetti

July 25, 2022

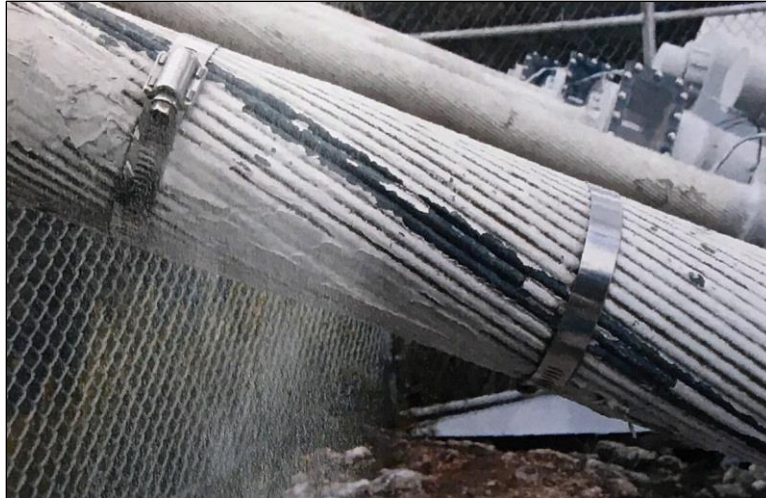
Figure 4: Original backstay B12-5 near anchor in 2003. Clamps and missing paint indicate a broken wire. Paint is also cracked between other wires (*photo: Ammann & Whitney¹*).

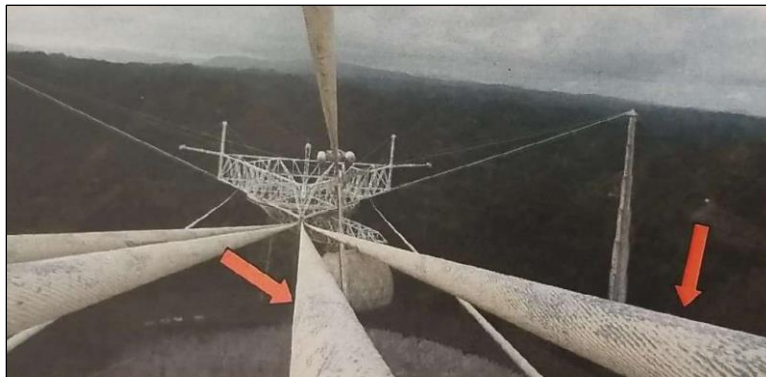
Figure 5: Paint deterioration on original mains at top of Tower 12 in 2011 (*photo: Ammann & Whitney²*).

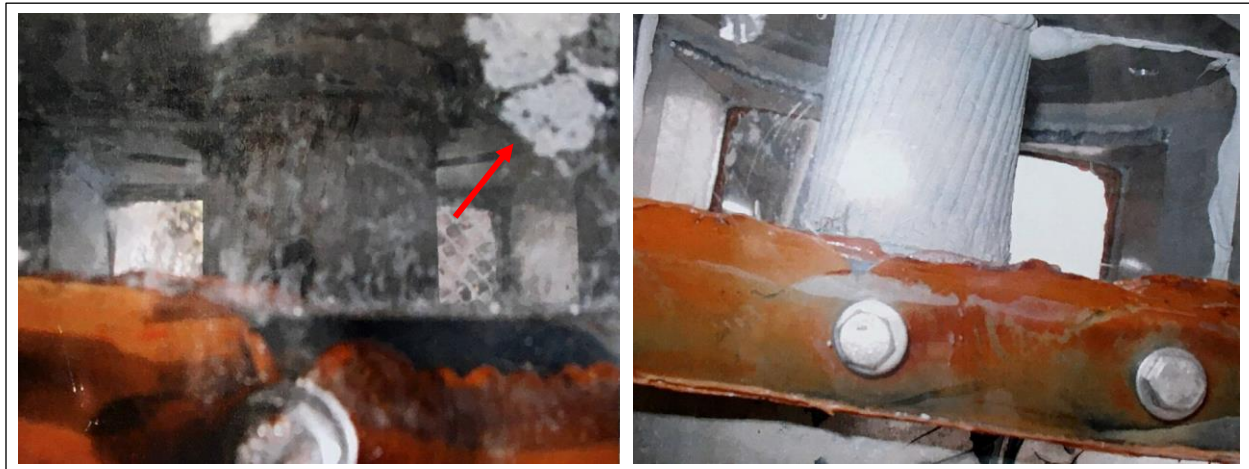
The maintenance and inspection documents include several reports, beginning in 2002, of condensation inside the dry air sleeves of some of the auxiliary cables (Figure 7 and Figure 8). The cause, extent and duration of the problem are not precisely known, although it affected backstays and main cables and persisted until at least 2011.

Figure 7: Condensation inside dry air sleeve of cable B4S (left) compared to typical condition of dry air sleeves (right) in 2003 (photos: Amman & Whitney⁴).

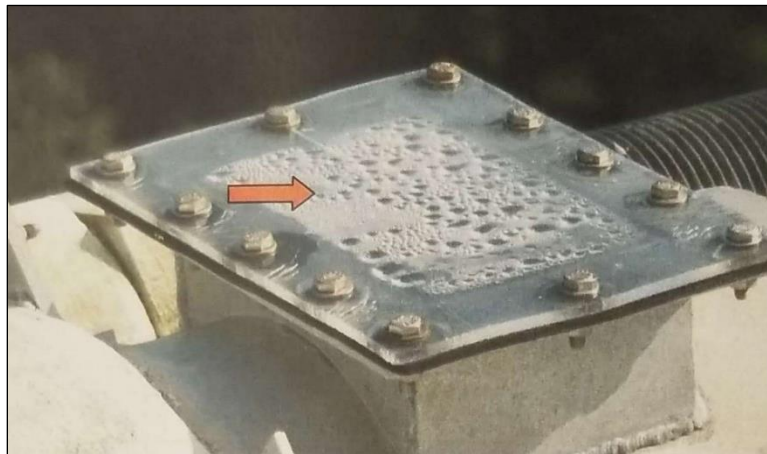
Figure 8: Condensation inside dry air sleeve on cable M4N in 2011 (photos: Amman & Whitney⁵).

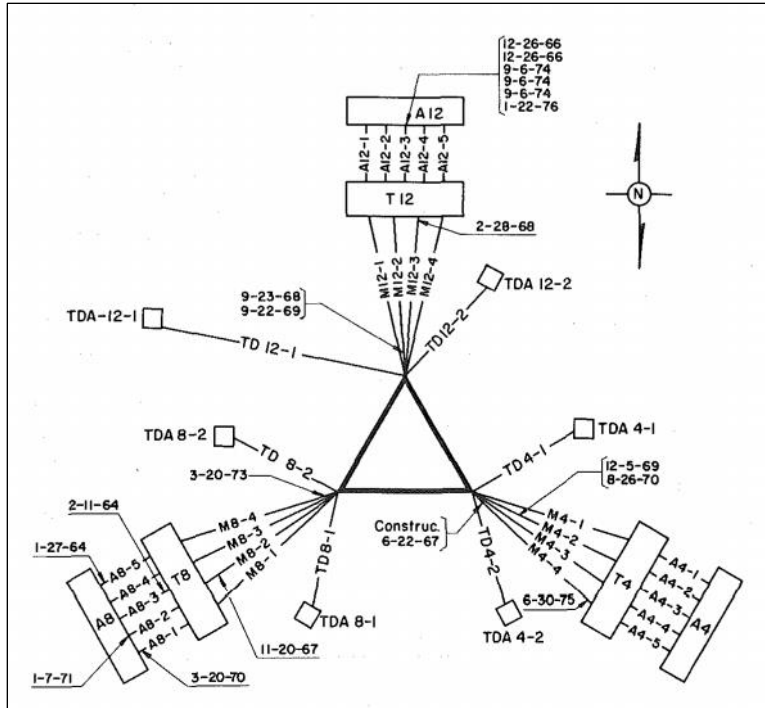
Figure 9: 1986 map of wire breaks (image: Phoenix, Johnson, and McGuire⁶).

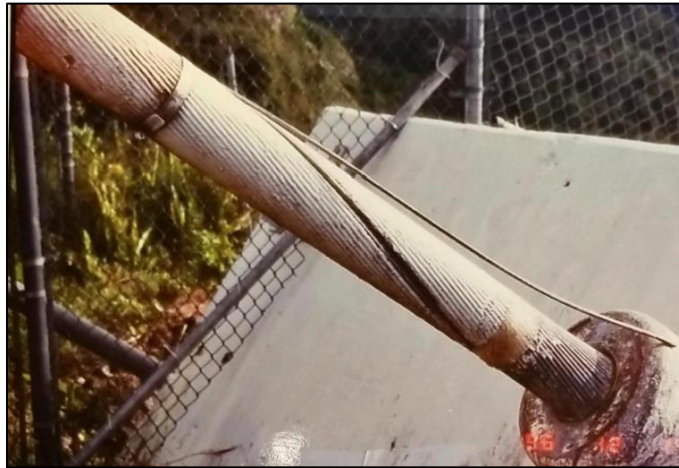
Figure 10: Wire break at ground end on B4-1 discovered on December 12, 1996 (photo: NAIC Arecibo Observatory, a facility of the NSF).

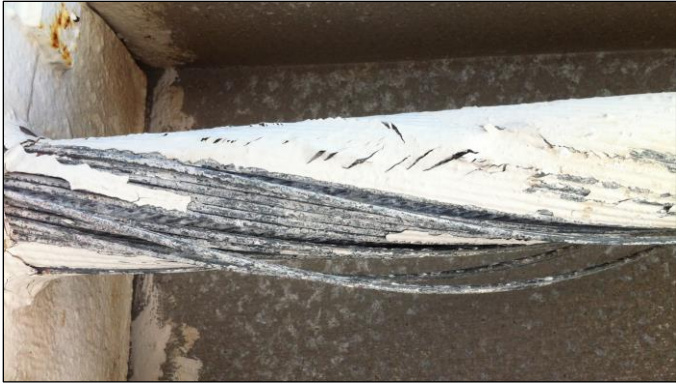
Figure 11: Multiple wire breaks near M8-4 splice discovered on January 14, 2014
(photo: NAIC Arecibo Observatory, a facility of the NSF).

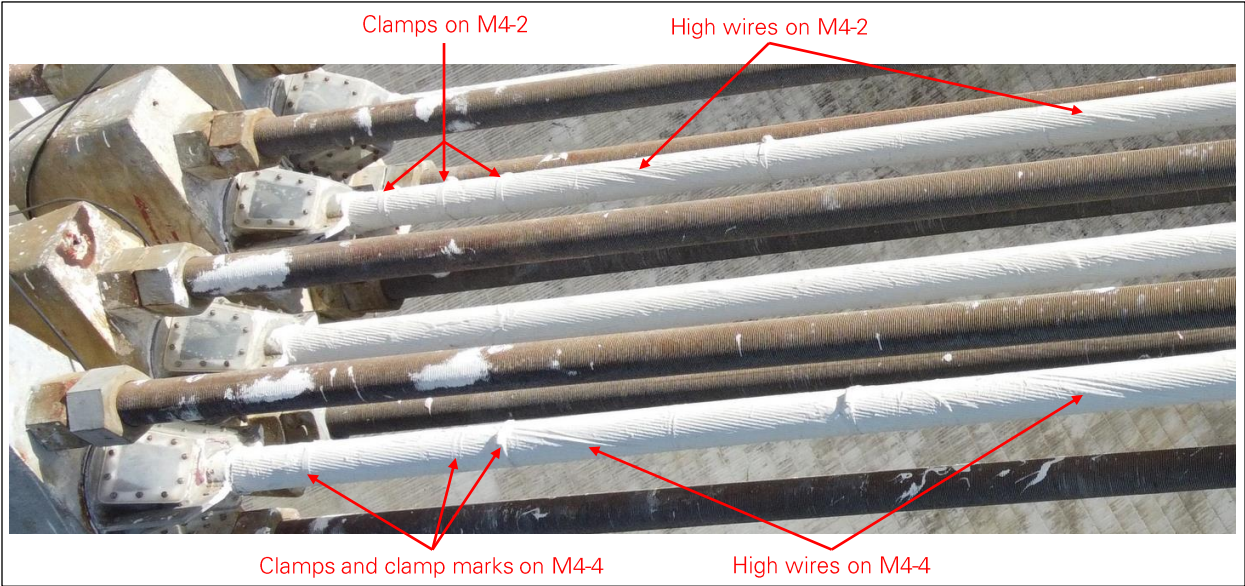
After discovering a wire break, the AO staff typically installed clamps on the cable to keep the broken wire in place. These clamps and the broken wires they hold remain visible after the cable is repainted (Figure 12). The numerous drone photos taken in 2020 after the first cable failure show evidence of past wire breaks at locations generally consistent with the breaks reported in the AO records. Past wire breaks could not be precisely counted from the drone photos, as some of the clamps appear to have been installed preventively while other clamps appear to have been removed or to have fallen from the cables.

Figure 12: Evidence of past wire breaks at platform end of M4 cables
(photo: NAIC Arecibo Observatory, a facility of the NSF).

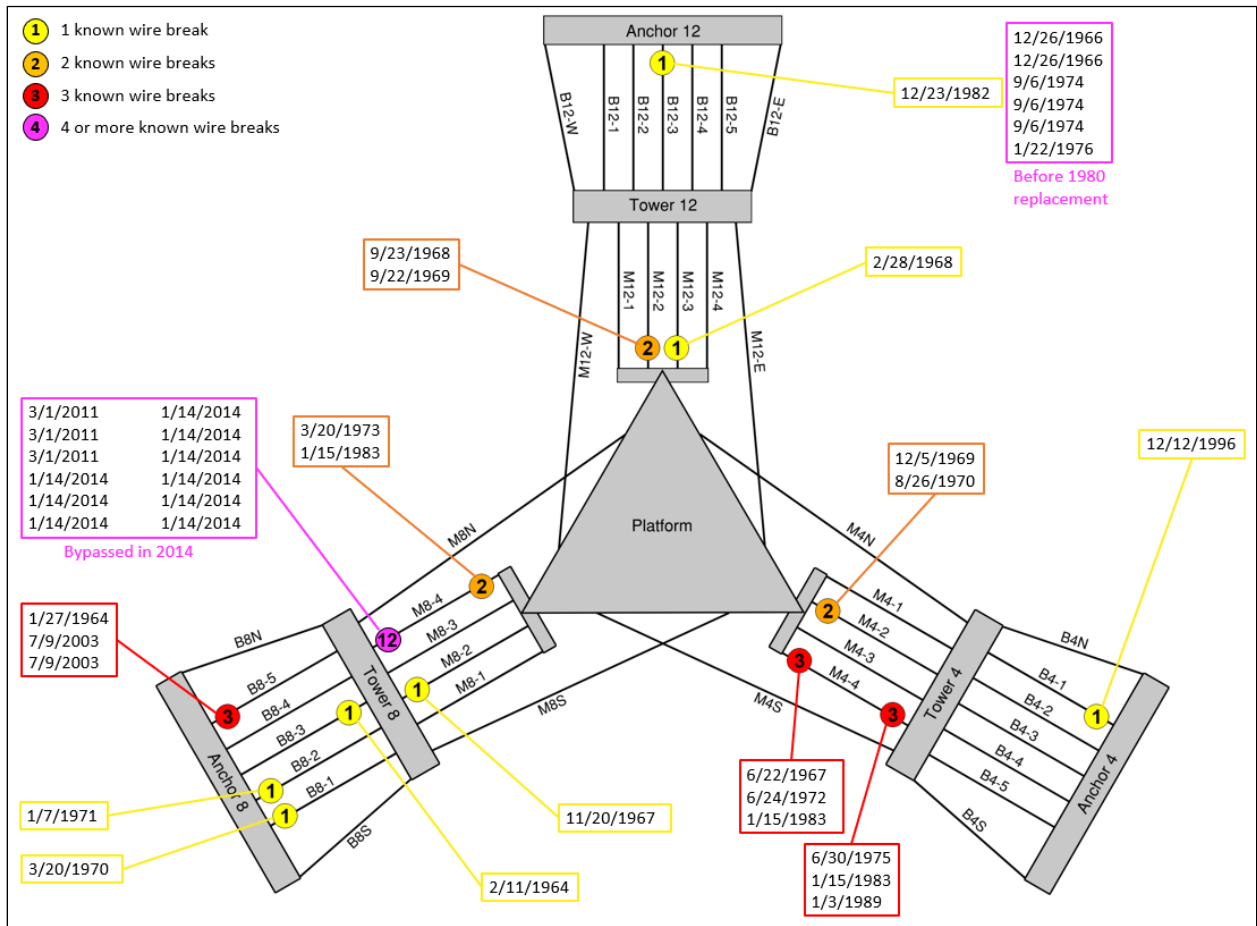
Figure 13: Known wire break locations and discovery dates before first cable failure.

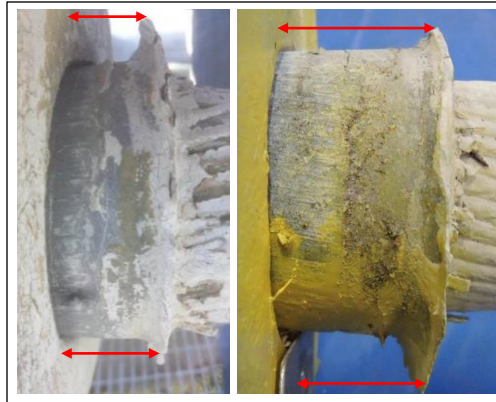
Before breaking free on August 8, 2020, the end of cable M4N at the top of Tower 4 had slipped by more than one inch from its socket. This one-inch slip is approximately one-third of the cable’s diameter and significantly more than typically observed in structural cables terminated with zinc-filled spelter sockets. We reviewed the telescope’s maintenance and inspection records, as well as photographs, provided by AO to determine the history, extent, and severity of cable slip in the telescope structure. The available information is presented in this section.

Figure 16: Cable slip at socket M4N_T (left) and B12W_G (right) (photos: NAIC Arecibo Observatory, a facility of the NSF).

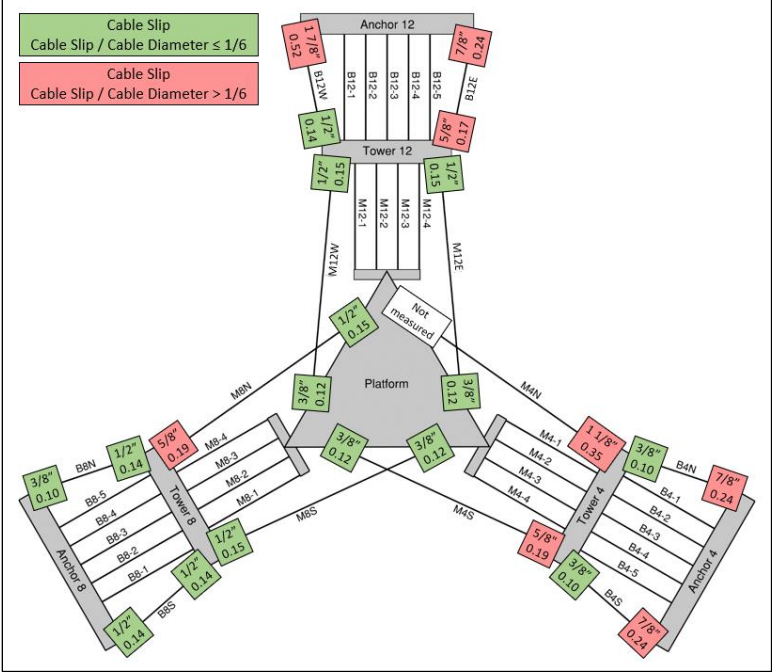
The map indicates the ratio of the cable slip to the cable diameter, and sockets are flagged when this ratio is greater than one sixth. The one-sixth limit is based on the AASHTO M277⁷ standard for testing wire ropes used in moveable bridges. Because the telescope’s auxiliary cables had been loaded for 25 years when the structure collapsed and may therefore have experienced long-term creep effects that do not occur during short load tests, the comparison of the Arcibo cable slips to the one sixth limit is for reference only.

Figure 17: Cable slip at auxiliary sockets before collapse.

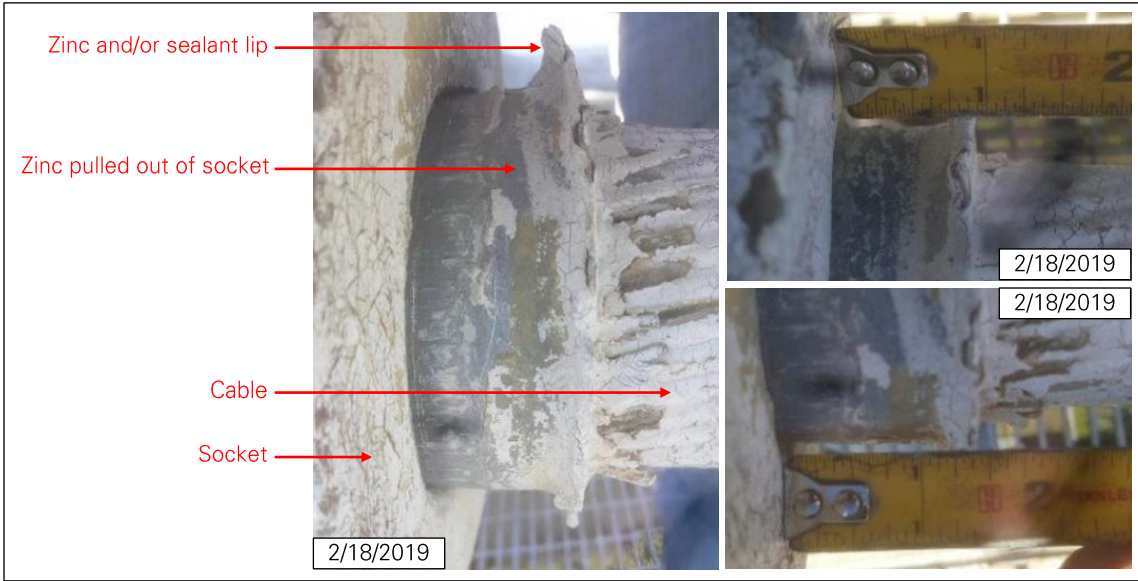
Socket M4N_T

Figure 18: Cable slip at socket M4N_T. As seen from the north side (left) and measured on north (top right) and south (bottom right) sides of socket (photos: NAIC Arecibo Observatory, a facility of the NSF).

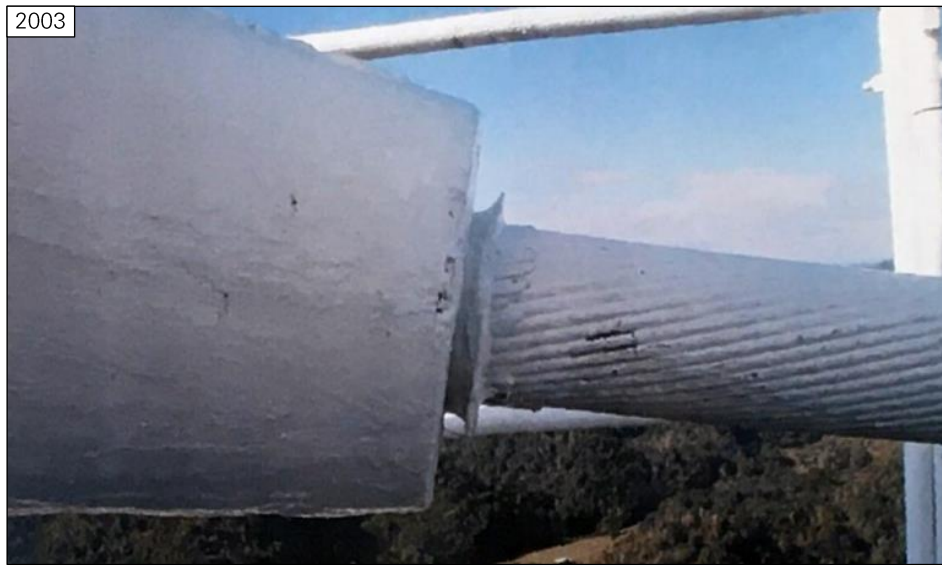
Socket M4S_T

Figure 19: Cable slip at socket M4S_T
(photo: Ammann & Whitney⁸).

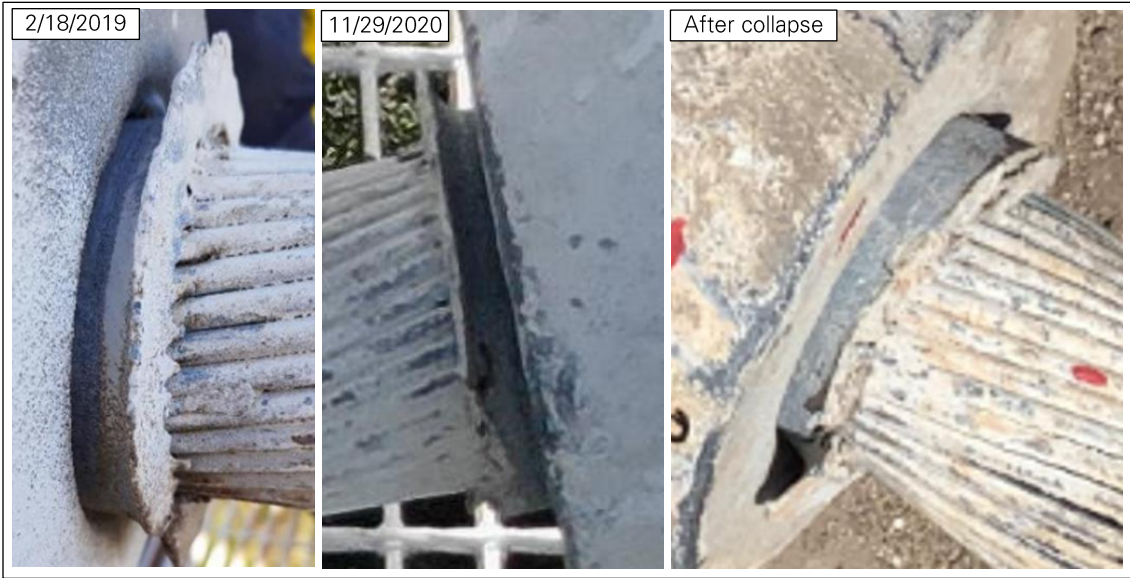
Socket M8N_T

Figure 21: Cable slip at socket M8N_T
(left and center photos: NAIC Arecibo Observatory, a facility of the NSF).

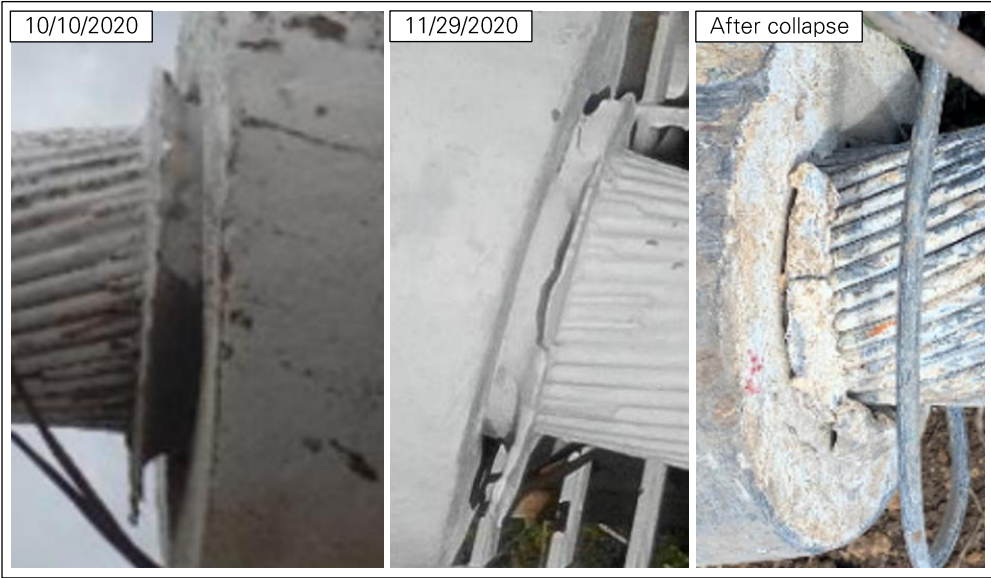
Socket M8S_T

Figure 22: Cable slip at socket M8S_T
(left photo: WJE¹⁰; center photo: NAIC Arecibo Observatory, a facility of the NSF).

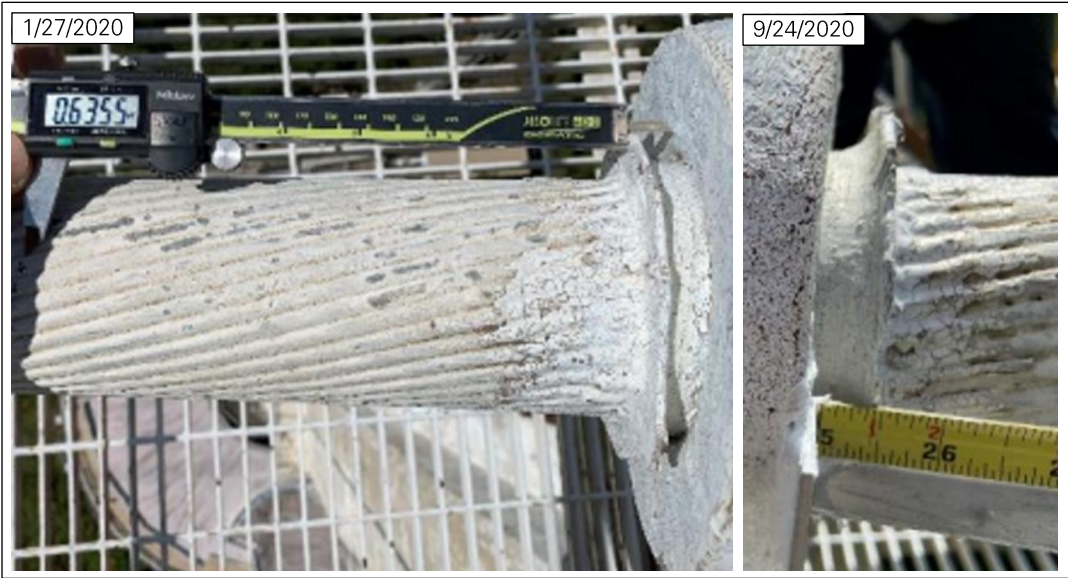
Socket M12W_T

Figure 25: Cable slip at socket M12W_T
(left photo: NAIC Arcibo Observatory, a facility of the NSF; right photo: WJE¹²).

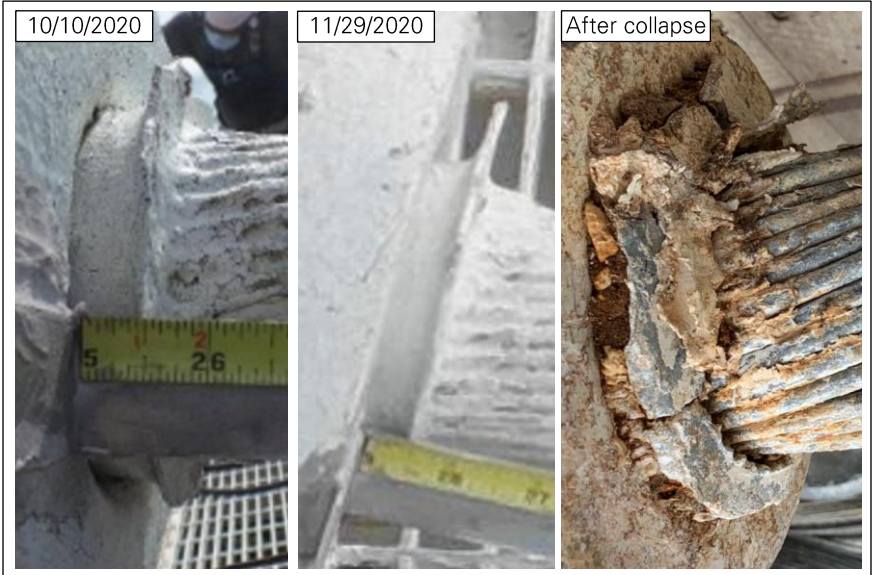
Figure 26: Cable slip at socket M12W_T
(left photo: WJE¹²; center photo: NAIC Arcibo Observatory, a facility of the NSF).

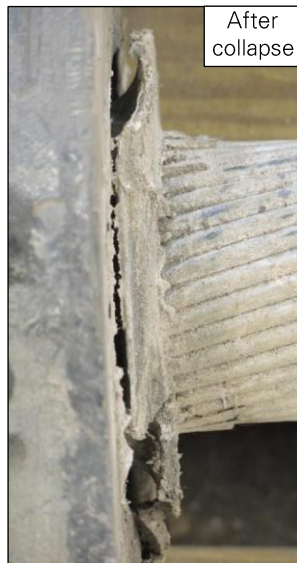
Socket M4S_P

Figure 27: Cable slip at socket M4S_P.

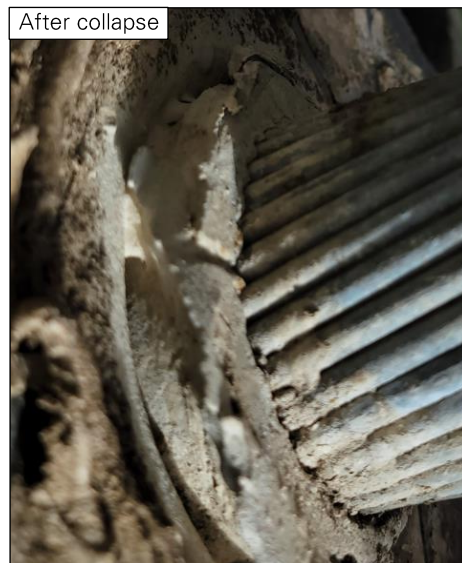
Socket M8N_P

Figure 28: Cable slip at socket M8N_P.

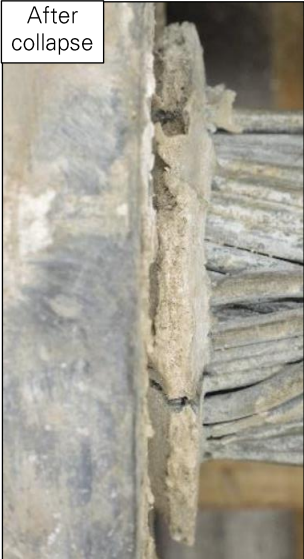
Socket M8S_P

Figure 29: Cable slip at socket M8S_P.

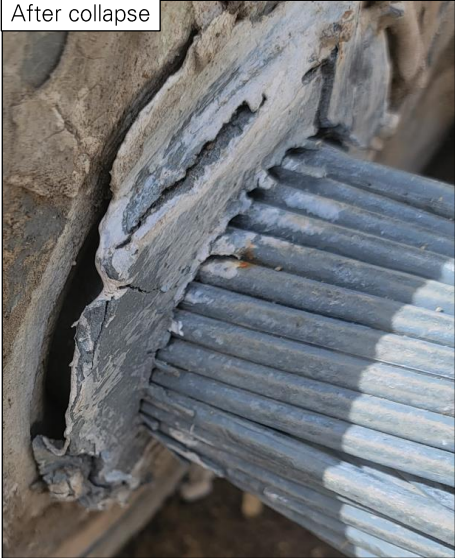
Socket M12E_P

Figure 30: Cable slip at socket M12E_P.

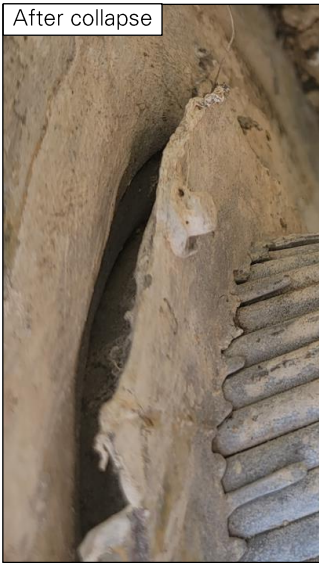
Socket M12W_P

Figure 31: Cable slip at socket M12W_P.

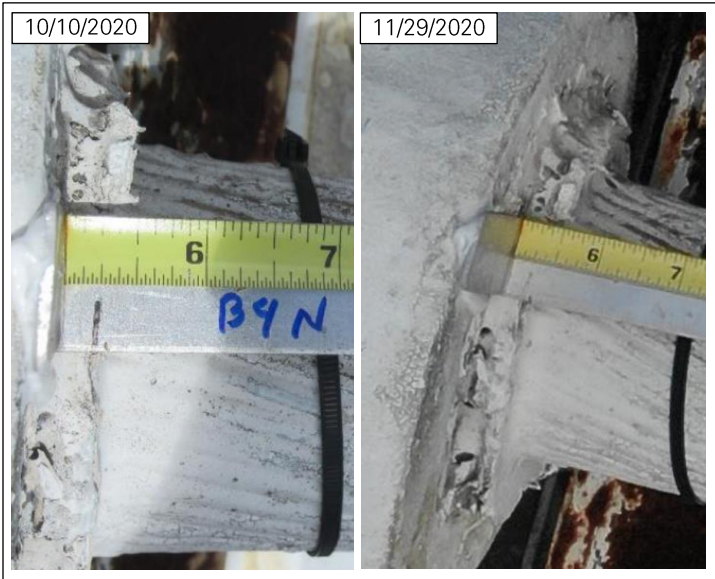
Socket B4N_T

Figure 32: Cable slip at socket B4N_T (left photo: WJE¹³; right photo: NAIC Arecibo Observatory, a facility of the NSF).

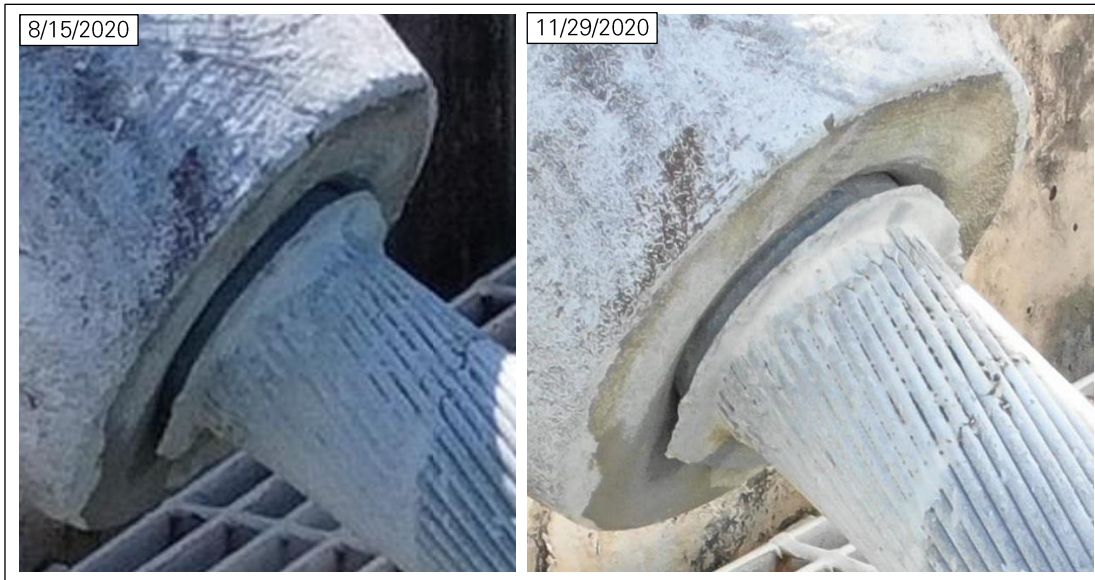
Socket B8N_T

Figure 34: Cable slip at socket B8N_T
(photos: NAIC Arecibo Observatory, a facility of the NSF).

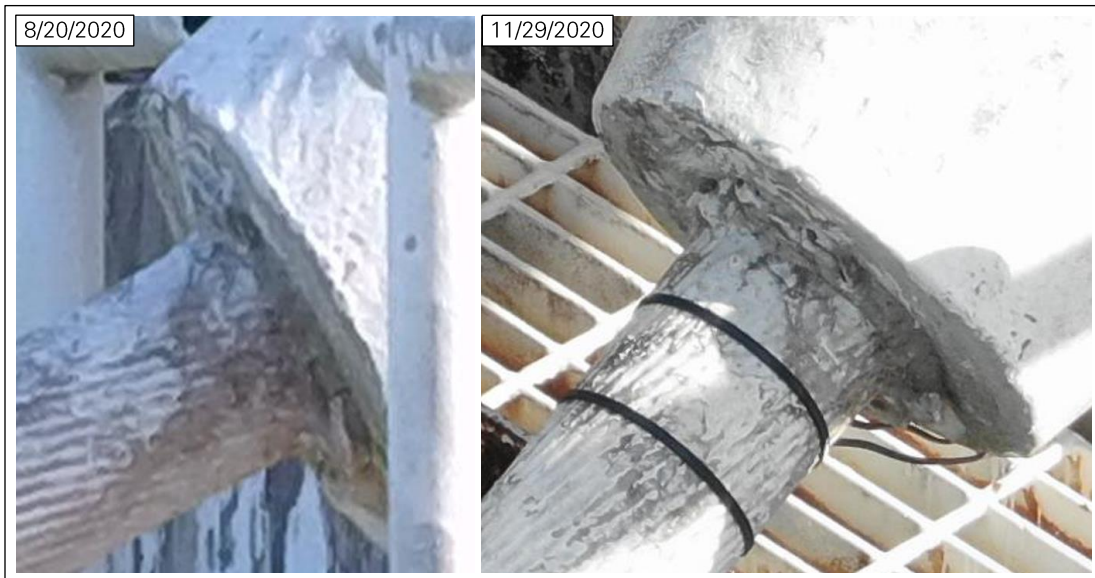
Socket B8S_T

Figure 35: Cable slip at socket B8S_T
(photos: NAIC Arecibo Observatory, a facility of the NSF).

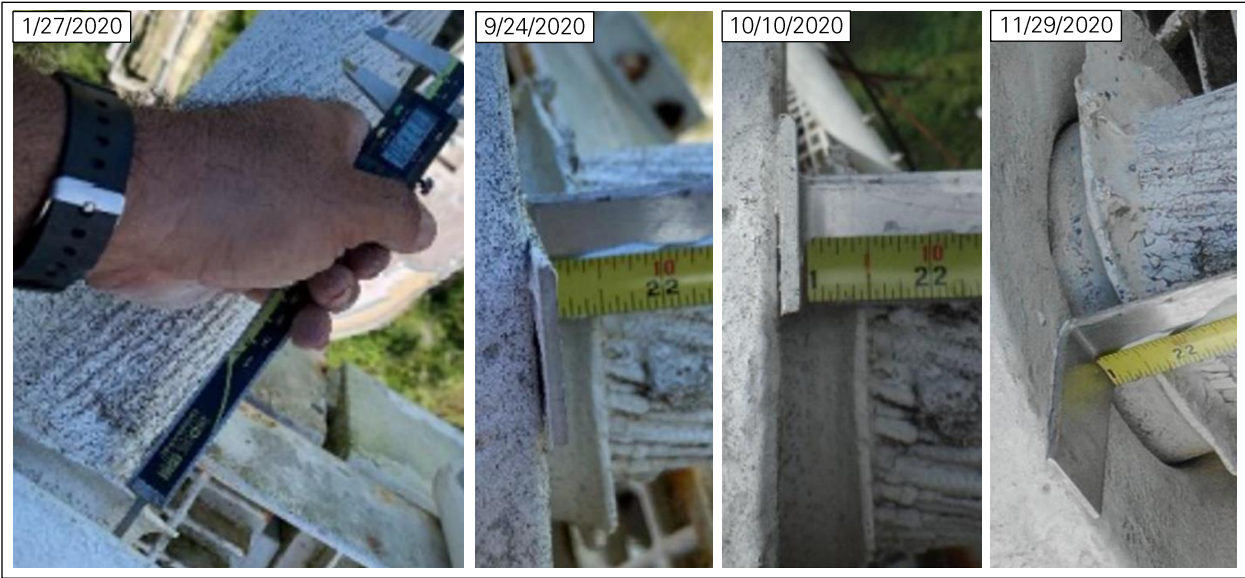
Socket B12E_T

Figure 36: Cable slip at socket B12E_T
(left and right photos: NAIC Arecibo Observatory, a facility of the NSF; center photos: WJE¹⁴).

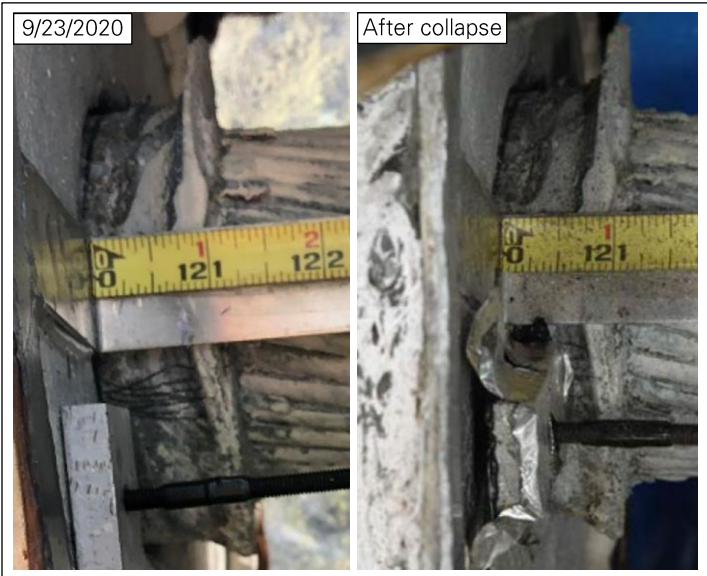
Socket B4N_G

Figure 38: Cable slip at socket B4N_G (left photo: WJE¹⁵).

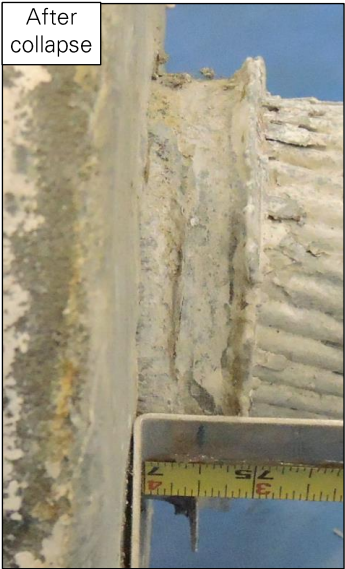
Socket B4S_G

Figure 39: Cable slip at socket B4S_G.

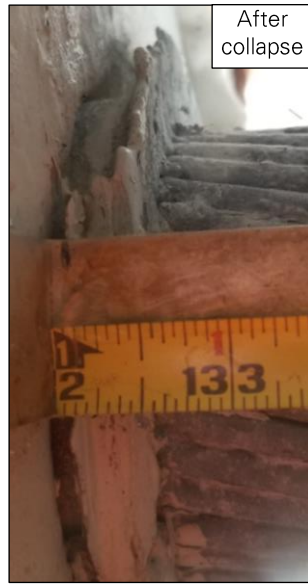
Socket B8N_G

Figure 40: Cable slip at socket B8N_G.

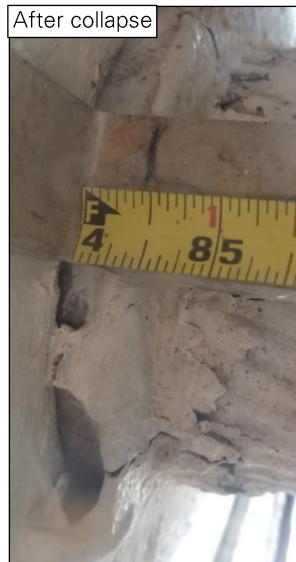
Socket B8S_G

Figure 41: Cable slip at socket B8S_G.

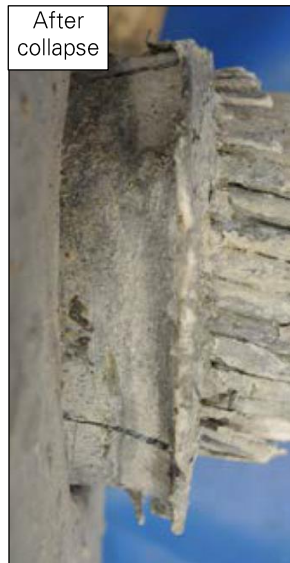
Socket B12E_G

Figure 42: Cable slip at socket B12E_G.

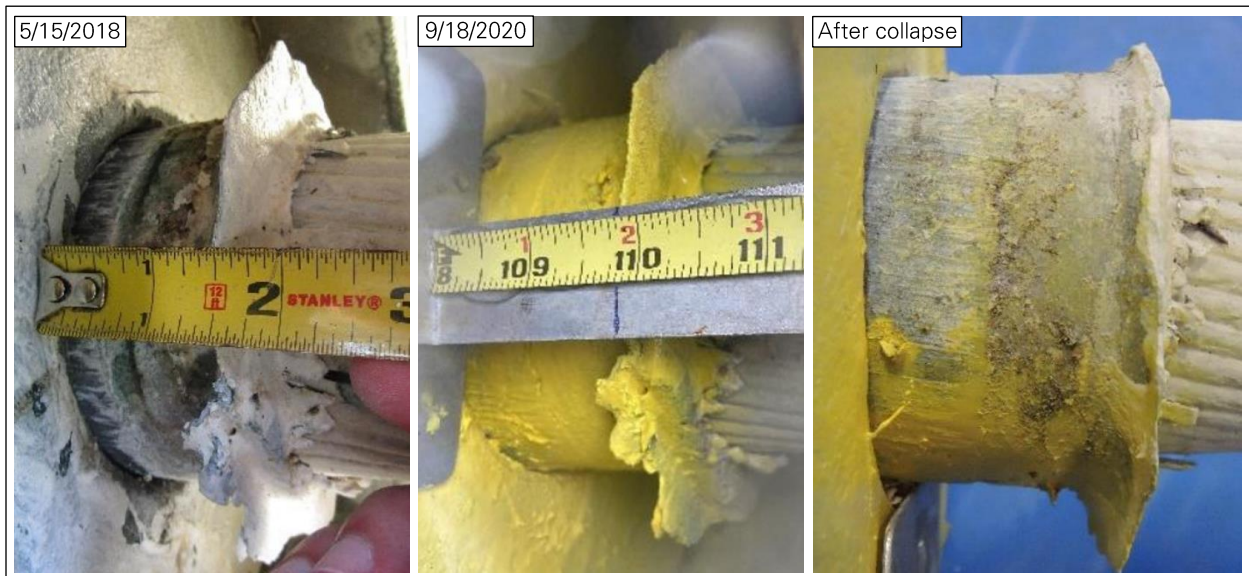
Socket B12W_G

Figure 43: Cable at socket B12W_G
(left and center photos: NAIC Arecibo Observatory, a facility of the NSF).

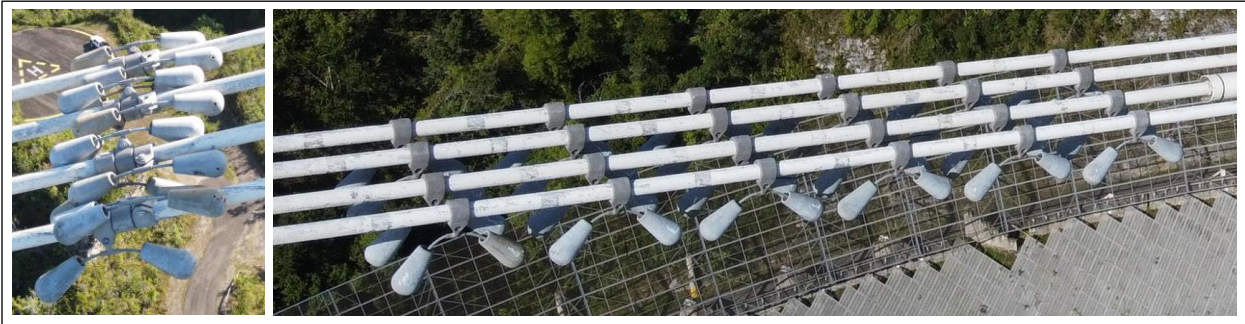
The main and backstay cables began experiencing wind-induced vibrations immediately after construction of the telescope in 1963, and Stockbridge dampers (Figure 44) were then installed to mitigate the vibrations.¹⁶ As shown in Table 3, cable vibrations continued to be reported throughout the lifespan of the telescope, which led to upgrades and adjustments of the dampers. While we have not seen any data on the amplitude of the cable movement, AW did not consider that the vibrations were a concern from a structural standpoint. The vibrations also appear to have been relatively infrequent and may have occurred only under specific wind conditions. Finally, the initial installation and later adjustments of the damper system appear to have been effective.

Figure 44: Stockbridge dampers near top (left) and bottom (right) of original M4 cables in 2020
(photos: NAIC Arecibo Observatory, a facility of the NSF).

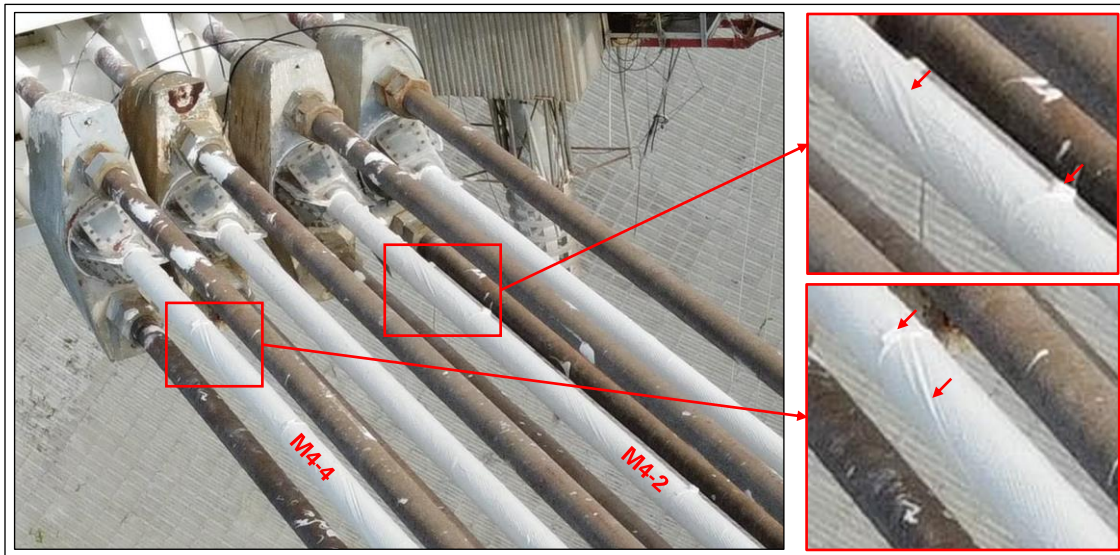
According to the AO inspection records, a total of eight wire breaks were observed on the M4-2 and M4-4 cables between 1967 and 1989 (Table 1). Drone photos taken after the M4N failure (Figure 2, Figure 3) are consistent with those records, as they show protruding wires and/or clamps on the two cables. The clamps were likely installed to keep the broken wires tight with the rest of the cable. However, we noted

Figure 2: Clamps and evidence of previous wire breaks on M4-2 and M4-4 near platform
(photo: NAIC Arecibo Observatory, a facility of the NSF).

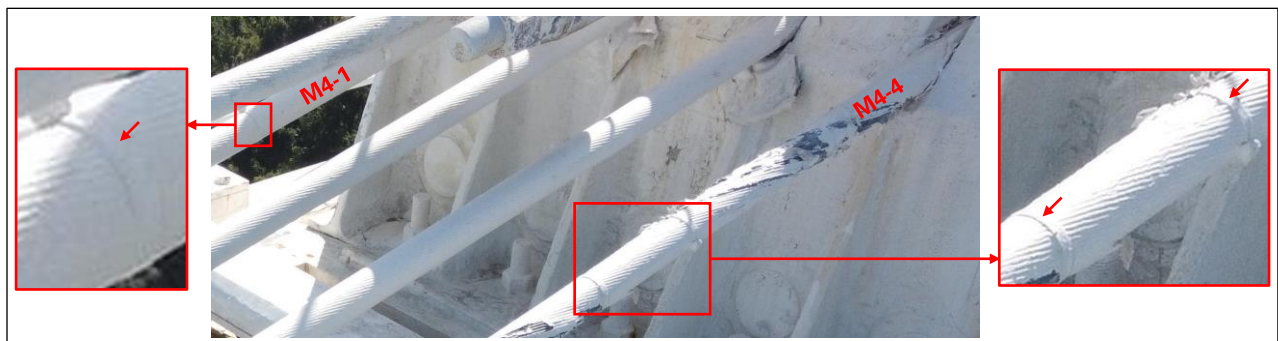
Figure 3: Clamps on M4-1 and M4-2 near Tower 4, likely installed after previous wire breaks.
The paint damage on M4-4 corresponds to fresh wire breaks following the M4N failure.
(Photo: NAIC Arecibo Observatory, a facility of the NSF.)

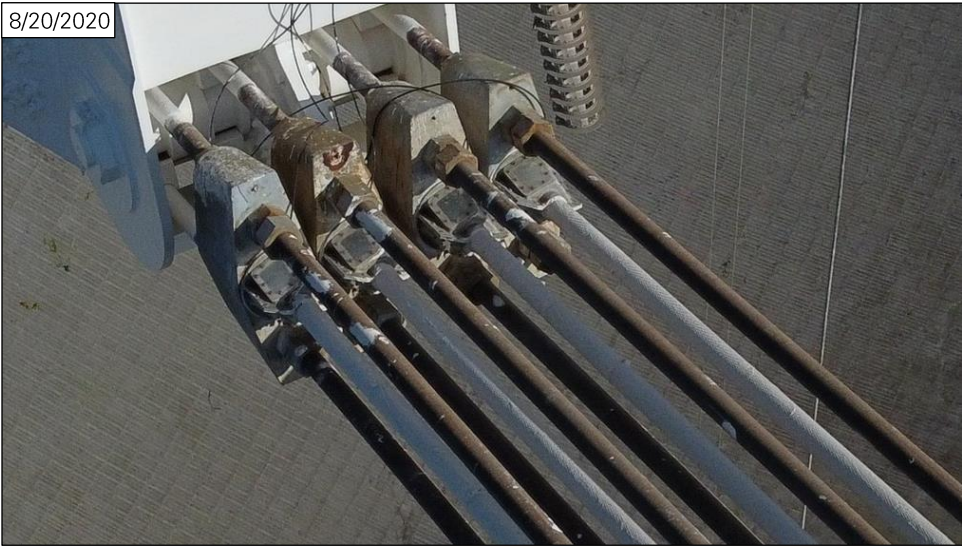
Shortly after the M4N failure, four wire breaks were observed in M4-4 near Tower 4 (Figure 4). No wire break was observed in any other M4 cable or near the platform (Figure 5).

Figure 5: M4 cable near platform on August 20, 2020. No wire is broken. (Photo: NAIC Arecibo Observatory, a facility of the NSF.)

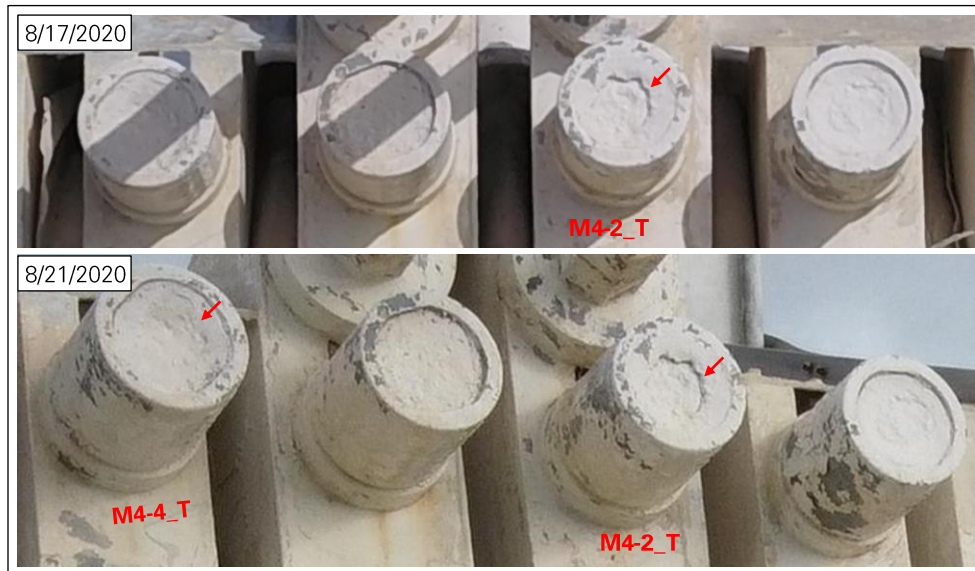
The back end of the M4 sockets at Tower 4 is shown in Figure 6 after the M4N failure. On socket M4-2_T, a circular crack is visible on the surface of the zinc casting, and the central part of the casting has moved inwards. On socket M4-4_T, the surface of the casting also appears to be deformed with the central part moving inwards, but to a lesser extent than for M4-2_T. It is unknown whether these deformations occurred before or during the M4N failure.

Figure 6: M4 sockets at Tower 4 after M4N failure
 (photos: NAIC Arecibo Observatory, a facility of the NSF).

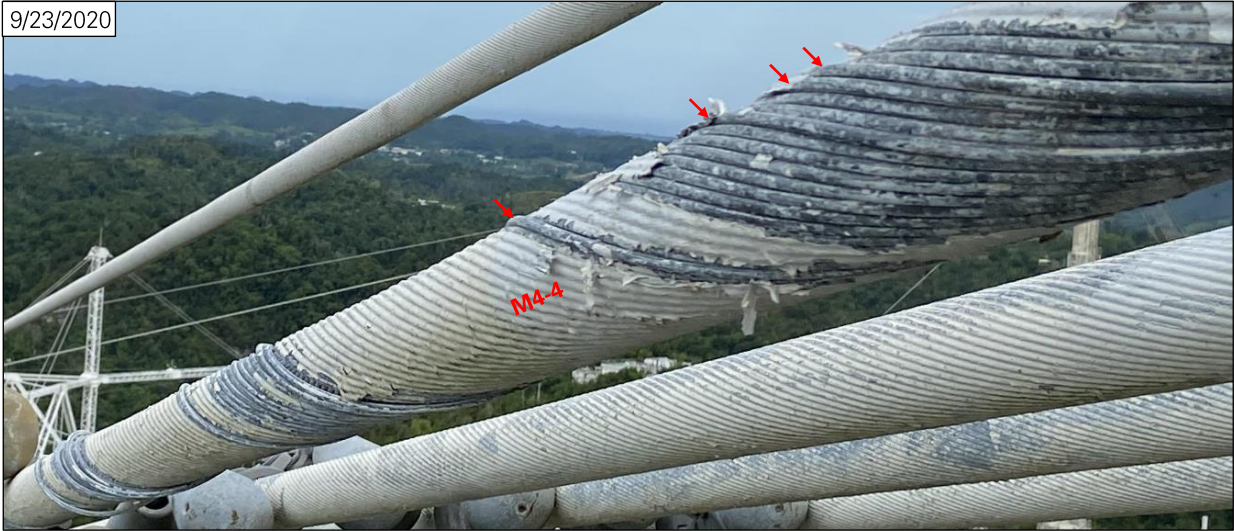
The failed M4N_T socket was removed from the top of Tower 4 on September 23, 2020 for forensic analysis. During the operation, AO took close-up photographs of the M4 cables. The photographs show four broken wires on M4-4 (Figure 7), and one broken wire on M4-1 (Figure 8). The M4 cables were then repainted at the top of Tower 4 (Figure 9).

Figure 7: Close-up view of M4-4 near Tower 4 on September 23, 2020. Four wires are broken. (Photo: NAIC Arecibo Observatory, a facility of the NSF.)

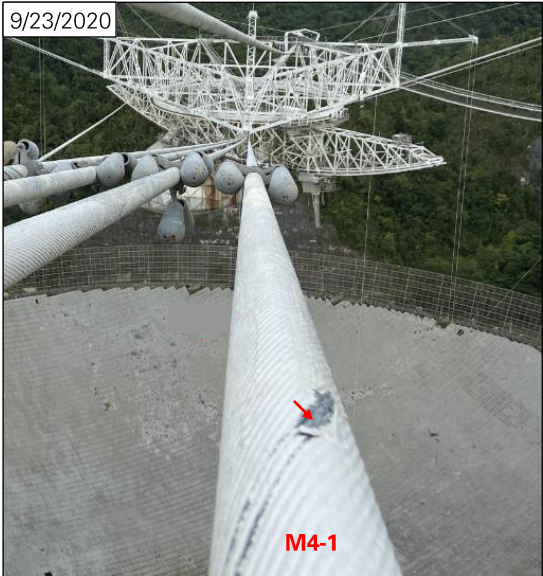
Figure 8: Close-up view of M4-1 near Tower 4 on September 23, 2020. A wire is broken. (Photo: NAIC Arecibo Observatory, a facility of the NSF.)

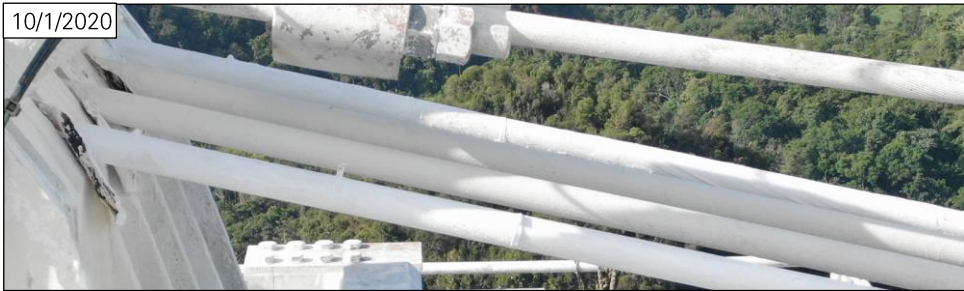
Figure 9: M4 cables freshly repainted near Tower 4 on October 1, 2020 (photo: NAIC Arecibo Observatory, a facility of the NSF.)

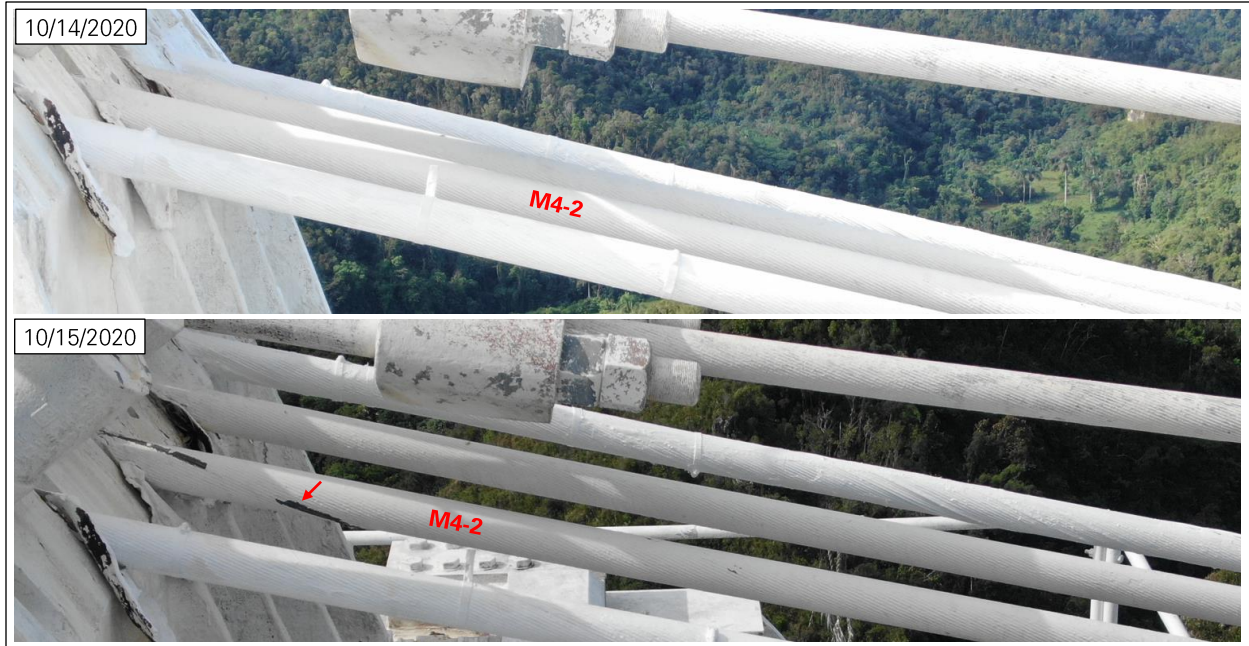
A new wire break was discovered on M4-2 on October 15, 2020 (Figure 10), and new paint damage was observed on M4-4 on October 19, 2020 (Figure 11). This paint damage, however, appears to be due to the movement of wires already broken. No more changes were observed by 10/30/2020 (Figure 12, Figure 13), which is a week before the failure of M4-4.

Figure 10: New wire break in M4-2 on October 15, 2020
(photos: NAIC Arecibo Observatory, a facility of the NSF).

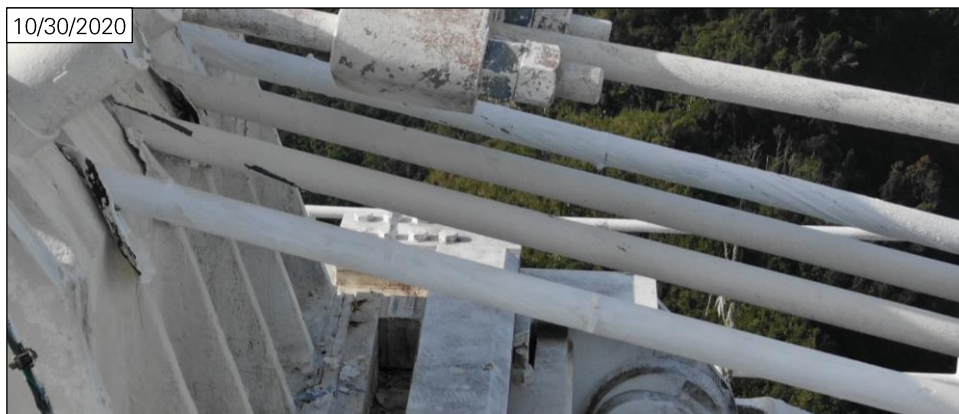
Figure 12: M4 cables near Tower 4 on October 30, 2020. No significant change is visible since October 19, 2020.
(Photo: NAIC Arecibo Observatory, a facility of the NSF.)

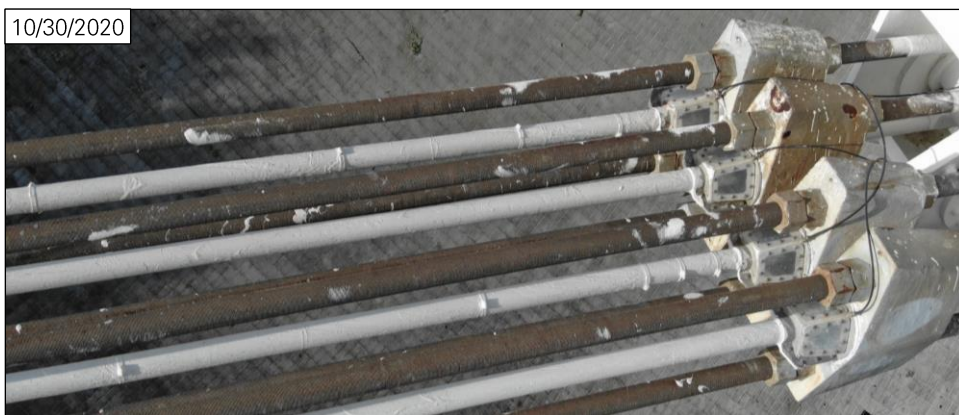
Figure 13: M4 cables near platform on October 30, 2020. No wire is broken.
(Photo: NAIC Arecibo Observatory, a facility of the NSF.)

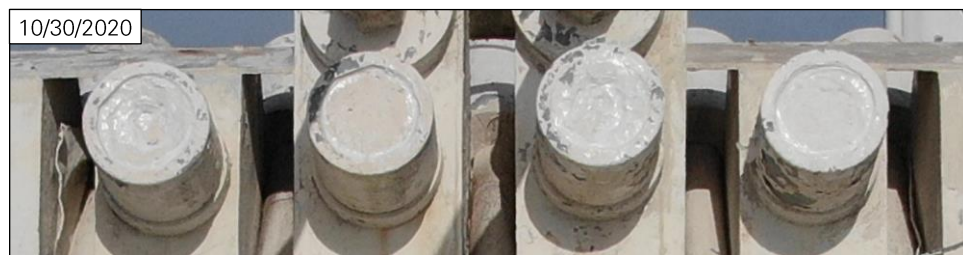
The crack in the zinc casting at the back of socket M4-2_T was sealed by October 1, 2020 (Figure 14). No significant change was observed on the sockets in October 2020 (Figure 15).

Figure 15: M4 sockets at Tower 4 on October 30, 2020. No significant change is visible since October 1, 2020.
(Photo: NAIC Arecibo Observatory, a facility of the NSF.)

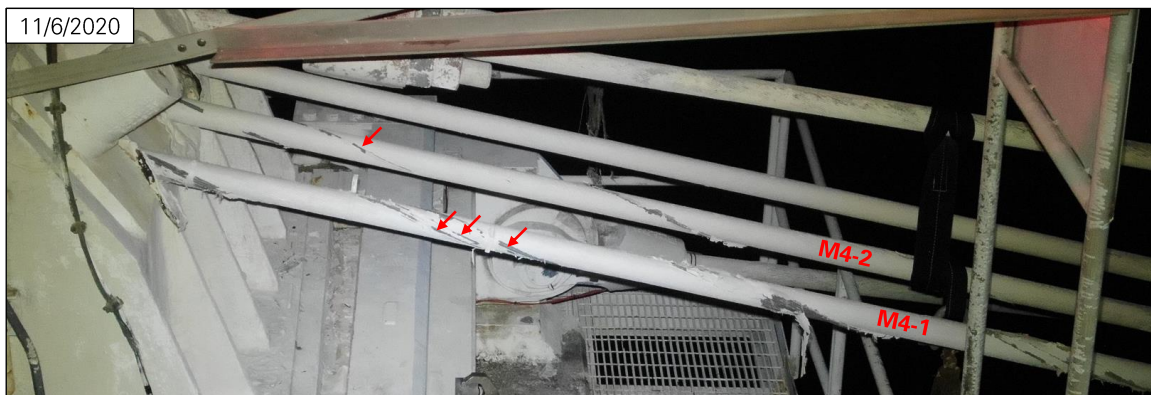
Shortly after the M4-4 failure, three new wire breaks were observed in M4-1 and a new wire break was observed in M4-2 near Tower 4 (Figure 16). Four wire breaks were also observed in M4-2 near the platform (Figure 17).

Figure 16: M4 cables near Tower 4 on November 6, 2020, with three new wire breaks in M4-1 and a new wire break in M4-2
(photos: NAIC Arecibo Observatory, a facility of the NSF).
