Arecibo Telescope Collapse Forensic Investigation

Thornton Tomasetti

July 25, 2022

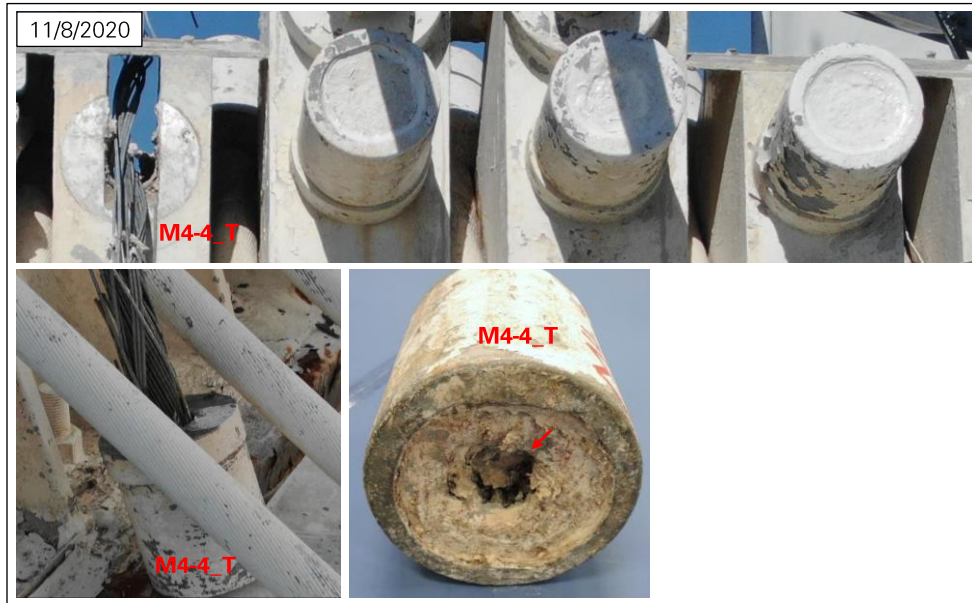
The zinc casting of socket M4-4_T experienced significant deformation during the M4-4 failure or in the week preceding it, with the central part of the casting moving inwards (Figure 18). The M4-4 failure did not cause any visible change in the other three sockets (Figure 18).

Figure 18: M4 sockets at Tower 4 on November 8, 2020, and socket M4-4_T as recovered after collapse (top and bottom left photos: NAIC Arecibo Observatory, a facility of the NSF; bottom center photo: Socotec).

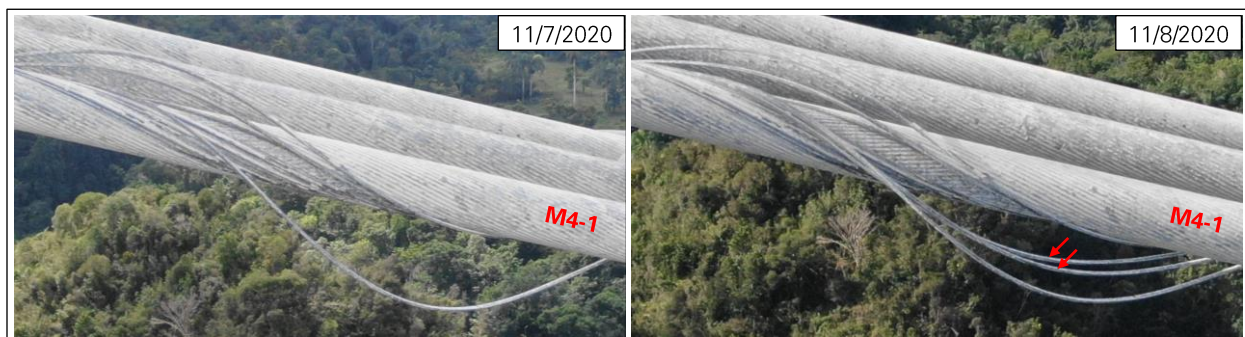
Between the M4-4 failure and the collapse, seven and five new wire breaks were observed in the M4-1 and M4-2 cables respectively near Tower 4. The new wire breaks are shown in Figure 19 through Figure 27. No new wire break was observed in the M4 cables near the platform (Figure 28).

Figure 19: Two new wire breaks in M4-1 on November 8, 2020 (photos: NAIC Arecibo Observatory, a facility of the NSF).

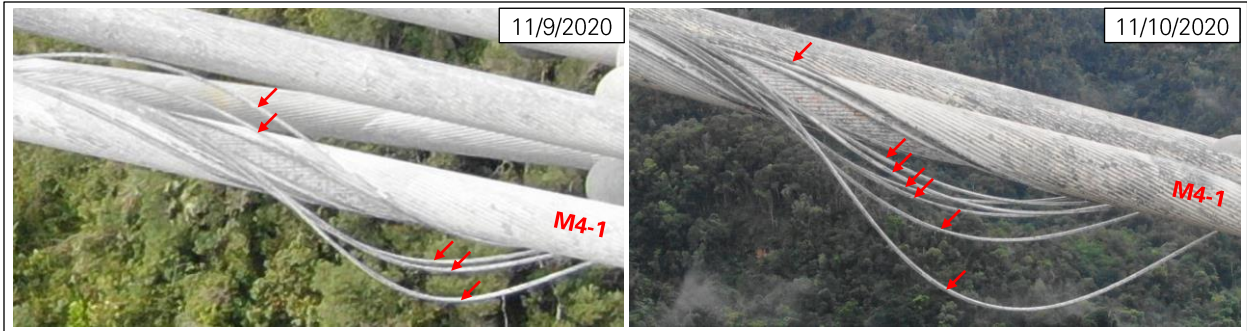
Figure 20: Two new wire breaks in M4-1 on November 10, 2020
(photos: NAIC Arecibo Observatory, a facility of the NSF).

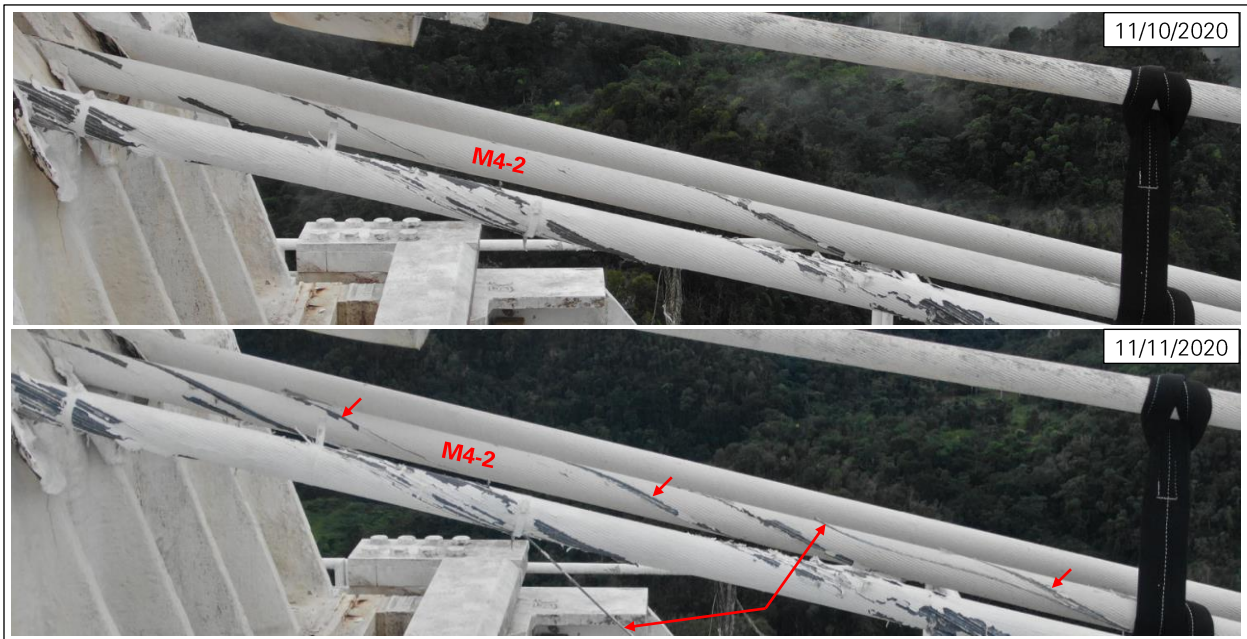
Figure 21: New wire break in M4-2 on November 11, 2020. The break occurred away from the socket.
(Photos: NAIC Arecibo Observatory, a facility of the NSF.)

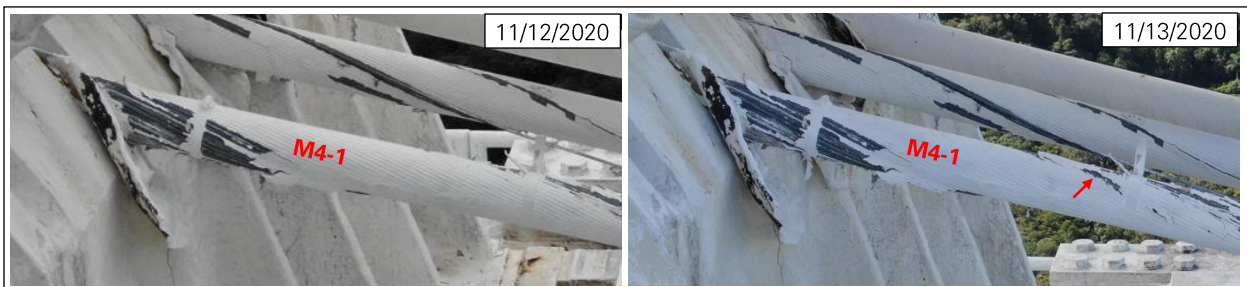
Figure 22: New wire break in M4-1 on November 13, 2020
(photos: NAIC Arecibo Observatory, a facility of the NSF).

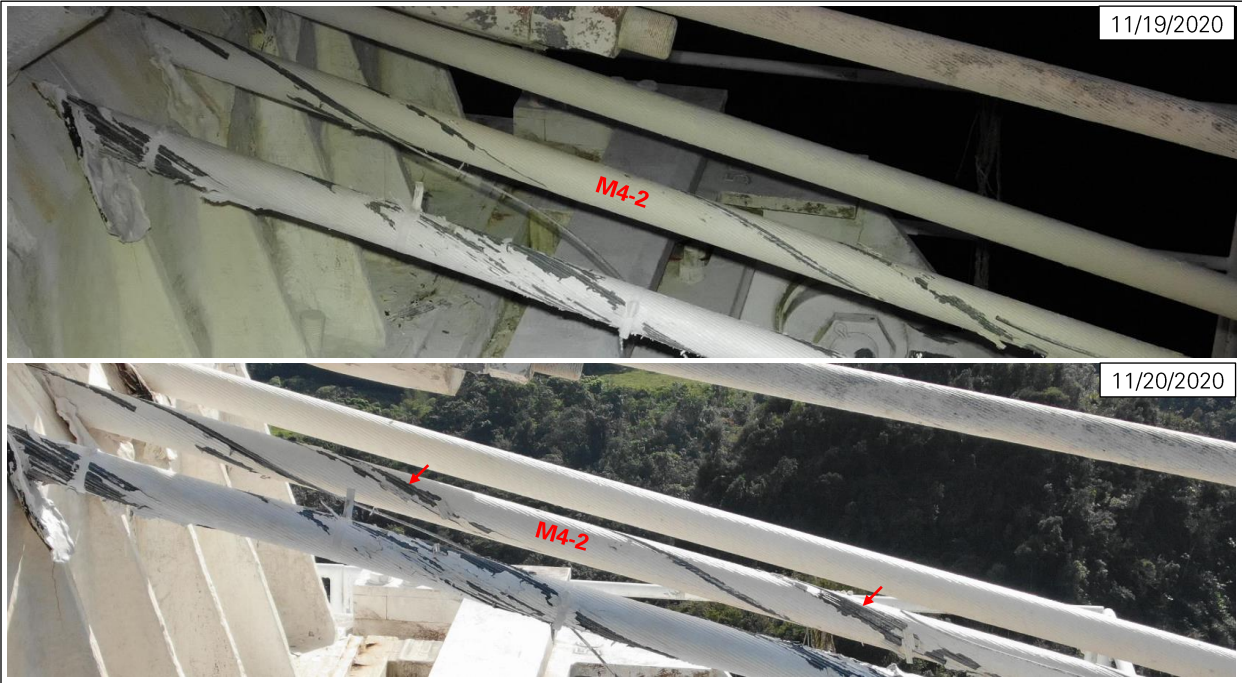
Figure 23: New wire break in M4-2 on November 20, 2020
(photos: NAIC Arecibo Observatory, a facility of the NSF).

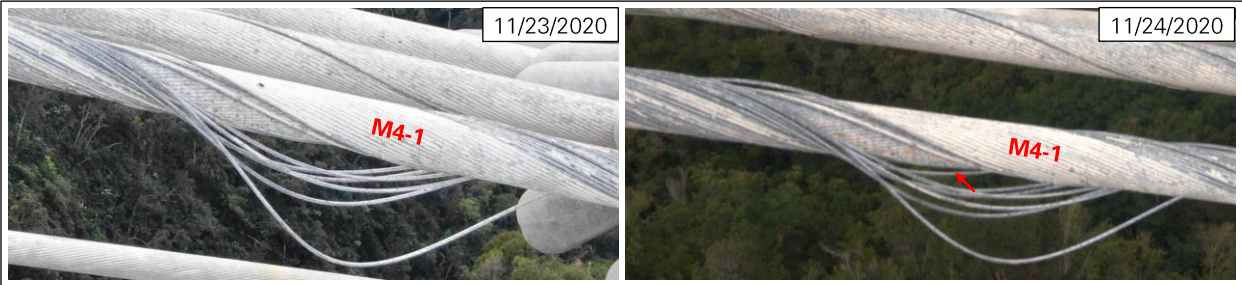
Figure 24: New wire break in M4-1 on November 20, 2020
(photos: NAIC Arecibo Observatory, a facility of the NSF).

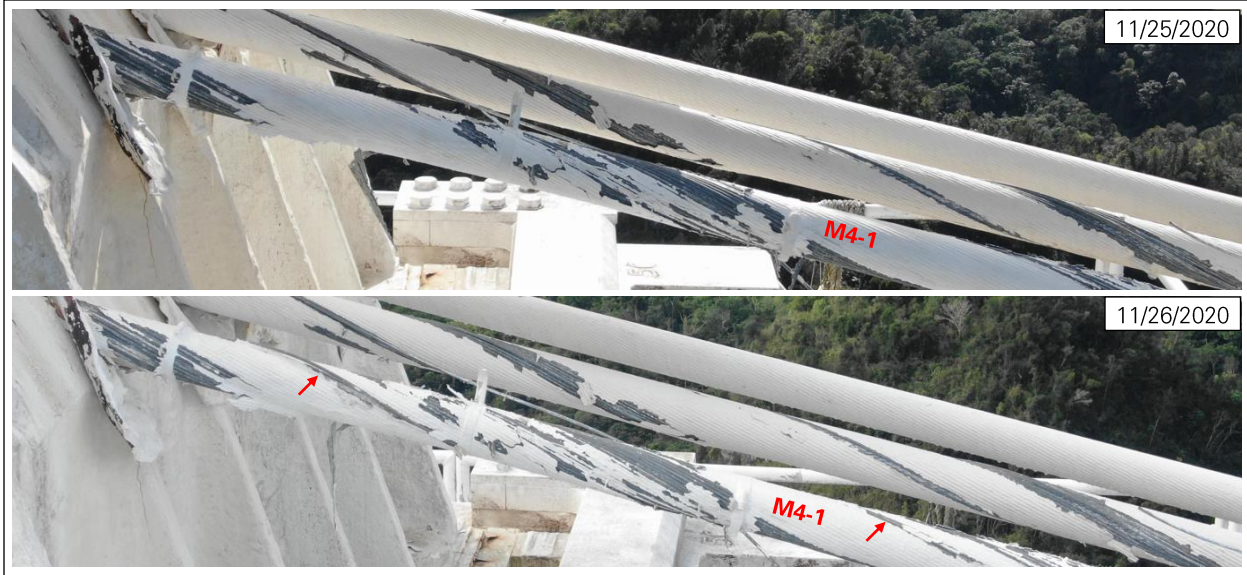
Figure 25: New wire break in M4-1 on November 26, 2020
(photos: NAIC Arecibo Observatory, a facility of the NSF).

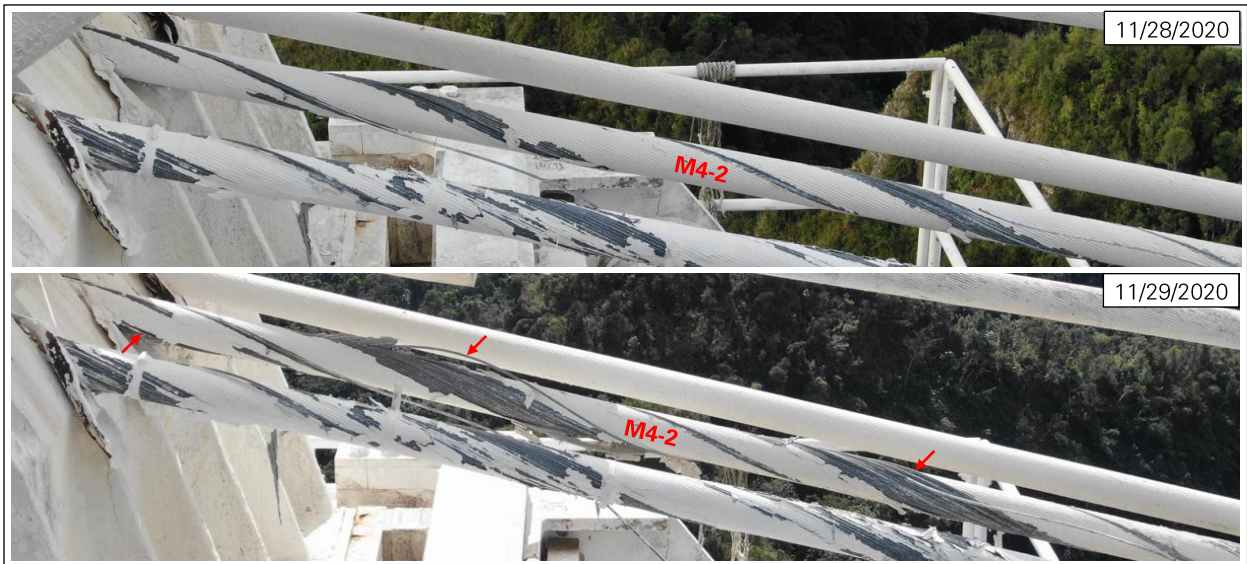
Figure 26: New wire break in M4-2 on November 29, 2020
(photos: NAIC Arecibo Observatory, a facility of the NSF).

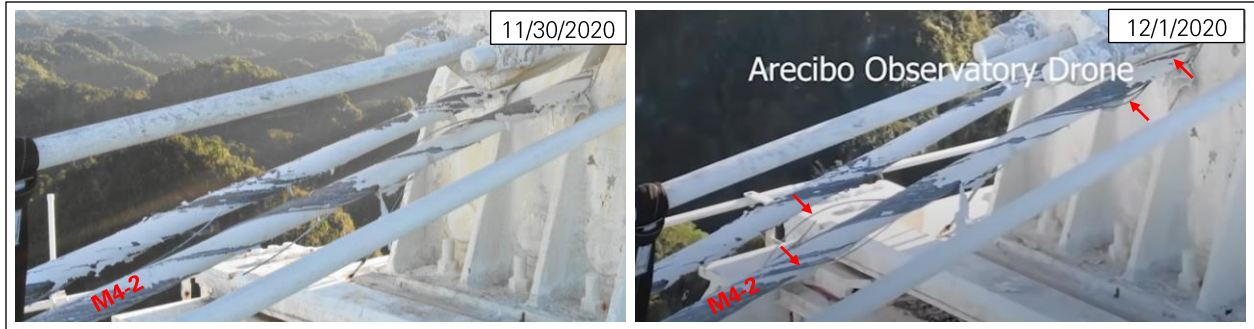
Figure 27: Two new wire breaks in M4-2 on December 1, 2020
 (photos: NAIC Arecibo Observatory, a facility of the NSF).

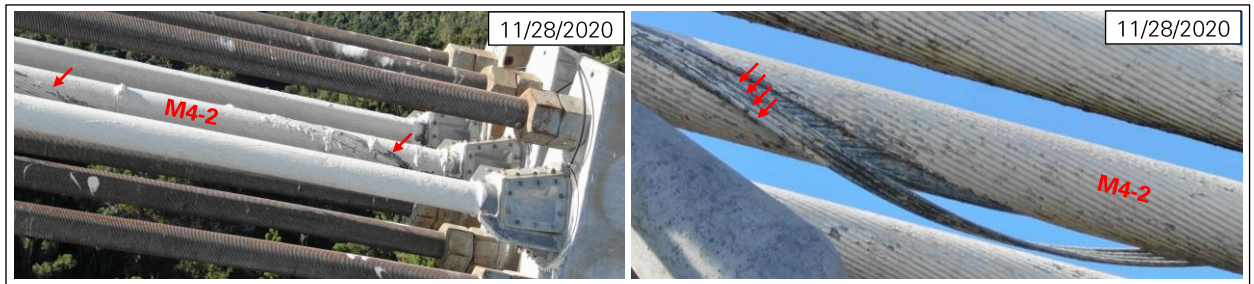
Figure 28: M4 cables near platform on November 28, 2020, with no visible change since November 7, 2020
 (photos: NAIC Arecibo Observatory, a facility of the NSF).

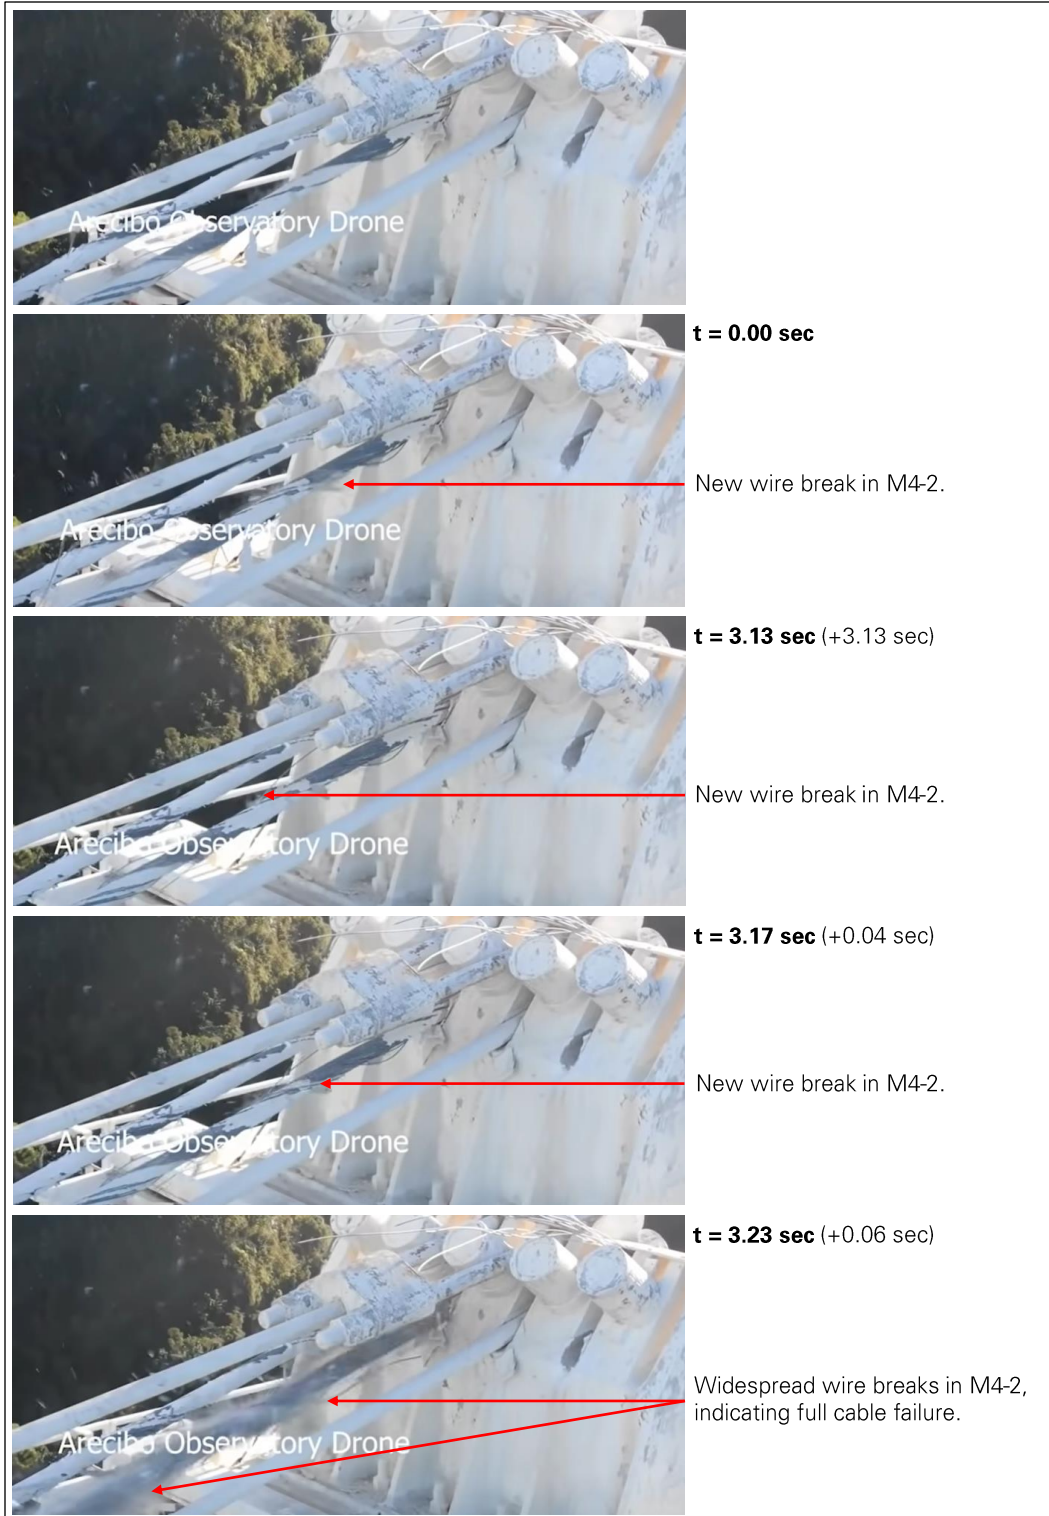
The AO staff was performing a drone inspection of the top of Tower 4 when cable M4-2 failed and triggered the collapse of the telescope. Key frames of the video recorded by the drone are compiled on Figure 31 through Figure 33.

Figure 31: Still images of drone video of top of Tower 4 during telescope collapse: seconds 0.00 to 3.23 (video: NAIC Arecibo Observatory, a facility of the NSF).

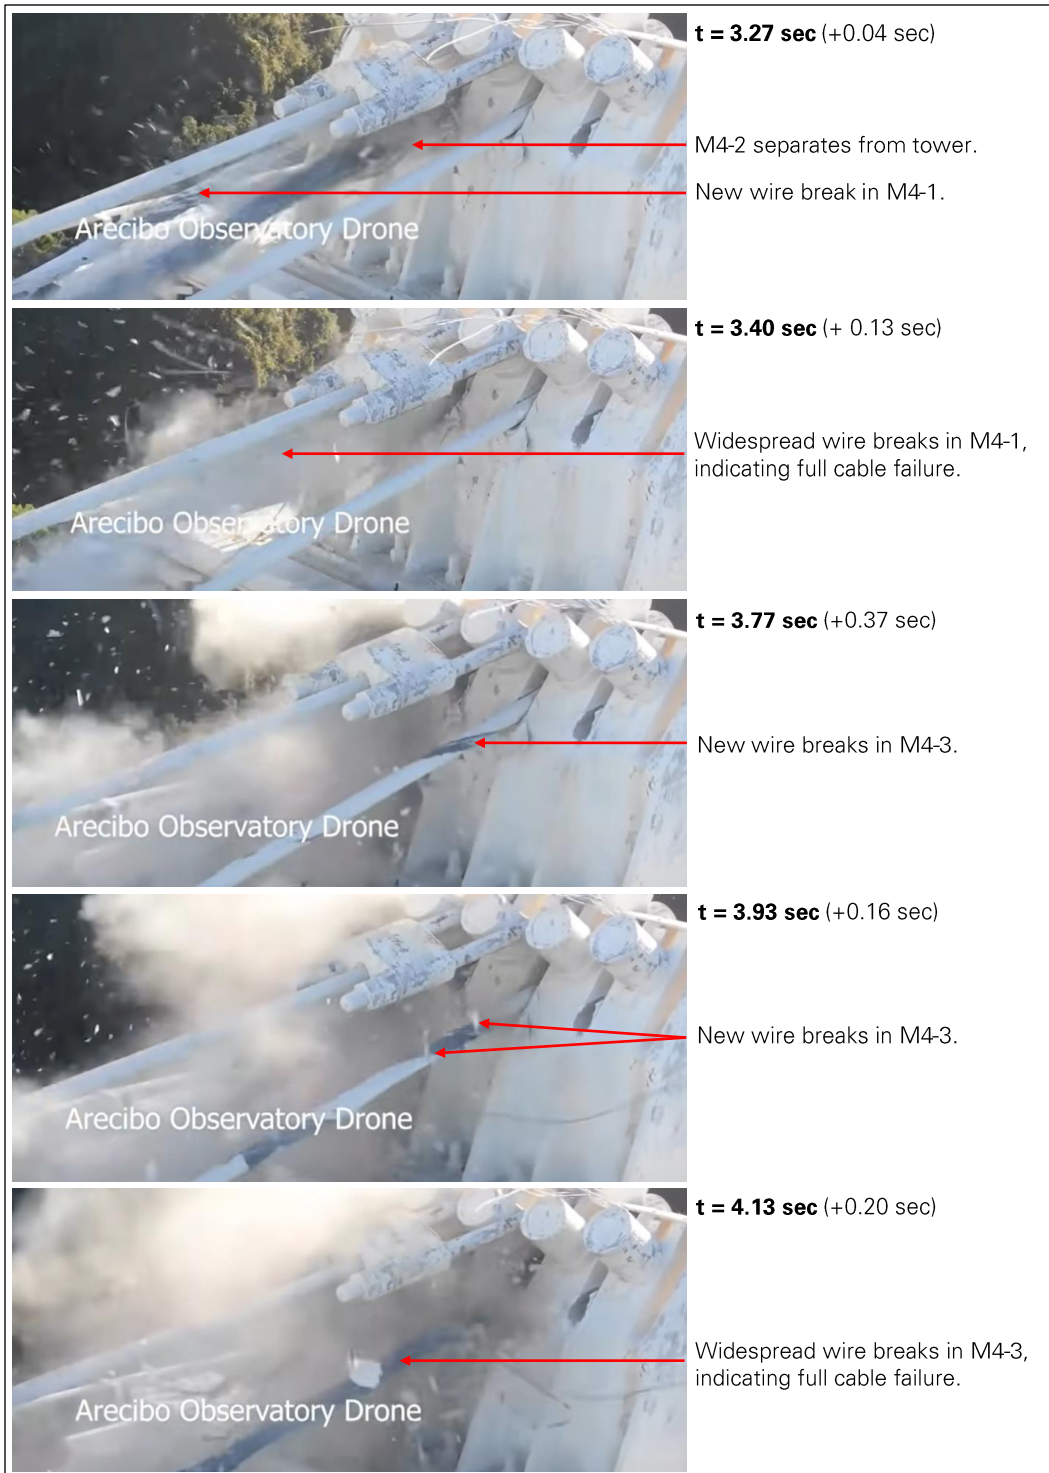
Figure 32: Still images of drone video of top of Tower 4 during telescope collapse: seconds 3.27 to 4.13 (video: NAIC Arcibo Observatory, a facility of the NSF).

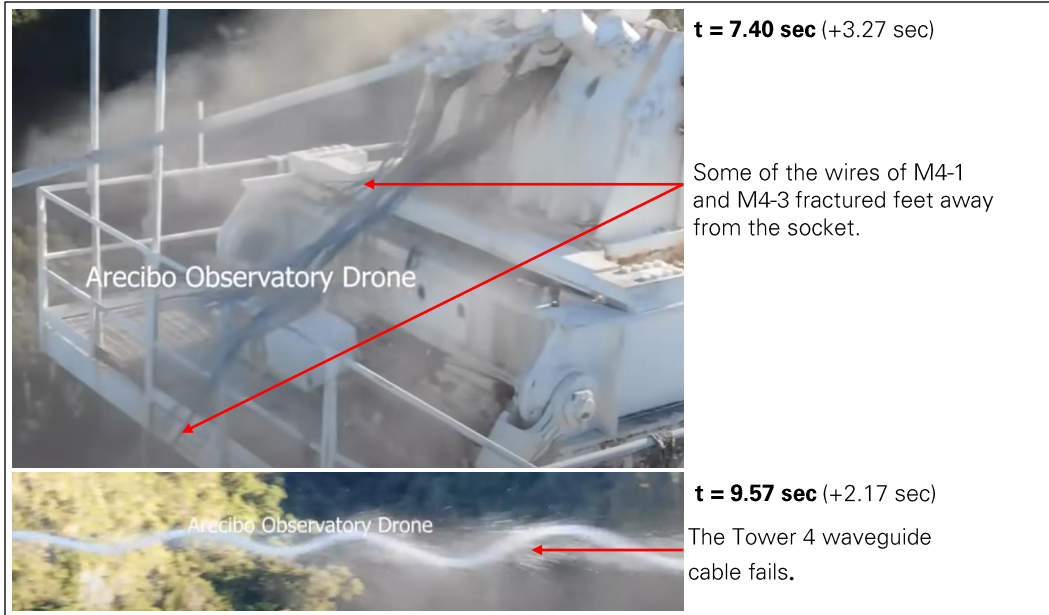
Figure 33: Still images of drone video of top of Tower 4 during telescope collapse: seconds 3.27 to 9.57 (video: NAIC Arecibo Observatory, a facility of the NSF).

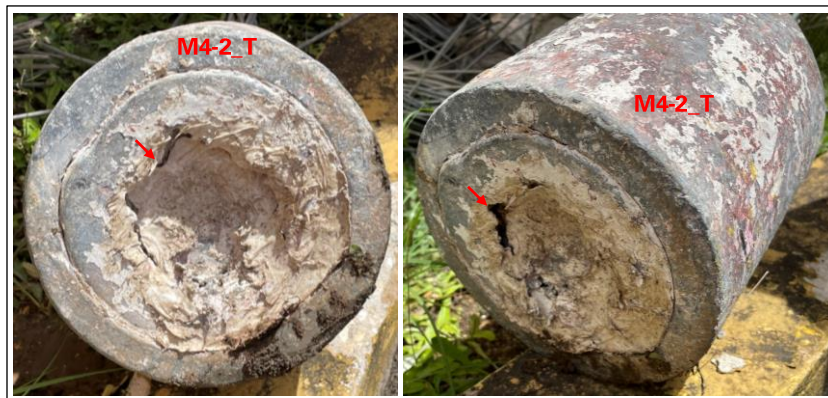
The M4-2 socket recovered after the collapse is shown in Figure 34. The central part of the zinc casting moved further inwards since the last known photo (November 25, 2020, Figure 30). This movement may have occurred suddenly when M4-2 failed.

Figure 34: Socket M4-2_T recovered after collapse.

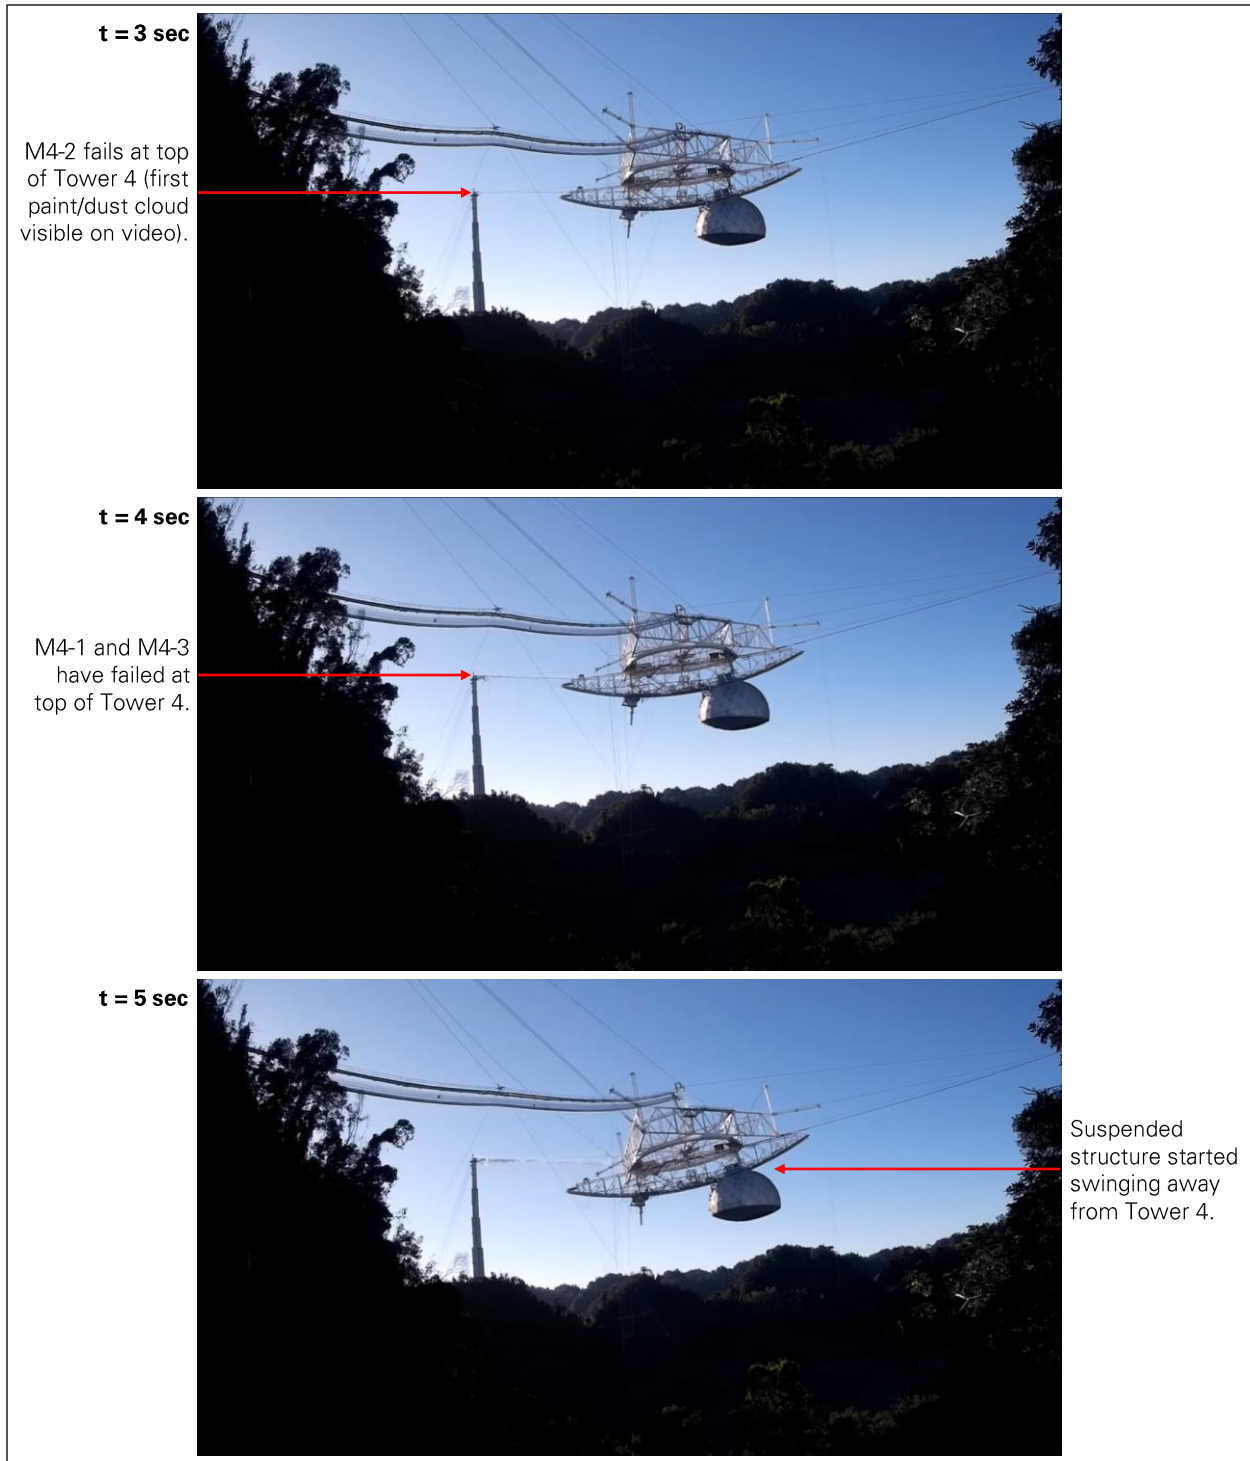
At the time of the collapse, a camera set up in the telescope's control room was recording the suspended structure. The collapse lasted approximately 15 seconds, between the M4-2 failure and the landing of the last cables and tower tops. Still images of the collapse video at one second intervals are shown in Figure 35 through Figure 40.

Figure 35: Still images of telescope collapse video: seconds 3 to 5 (video: NAIC Arecibo Observatory, a facility of the NSF).

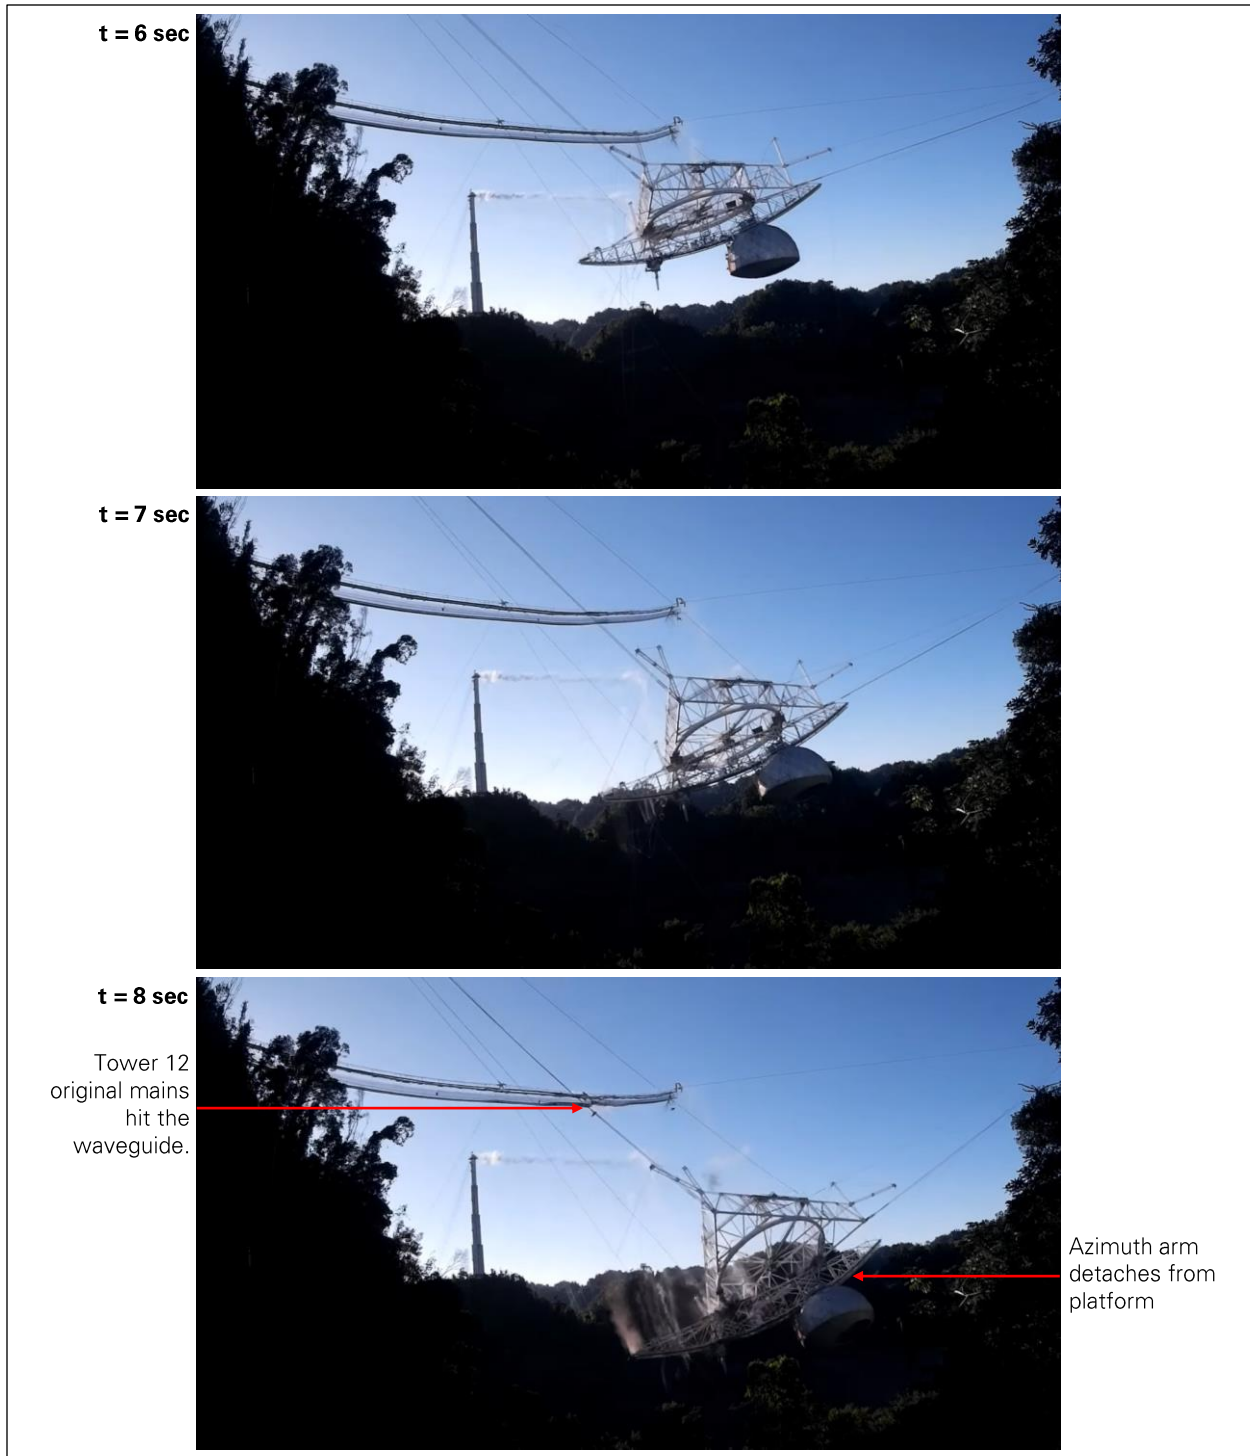
Figure 36: Still images of telescope collapse video: seconds 6 to 8 (video: NAIC Arecibo Observatory, a facility of the NSF).

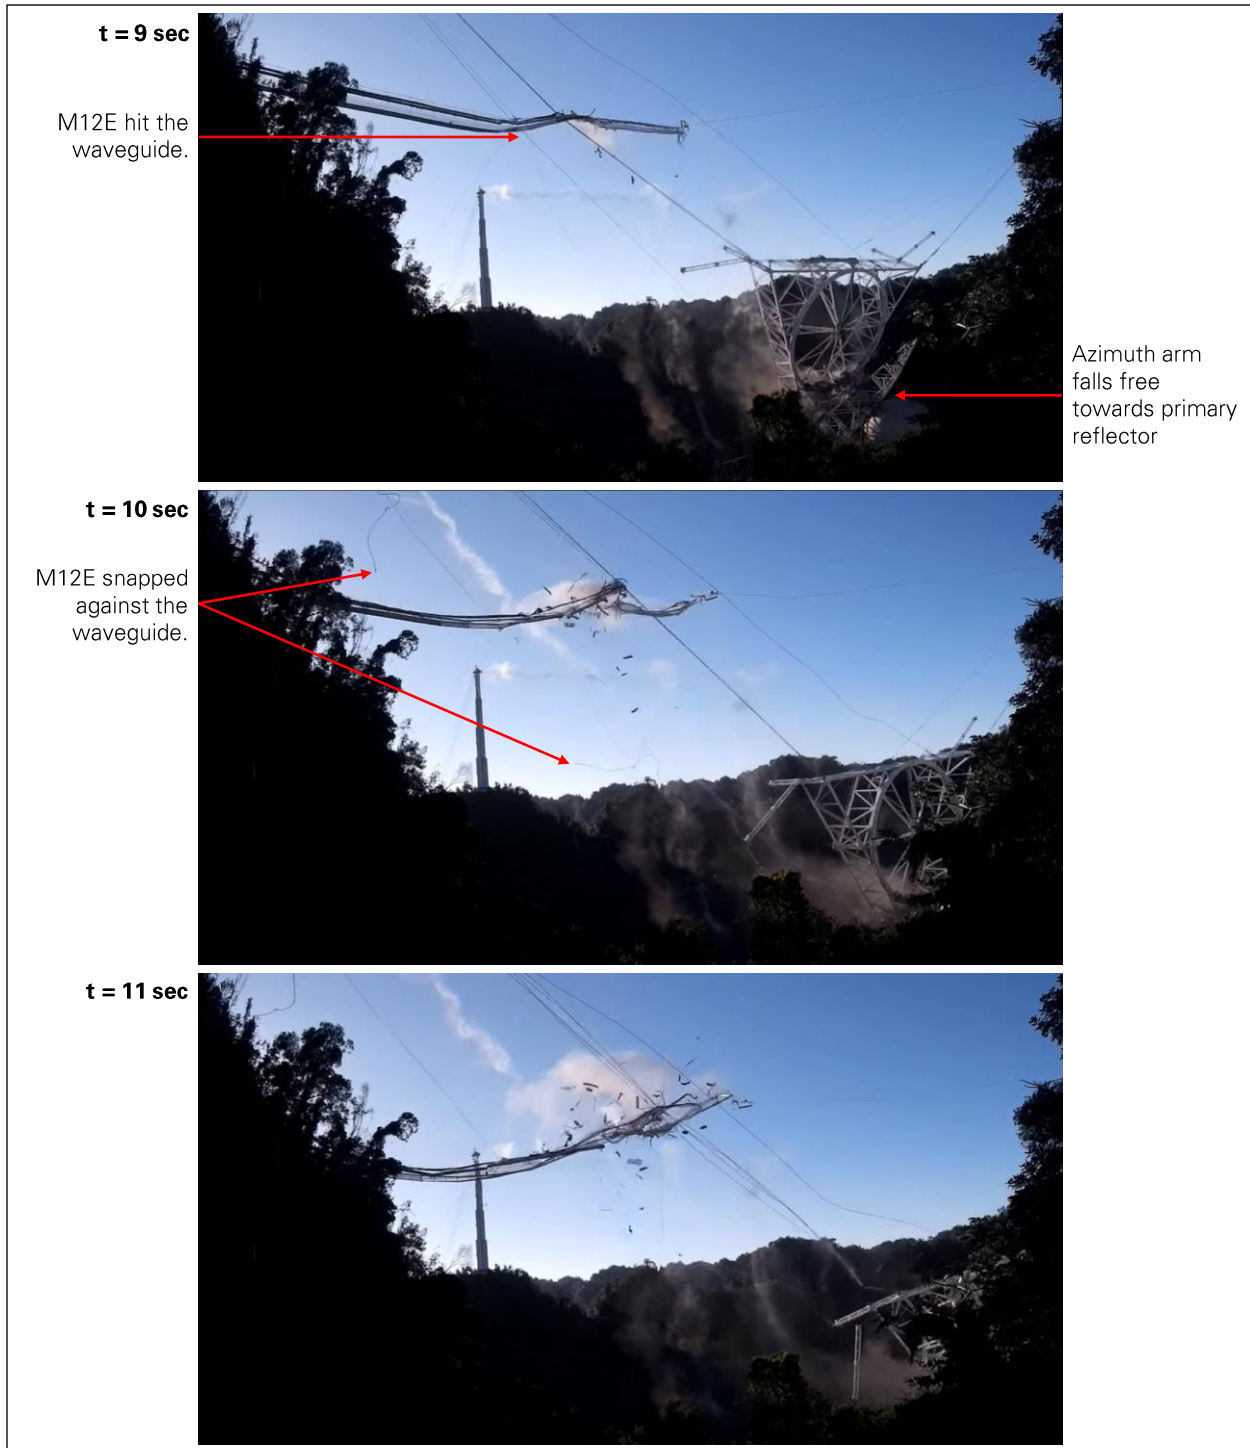
Figure 37: Still images of telescope collapse video: seconds 9 to 11
(video: NAIC Arecibo Observatory, a facility of the NSF).

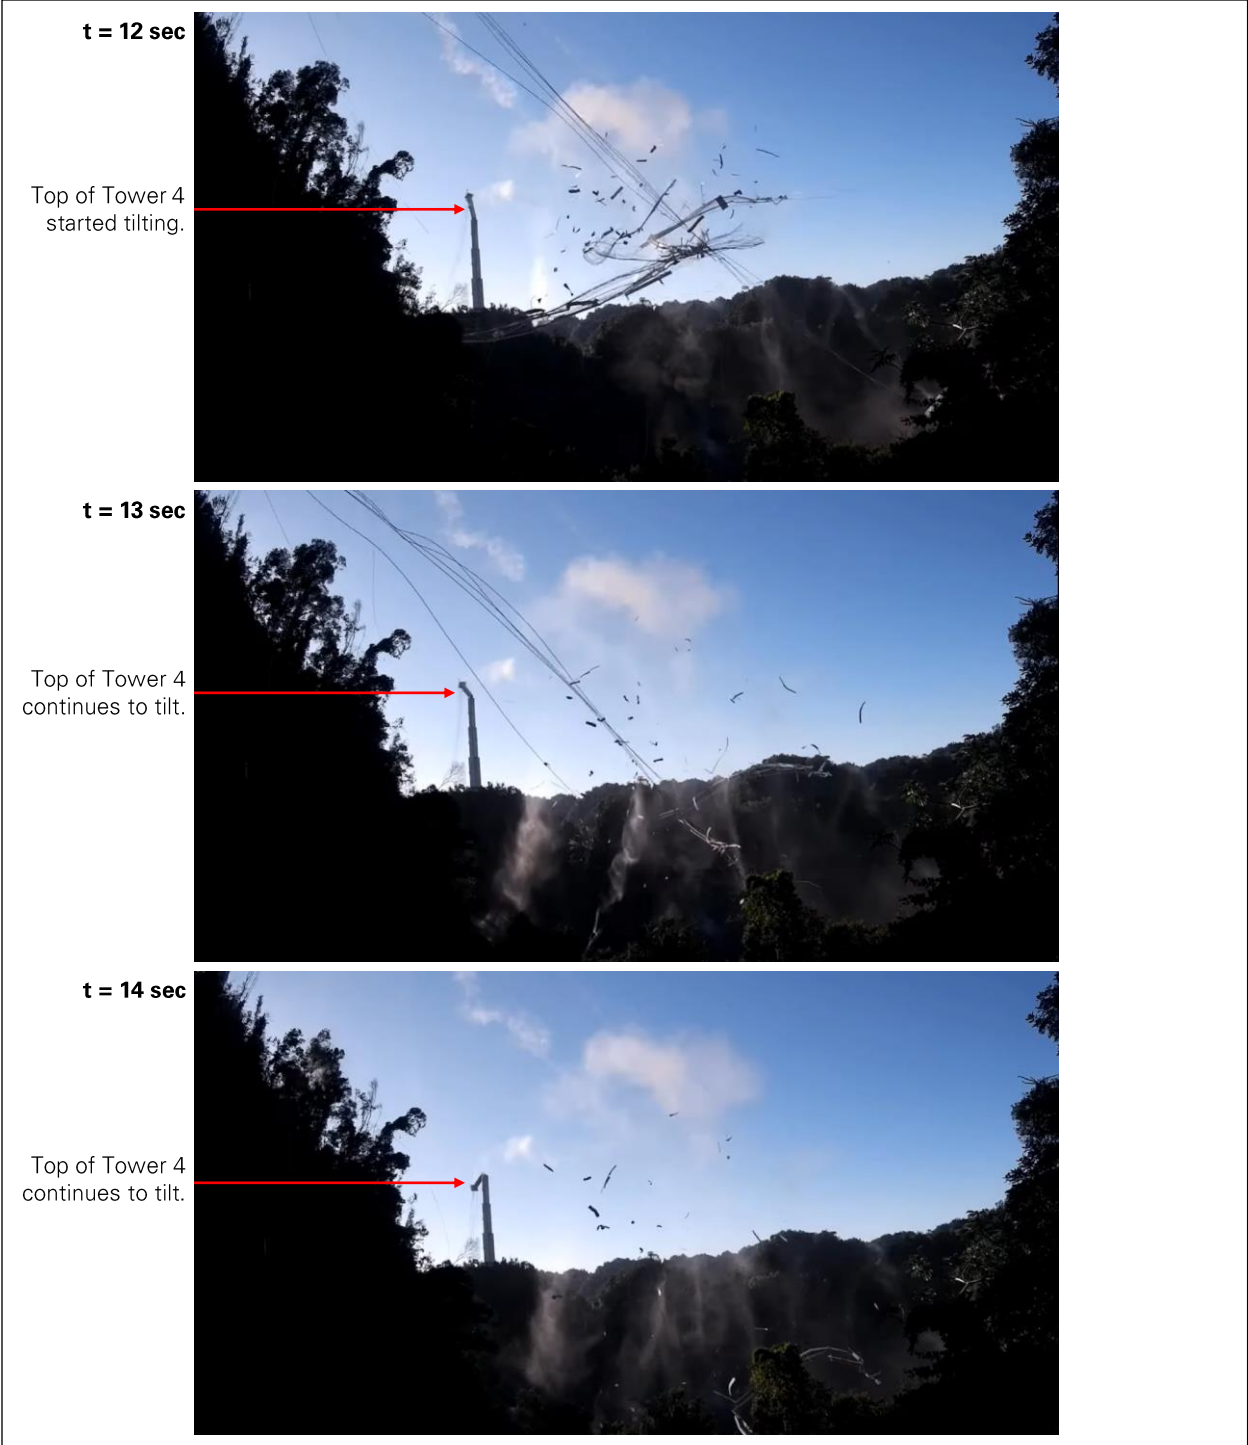
Figure 38: Still images of telescope collapse video: seconds 12 to 14 (video: NAIC Arecibo Observatory, a facility of the NSF).

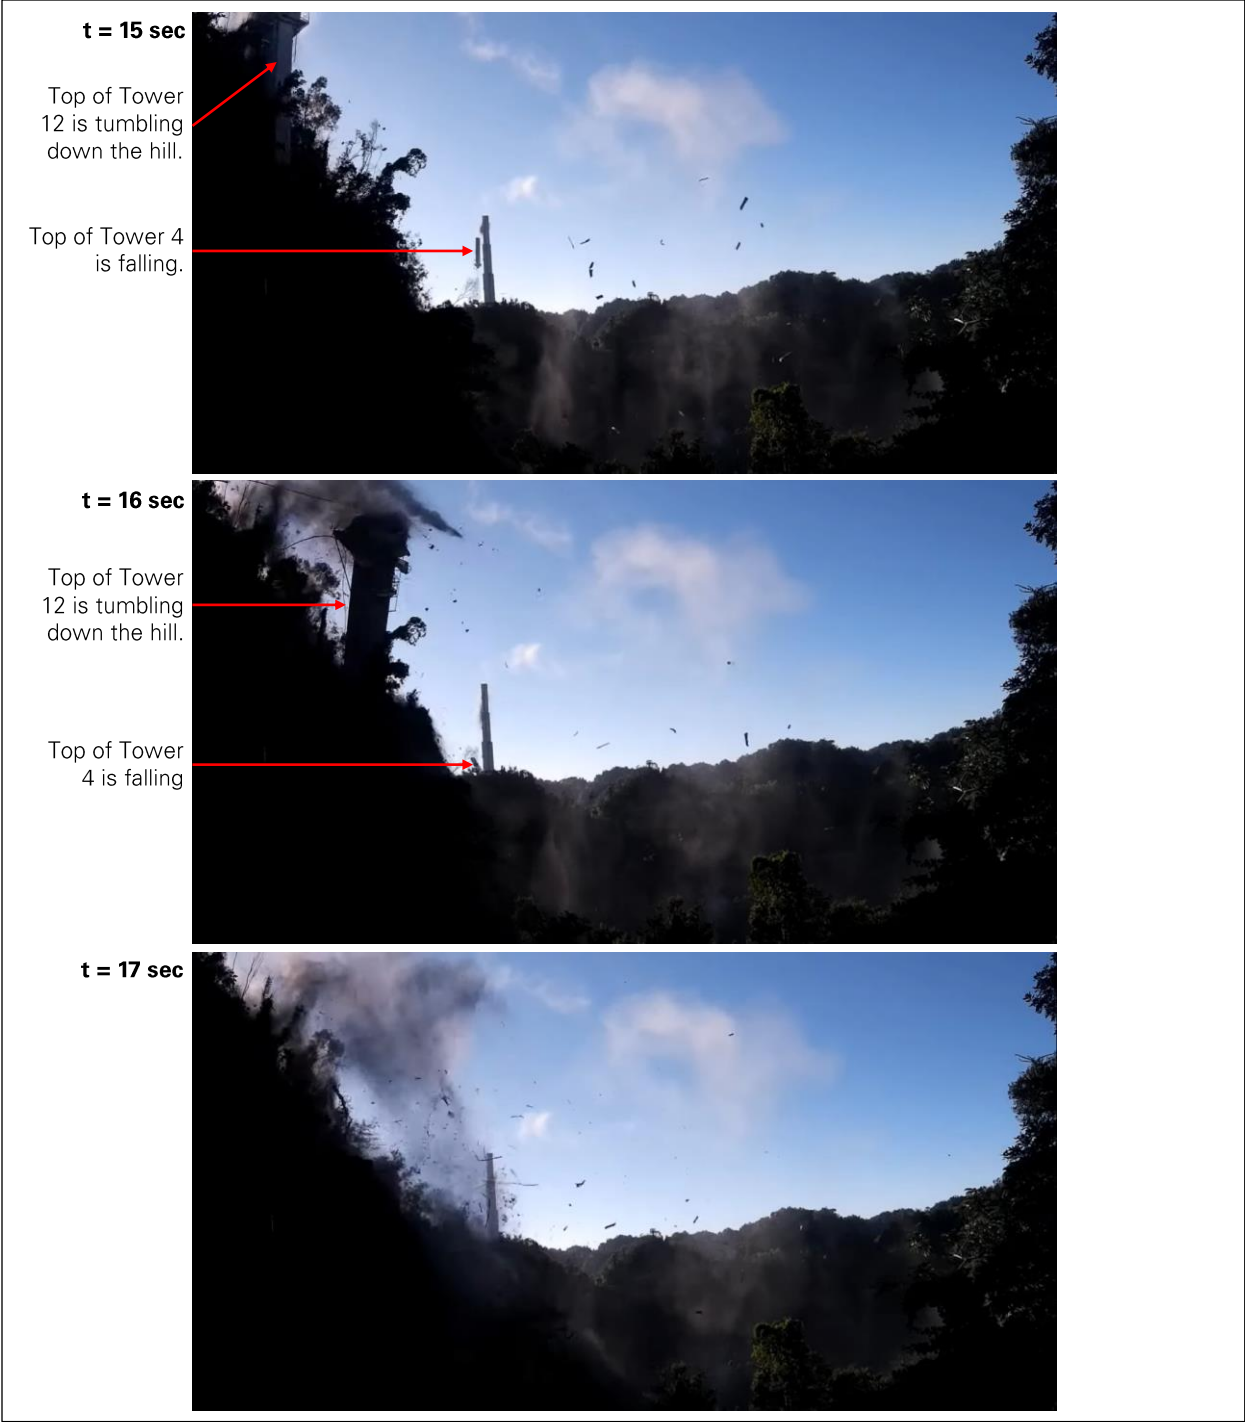
Figure 39: Still images of telescope collapse video: seconds 15 to 17 (video: NAIC Arecibo Observatory, a facility of the NSF).

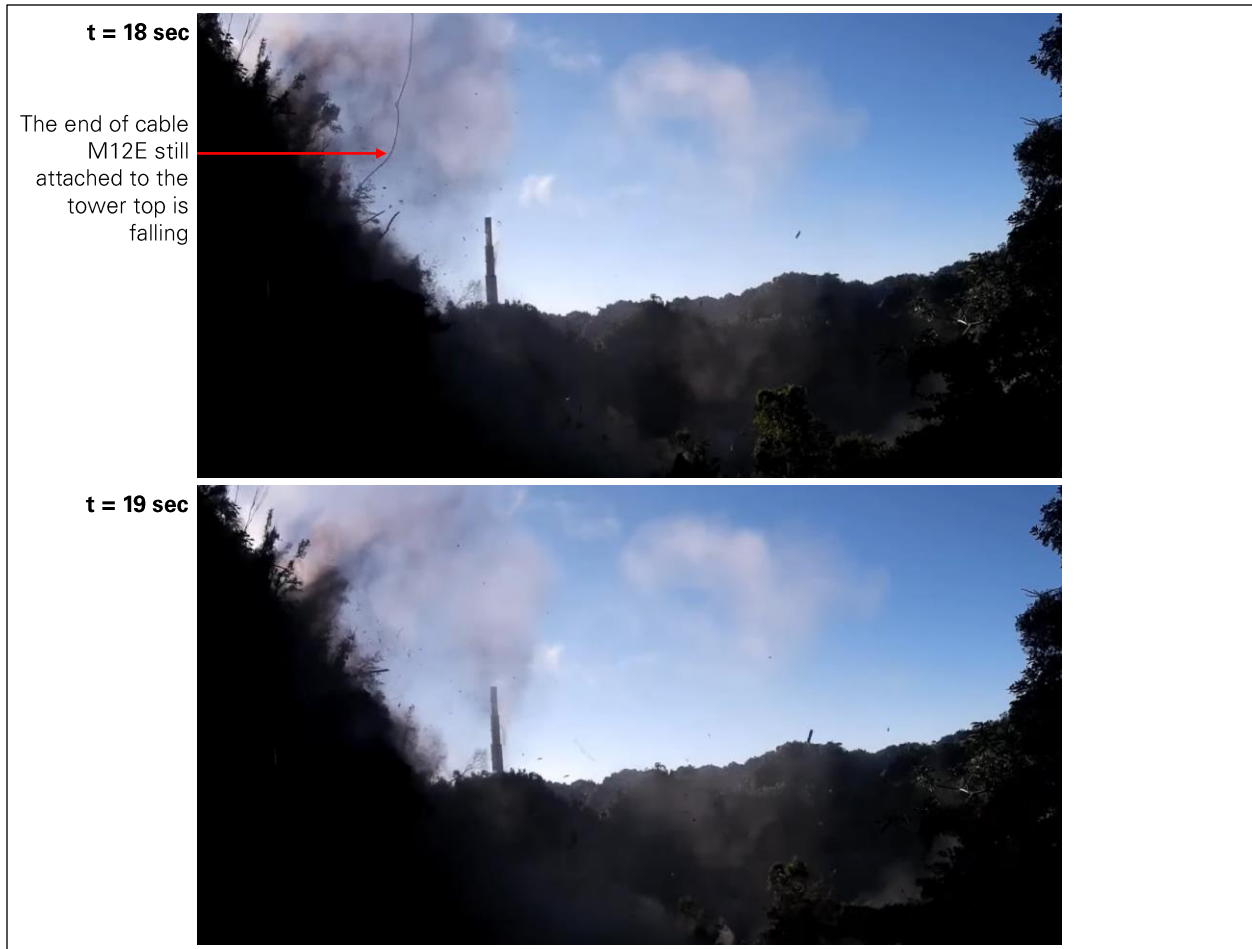
Figure 40: Still images of telescope collapse video: seconds 18 to 19
(video: NAIC Arecibo Observatory, a facility of the NSF).

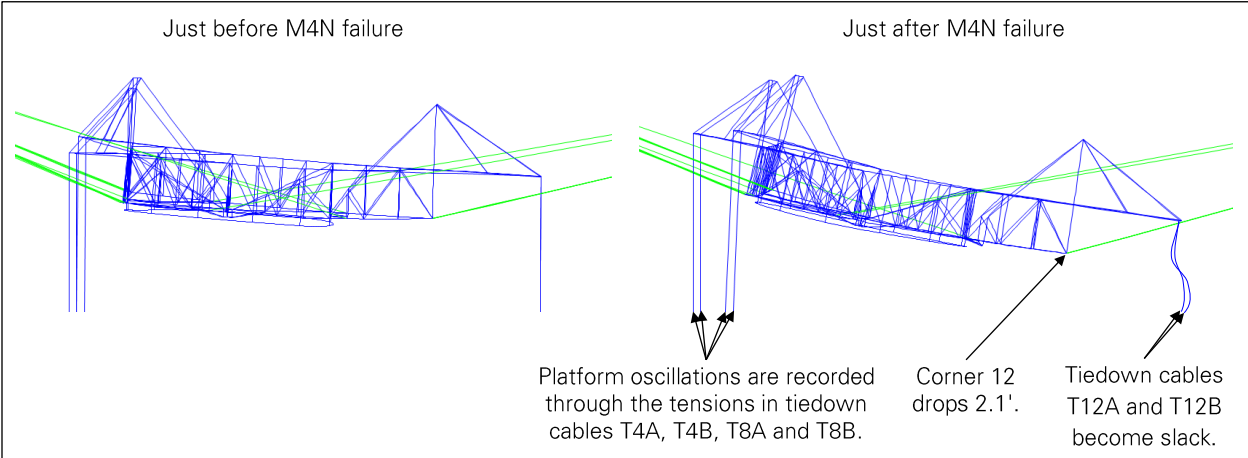
Each of the three platform corners had two tiedown cables, and each tiedown cable tension was measured independently. Platform corner 12 dropped approximately two feet when the M4N cable failed, causing its tiedown cables to become slack, while the tiedown cables at platform corners 4 and 8 remained taut (Figure 8). The tiedown cable tensions after failure are shown in Figure 9. The tensions

Figure 8: Platform response to M4N failure (looking west, displacements magnified x10).
