Arecibo Telescope Collapse Forensic Investigation

Thornton Tomasetti

July 25, 2022

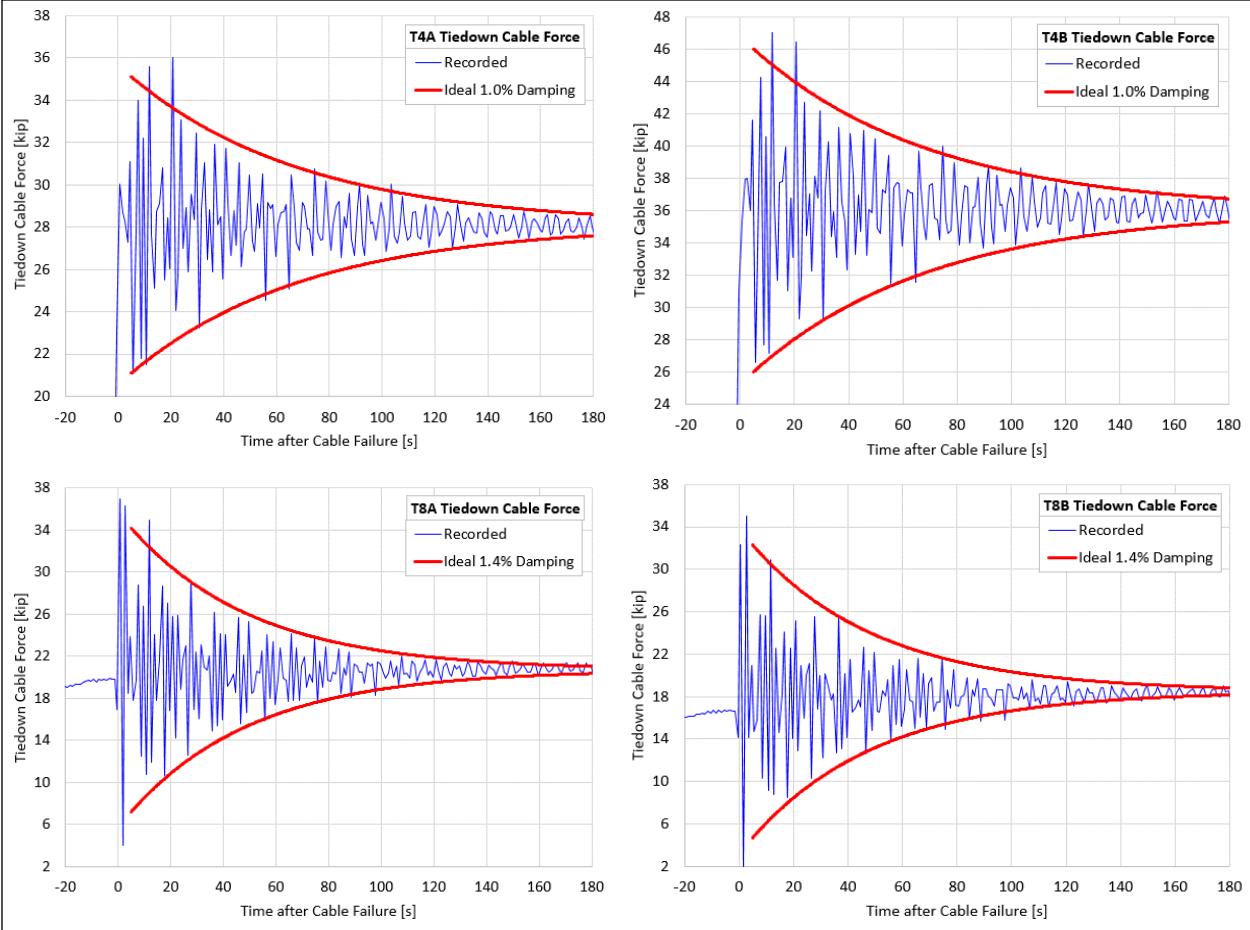
were recorded once every second, with the periods of the vertical vibration of the platform expected to be in the order of three seconds (section 6.0 below). As a result, the vibration cycles are visible in the recorded cable tensions, but the peak cable tensions are not captured for every cycle. As shown in Figure 9, by fitting a logarithmic decrement to each recorded cable tension to estimate damping, we obtain a damping ratio of 1.0 percent from the corner 4 tiedown cables and 1.4 percent from the corner 8 tiedown cables. Based on these results, we assumed a damping ratio of one percent for every global vibration mode of the telescope structure in our dynamic analyses.

Figure 9: Damping measurement from tiedown tensions during first cable failure.

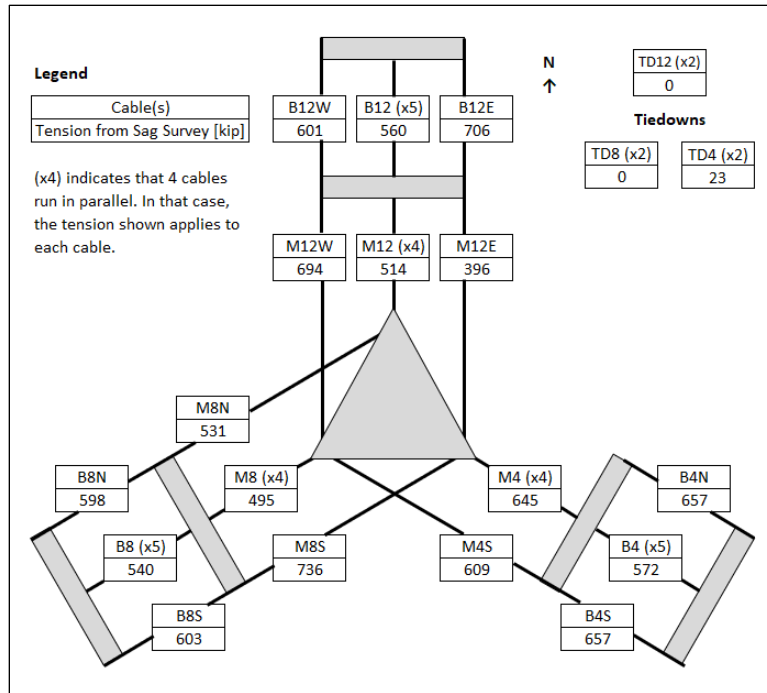
Figure 10: Cable tensions derived from August 2020 sag survey.

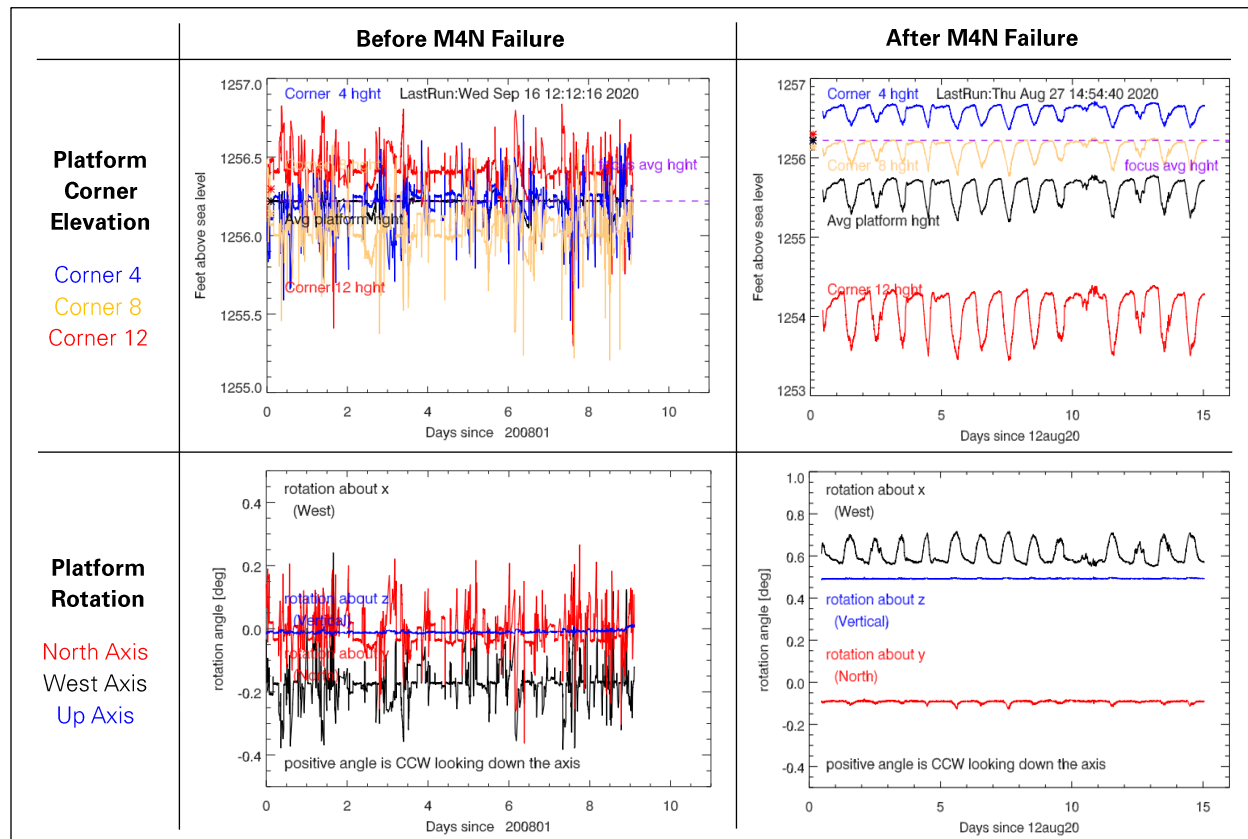
Since cable M4N is connected to the east side of the platform near corner 12, its failure caused corner 12 to drop down and move west. During telescope operation, the platform corner positions were continuously monitored with laser rangers to adjust the tiedown tensions in order to keep the platform at a constant elevation through the day-night temperature cycles. Plots of the laser ranger data before and after the M4N failure were provided by AO and are shown in Figure 12. The plots show the elevation of the three platform corners and the rotation of the platform about three orthogonal axes. The fluctuations before failure are due to the telescope's operation since the tiedowns compensated for temperature effects. After failure, the fluctuations are due to temperature since the telescope and tiedown jacks were no longer operating. Table 7 summarizes the average elevations and rotations before failure, and the nighttime elevations and rotations after failure. We considered the nighttime values after failure because they are more consistent between days than the daytime values.

Figure 12: Platform corner elevation and rotation before and after M4N failure
 (images: NAIC Arecibo Observatory, a facility of the NSF).

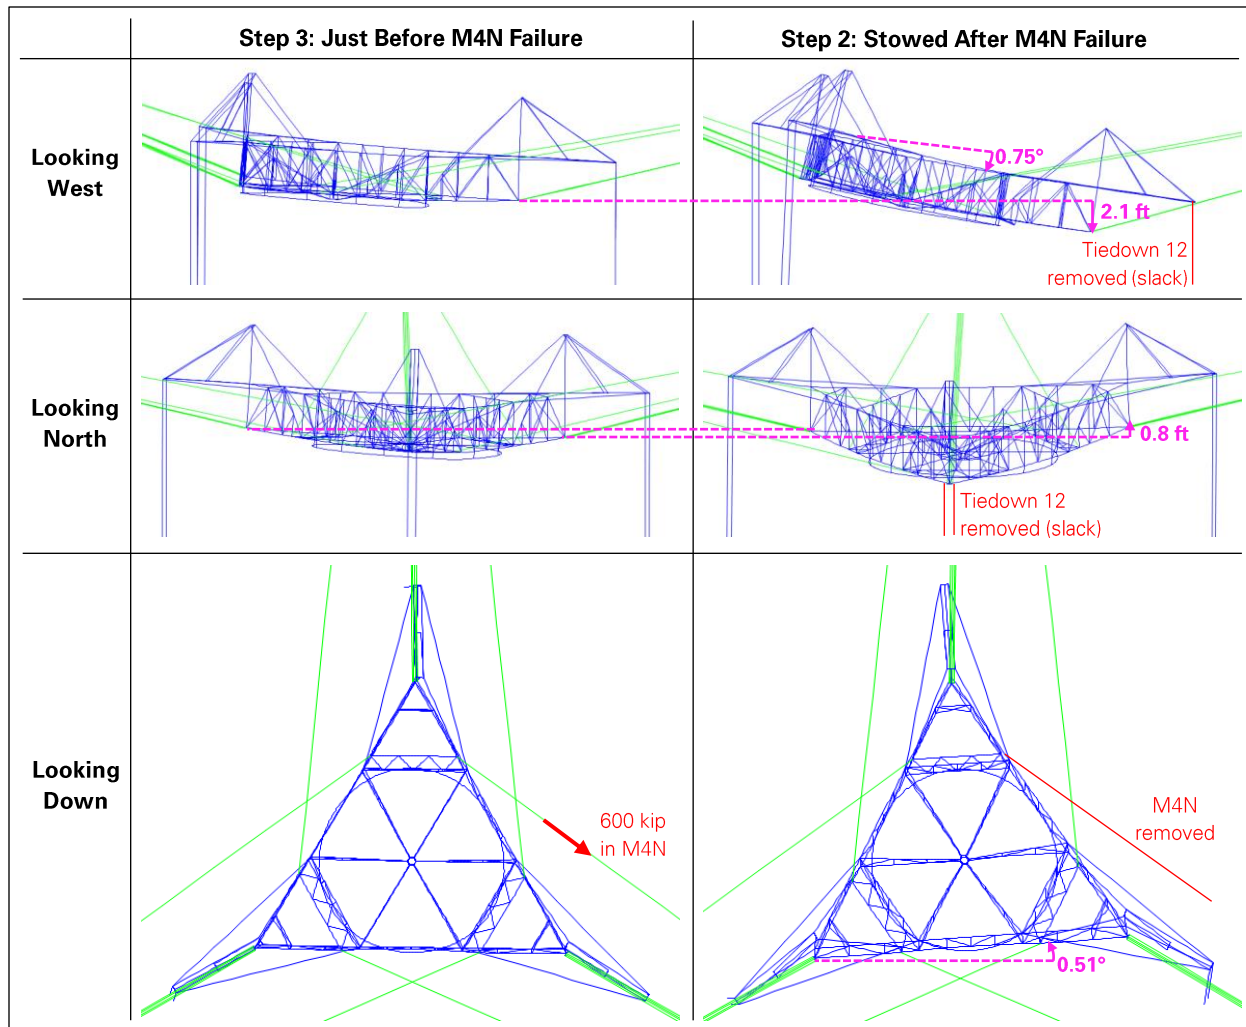
Steps 3 and 4 were repeated with increasing values of the M4N tension assumed at the time of failure, from 400 kip to 800 kip in 25 kip increments. After each analysis with a different M4N tension, we output the change in corner elevation and platform rotation from Step 3 to Step 2, as illustrated in Figure 13. For these analyses, we modeled the azimuth arm as loads on the platform’s ring girder and varied these loads to represent different positions of the azimuth arm and Gregorian.

Figure 13: Analysis of platform response to M4N failure assuming M4N carries 600 kip at failure time. (Displacements magnified x10. Azimuth arm, Gregorian and line feed modeled as loads on ring girder.)

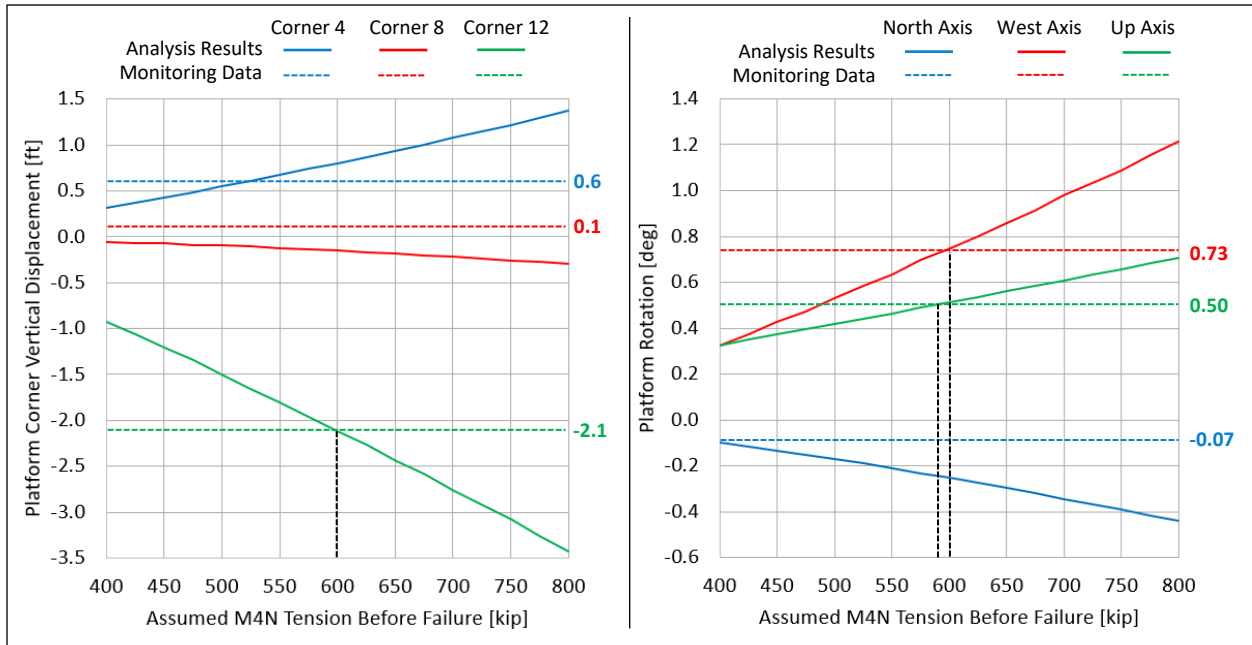
The results of the series of analyses are plotted in Figure 14 and compared to the monitoring data. The more significant changes observed in the monitoring data after the M4N failure are the rotation about the vertical axis (0.5 degree) and the drop of Corner 12 (2.1 feet), which results in a rotation about the west axis (0.73 degree). On the other hand, the rotation about the north axis (0.07 degree) and the vertical movement of Corner 4 (0.6 foot) and Corner 8 (0.1 foot) are less significant. For the three more significant parameters, the model matches the monitoring data when the M4N tension is between 580 kip and 600 kip at the time of failure.

Based on these results, we assume that M4N carried a tension of 600 kip when it failed. The complete set of cable tensions at the time of the M4N failure is provided in Figure 15 and compared to each cable's minimum breaking strength. The 600 kip in M4N are 46 percent of the cable's minimum breaking strength.

Figure 14: Determination of M4N tension just before failure from analysis results and monitoring data.

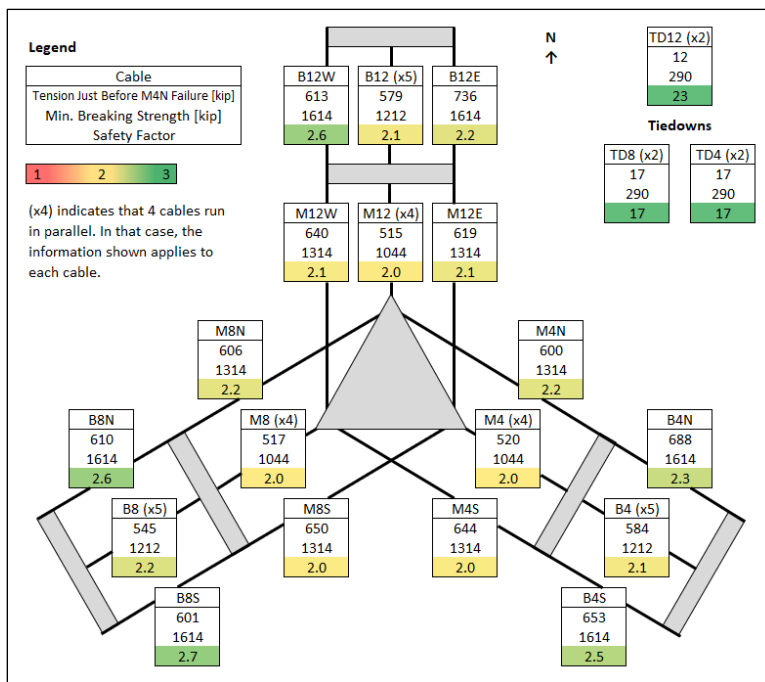
Figure 15: Cable tensions and safety factors just before M4N failure.

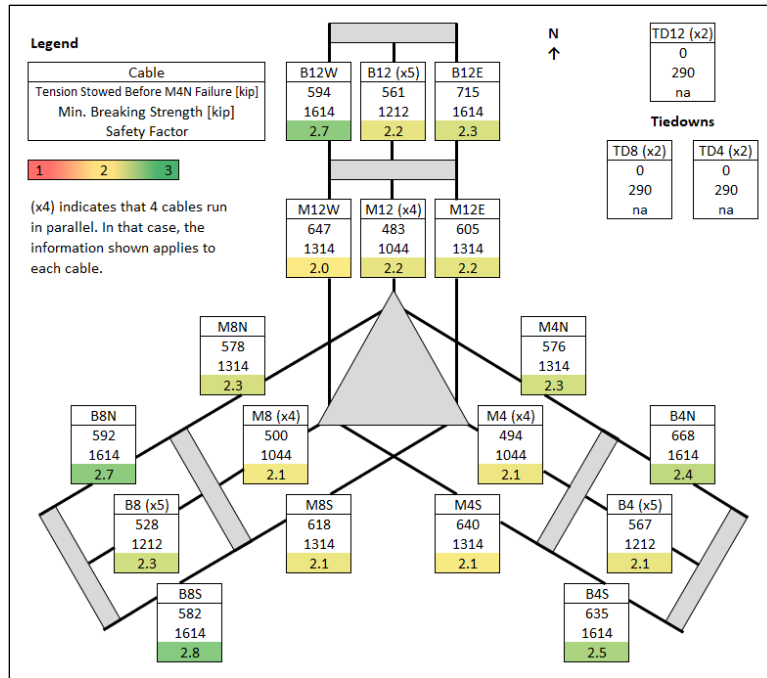
The cable tensions when the telescope is stowed with tiedowns released before the M4N failure are provided in Figure 16. These are the resultant tensions obtained in Step 4 of the analysis when the M4N tensions in Step 3 is 600 kip. With M4N still connected and the tiedowns released, these tensions correspond to a minimum stress state in the overall cable system.

Figure 16: Cable tensions and safety factors with telescope stowed and tiedowns slack before M4N failure.

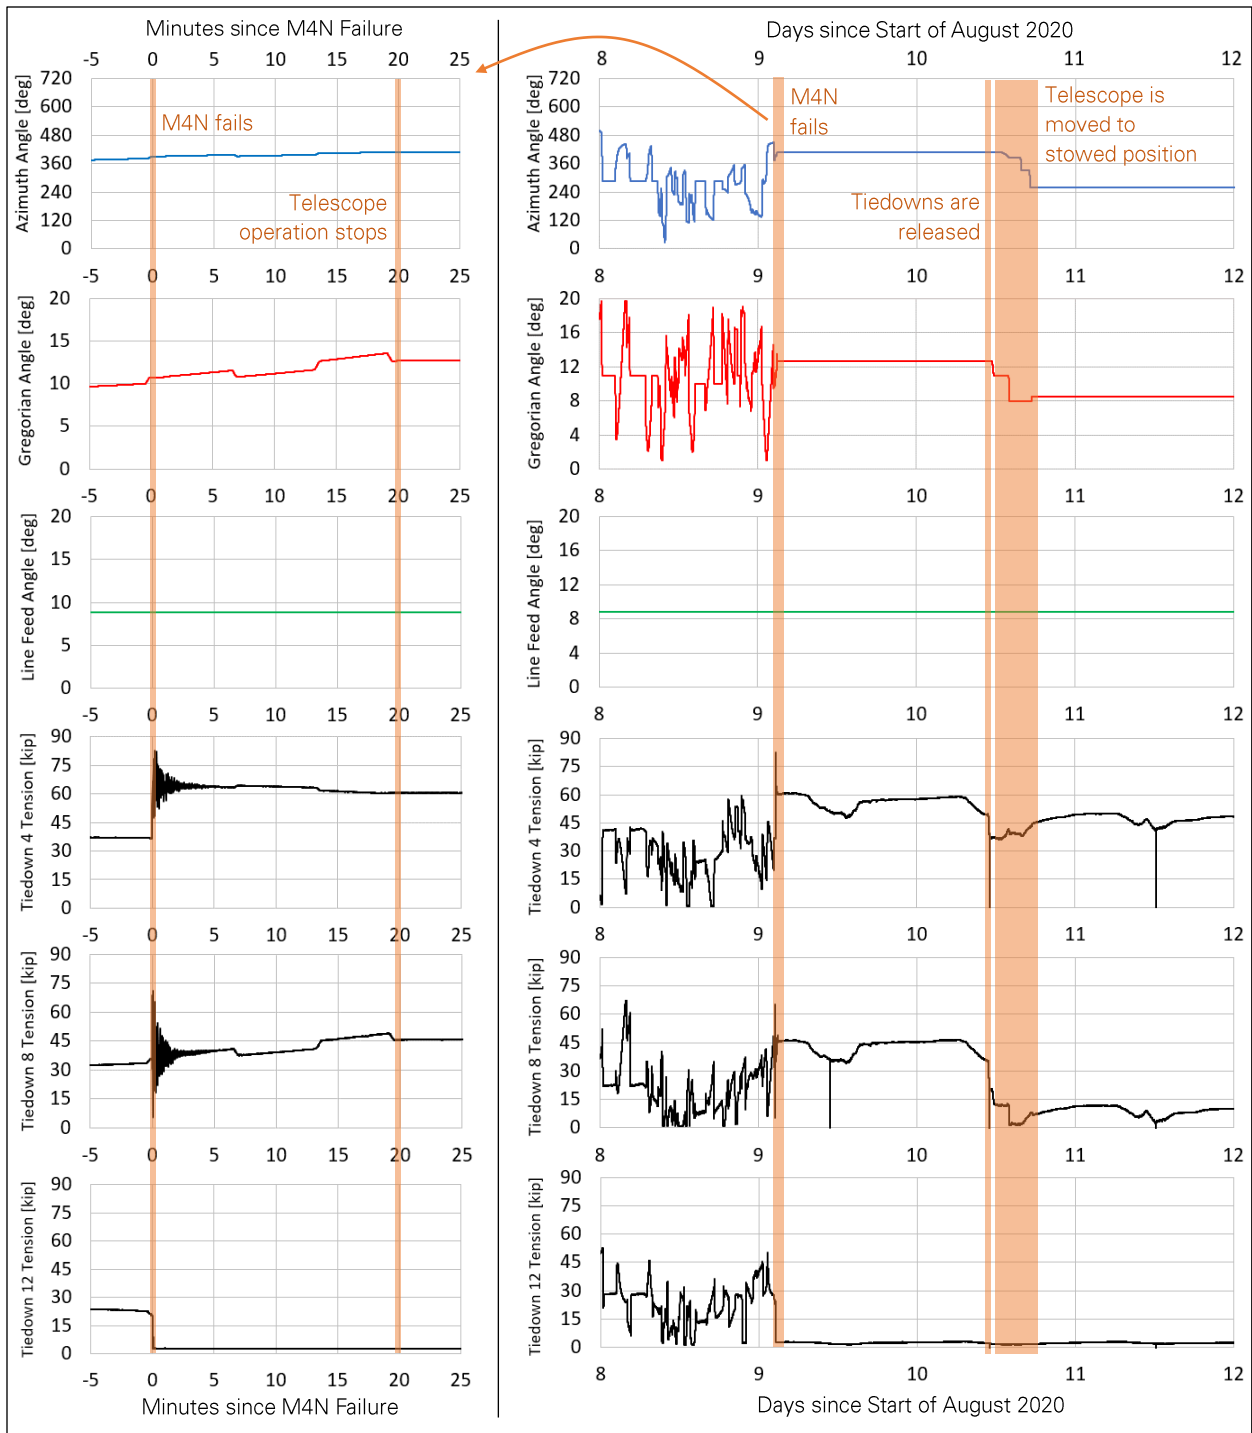
The telescope monitoring data provided by AO documents what the structure underwent in the few days following the failure of M4N (Figure 17). Cable M4N failed at 2:35 AM on August 10, 2020, causing Tiedown 12 to go slack while increasing the tension in Tiedown 4. The telescope continued to operate for 20 minutes after the failure, with the azimuth arm rotating by 17 degrees and the Gregorian moving outwards by 2.5 degrees. When telescope operation was stopped after 20 minutes, the Gregorian was still located in the northeast quadrant that cable M4N had contributed support. On August 11, 2020, AO fully extended the jacks at the base of Tiedown 4 and Tiedown 8 to reduce the stress on the remaining cables. Later that day, the azimuth arm and Gregorian were moved to the stowed position. After this move, no adjustment was made to the telescope position until the collapse on December 1, 2020.

As the damaged structure experienced day-night temperature cycles, the tension varied from 40 to 50 kip in Tiedown 4 and from 0 to 10 kip in Tiedown 8, while Tiedown 12 remained slack.

On November 6, 2020, cable M4-4 failed near its tower-end socket. On December 1, 2020, cable M4-2 also failed near its tower-end socket, immediately followed by the remaining M4 cables and triggering the collapse of the telescope.

Figure 17: Telescope position and tiedown tensions before and after first cable failure (M4N).

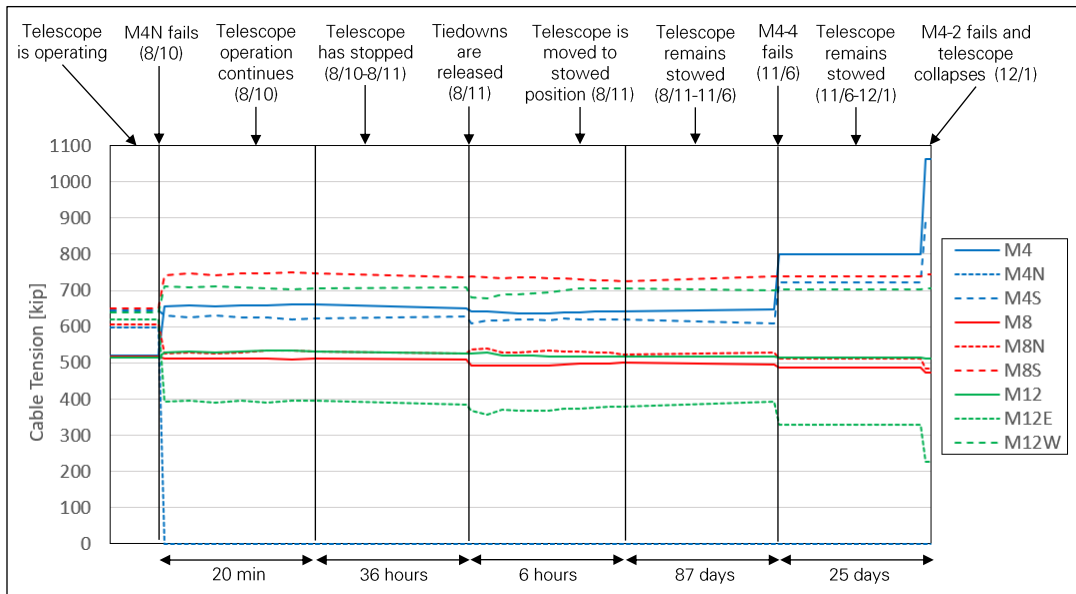
Figure 18: Main cable tensions from M4N failure to collapse.

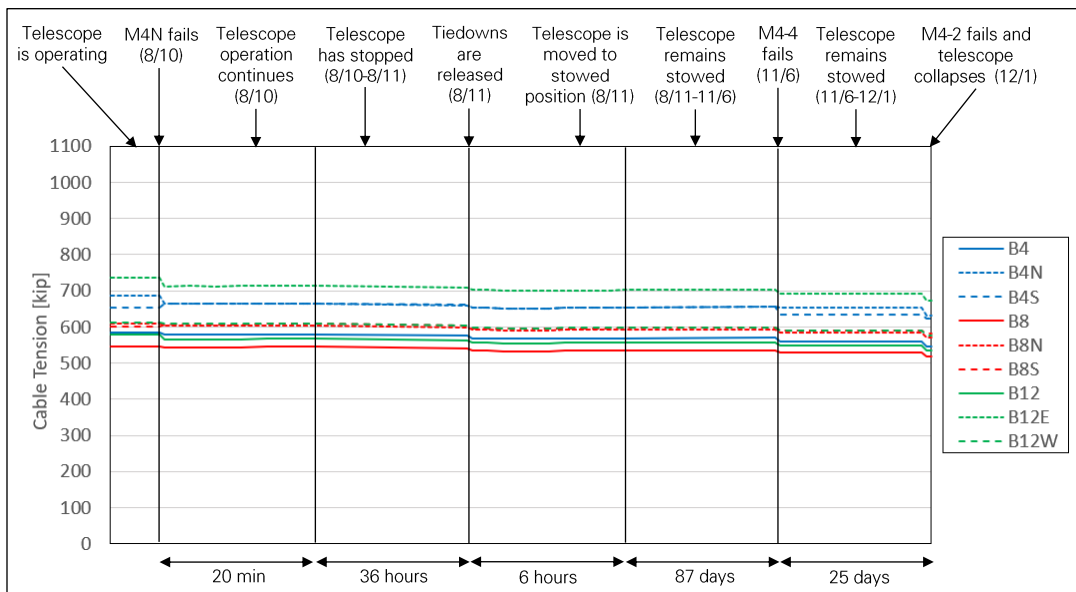
Figure 19: Backstay cable tensions from M4N failure to collapse.

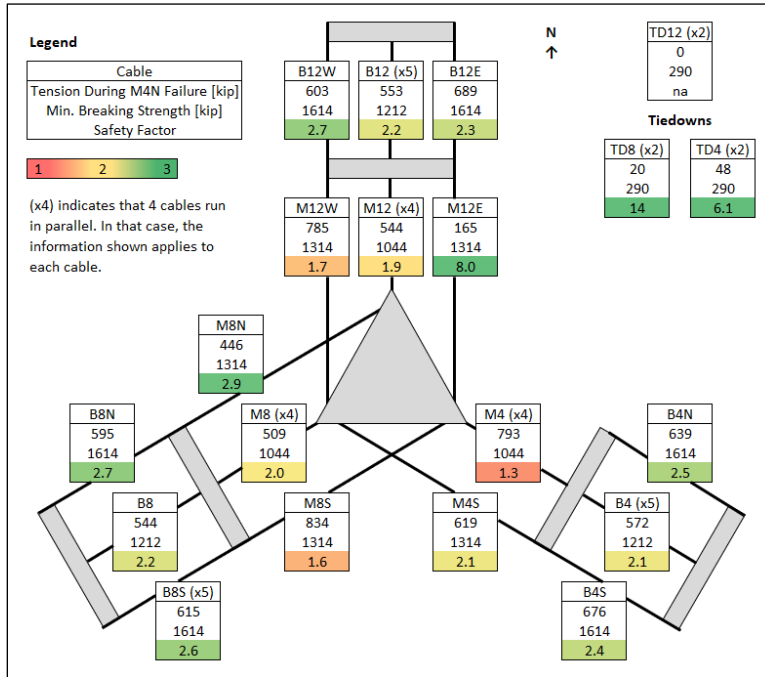
Figure 20 through Figure 25 indicate the cable safety factor during and after each cable failure. The safety factor is the ratio of the cable's minimum breaking strength to the actual cable tension. The tensions during each cable failure are estimated, assuming a dynamic amplification factor of 2.0 due to the sudden cable tension release. The safety factor in the M4 cables was 1.6 and 1.3 after the M4N and M4-4 failures, respectively, and would have been 0.98 if the structure had withstood the M4-2 failure.

Figure 20: Cable tensions and safety factors during M4N failure, with 2.0 dynamic amplification.

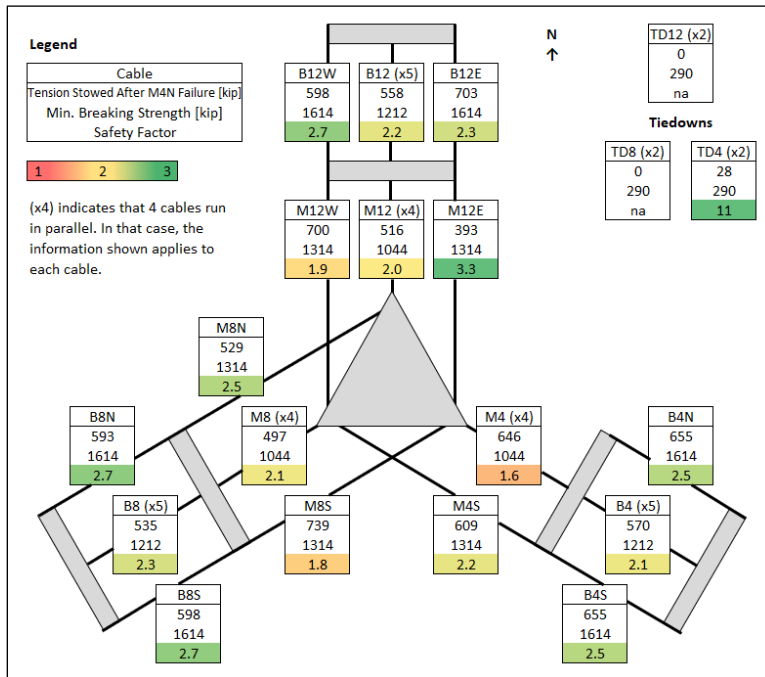
Figure 21: Cable tensions and safety factors when telescope is stowed after M4N failure.

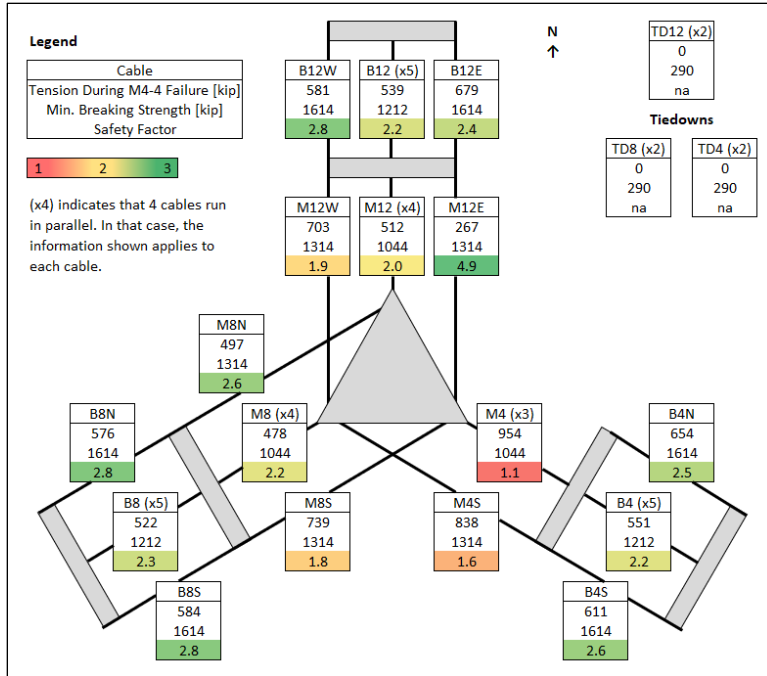
Figure 22: Cable tensions and safety factors during M4-4 failure, with 2.0 dynamic amplification.

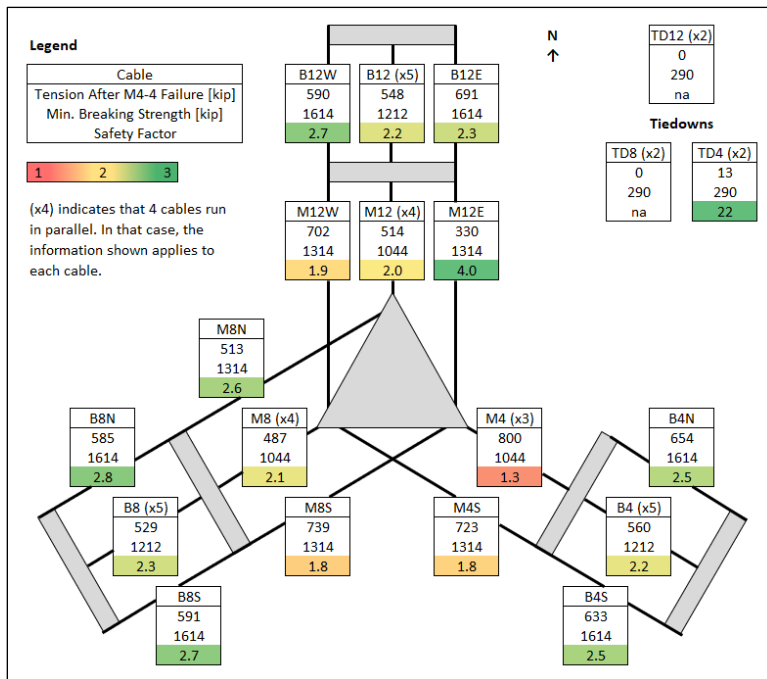
Figure 23: Cable tensions and safety factors after M4-4 failure.

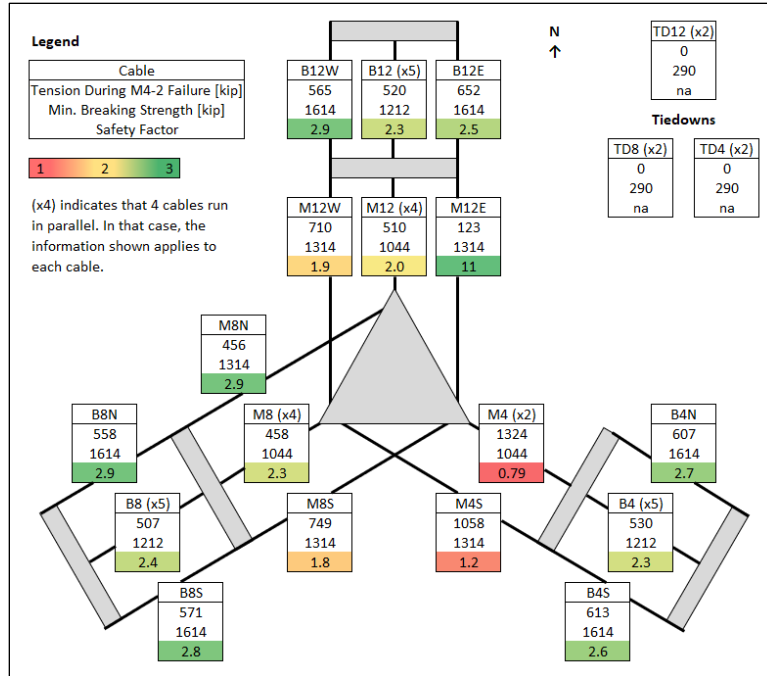
Figure 24: Hypothetical cable tensions and safety factors during M4-2 failure, with 2.0 dynamic amplification.

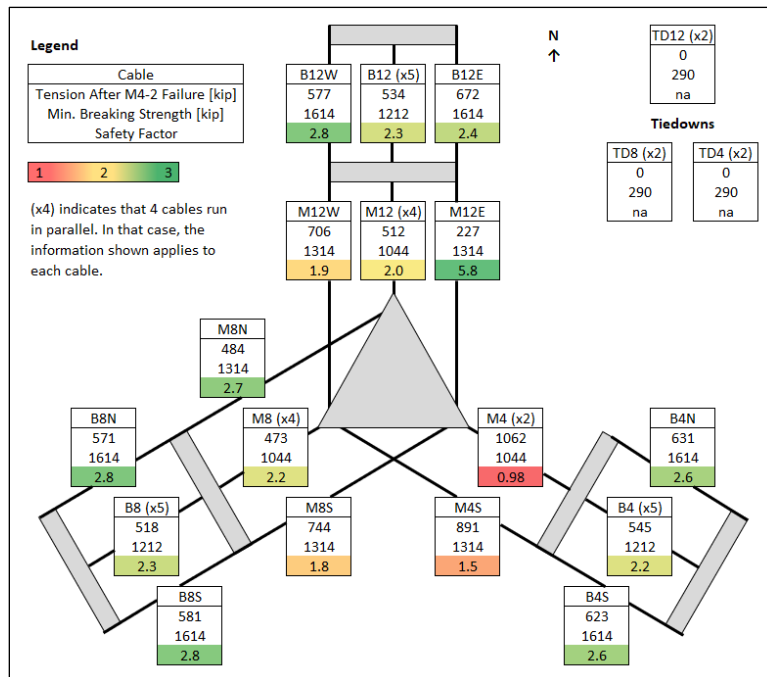
Figure 25: Hypothetical cable tensions and safety factors after M4-2 failure.

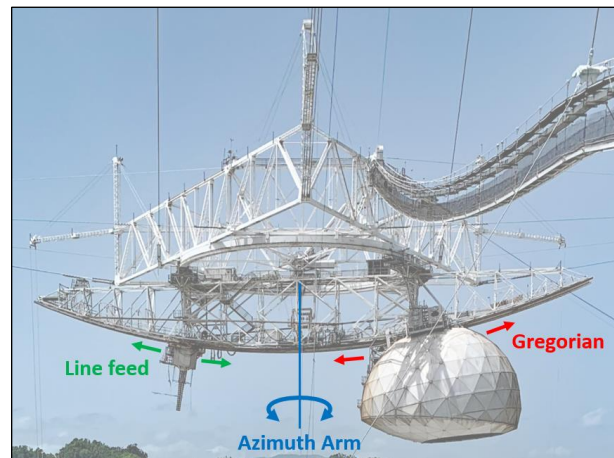
Figure 2: Moving parts of upgraded telescope, shown with line feed damage caused by Hurricane Maria (photo: Mario Roberto Durán Ortiz, Wikipedia - CC BY-SA 4.0).

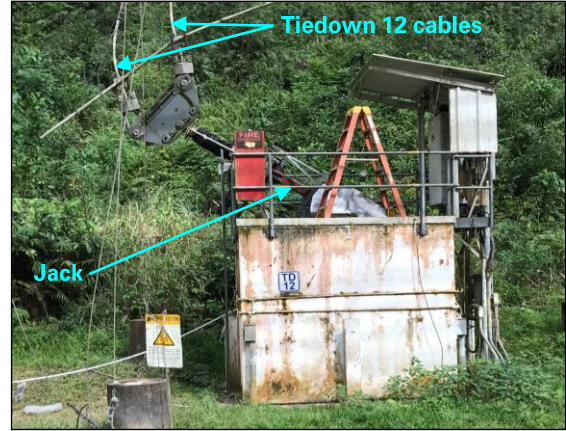
Figure 7: Base of tiedown 12, after telescope collapse.

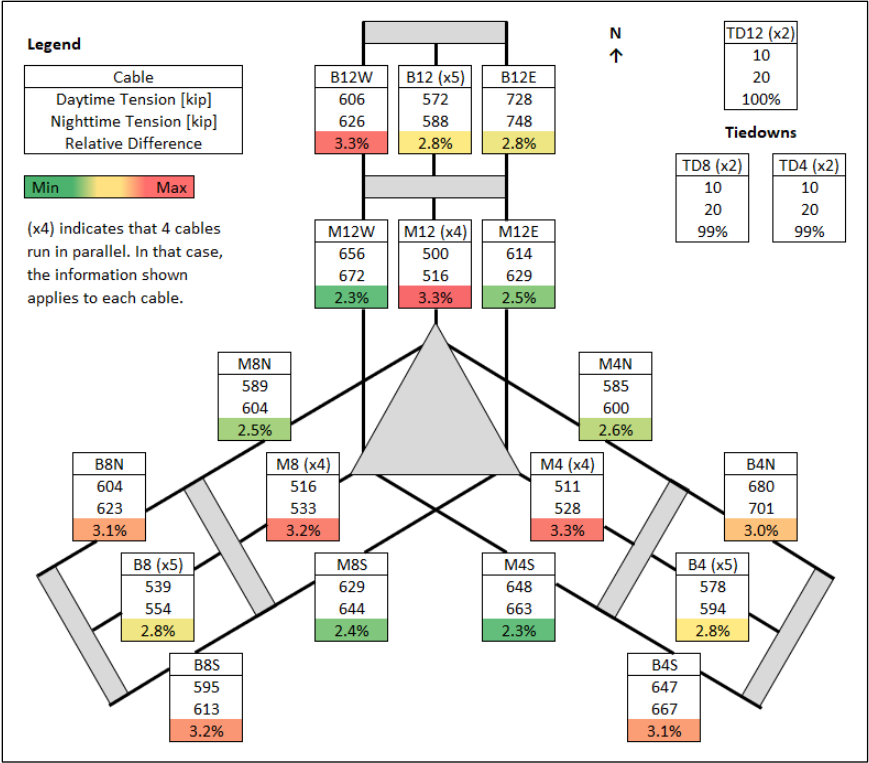
In the upgraded structure, the main and backstay tensions vary by approximately three percent during the daily temperature cycle (Figure 17), and the normalized stress range varies between one and two percent (Figure 18). While still low from a material fatigue perspective, the cable tension fluctuations are wider in the upgraded structure than in the original structure due to the tiedown jacks, which increase the tiedown tensions at night beyond the effect of the steel cooling down.

Figure 17: Cable tension change due to daily temperature cycle in upgraded structure.

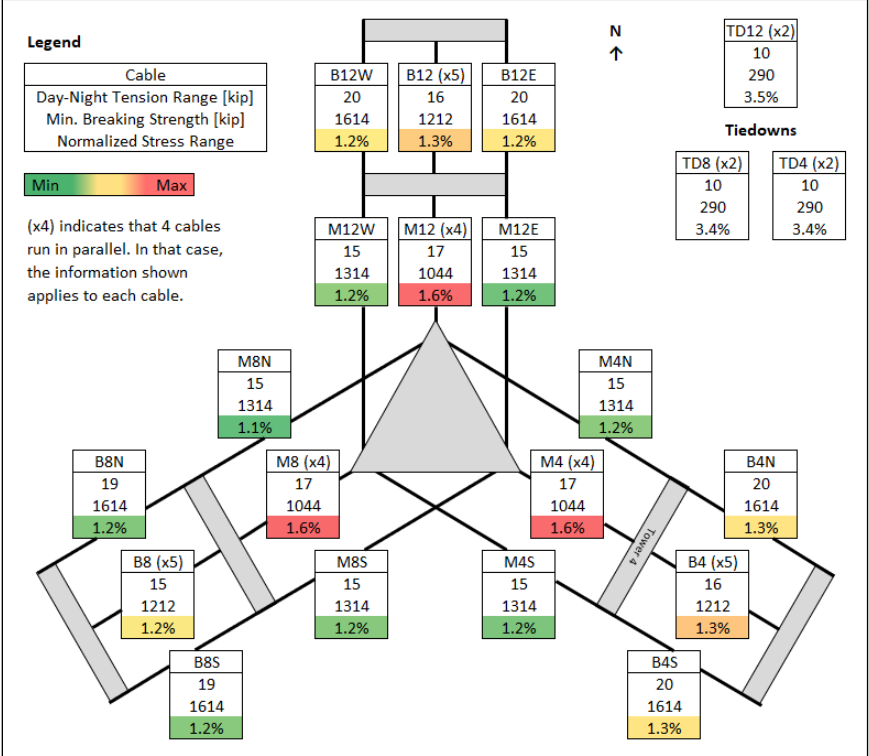
Figure 18: Cable normalized stress range due to daily temperature cycle in upgraded structure.

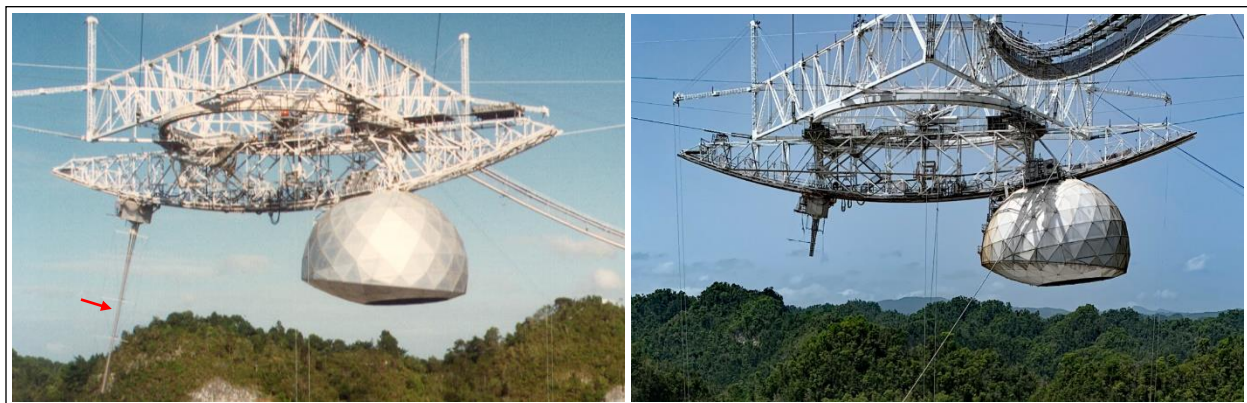
The highest instantaneous wind speed ever recorded at Arecibo Observatory is 110 mph and occurred as the eye of Hurricane Maria approached the site on September 20, 2017. While the hurricane caused widespread destruction in Puerto Rico, the only significant damage reported on the telescope was a failure of the line feed (Figure 1). However, because of the relatively short time between Hurricane Maria and the telescope's first cable failure (August 10, 2020), it is natural to investigate the storm as a potential factor contributing to the collapse. Hurricane Maria is therefore used as a reference load throughout our analysis of the wind load effects.

Figure 1: Suspended structure before (left) and after (right) Hurricane Maria, with damage to the line feed
 (left photo: NAIC Arecibo Observatory, a facility of the NSF;
 right photo: Mario Roberto Duran Ortiz, Wikipedia - CC By-SA 4.0).

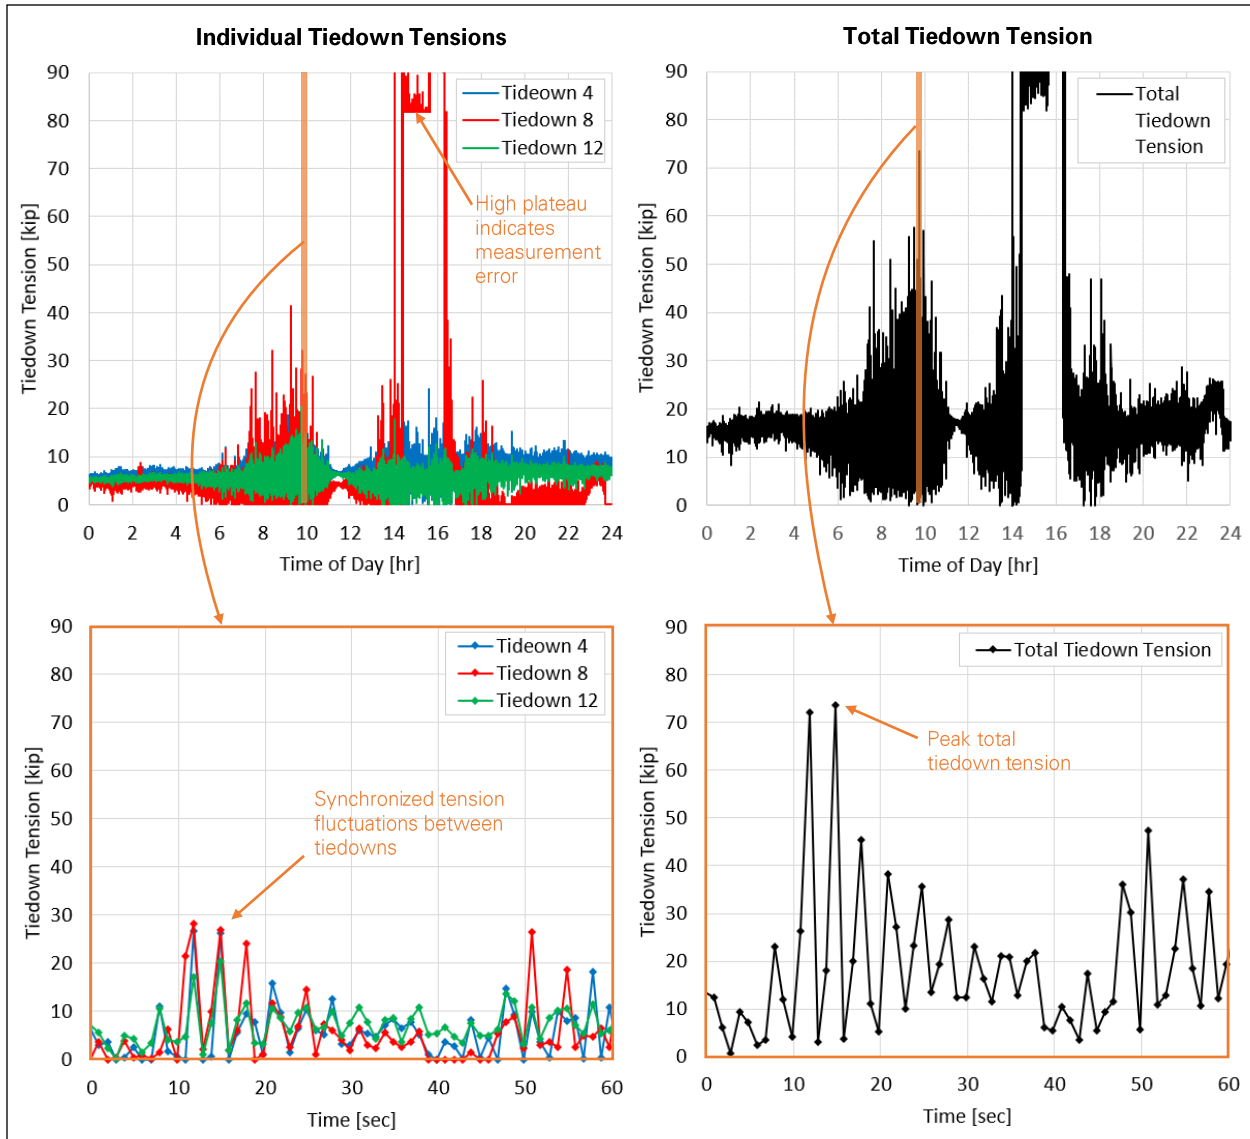
The tiedown tensions recorded during Hurricane Maria are shown in Figure 8. For tiedowns 8 and 12, the tiedown tension is calculated as the sum of the tensions in the tiedown's pair of load cells. For tiedown 4, the tiedown tension is calculated as twice the tension in one of the load cells, as the other load cell recorded unrealistically high values even before the storm. Finally, the total tiedown tension is also calculated. We observe that the three tiedown tensions are generally synchronized and fluctuate at a three-second period (3 data points per cycle), which is consistent with the period of the suspended structure's first mode of vibration.

Figure 8: Tiedown tensions recorded during Hurricane Maria.

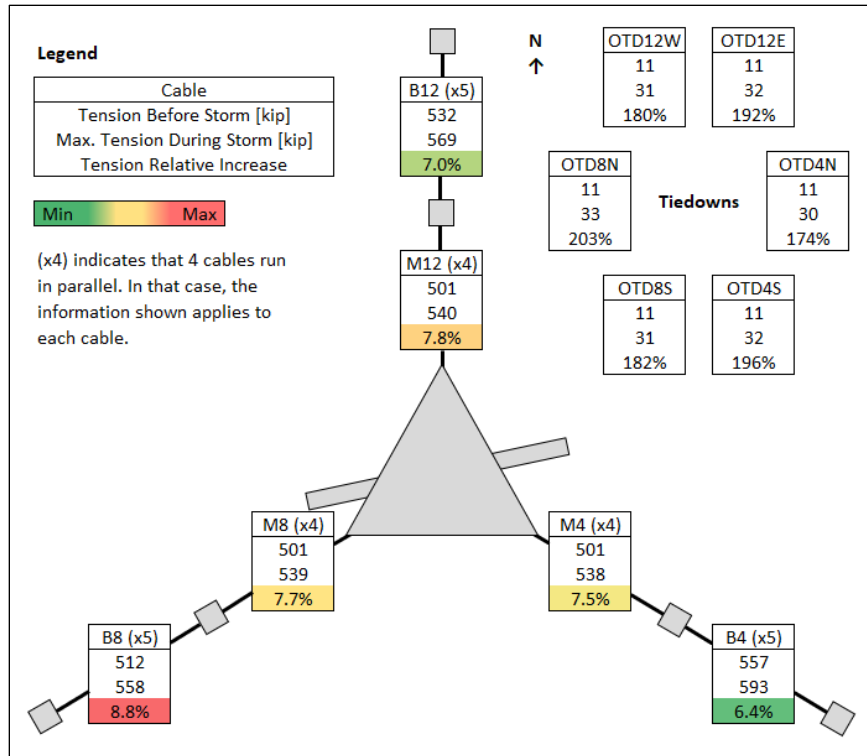
Figure 29: Maximum cable tension increase in original structure in hurricane conditions.

Figure 29 shows the maximum tension increase in each cable during the hurricane as a percentage of the pre-hurricane tension. Excluding the tiedowns, the maximum tension increase is nine percent and occurs in the backstays of tower 8.

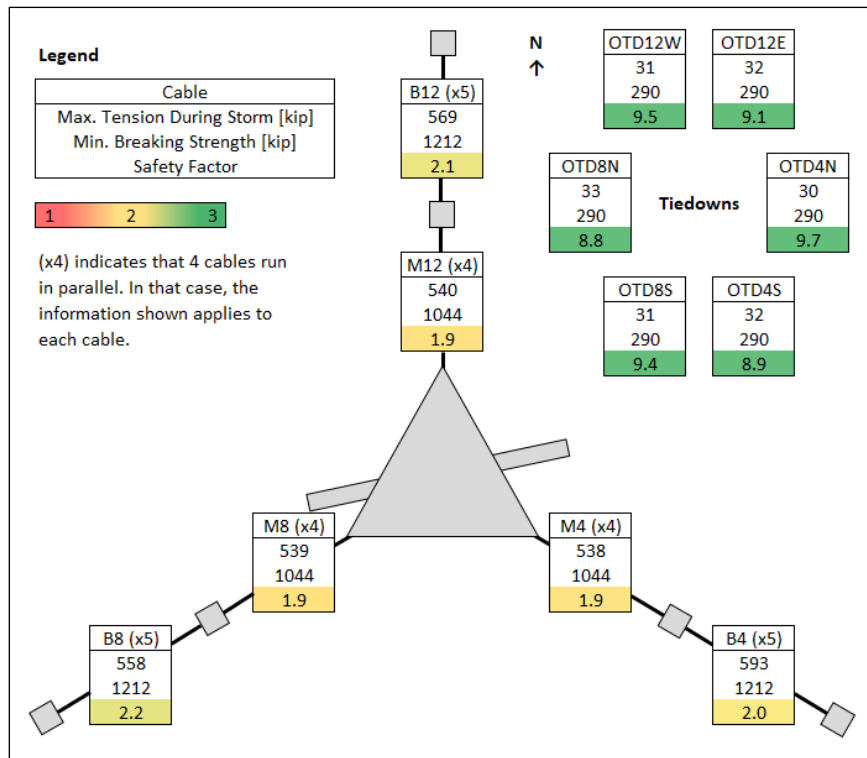
Figure 30: Maximum cable tension and corresponding safety factor in original structure in hurricane conditions.

Figure 30 shows the lowest safety factor reached in each cable during the hurricane. The lowest safety factor is the ratio of the highest cable tension experienced during the hurricane to the cable’s minimum breaking strength. The safety factors remain around two in all of the cables.

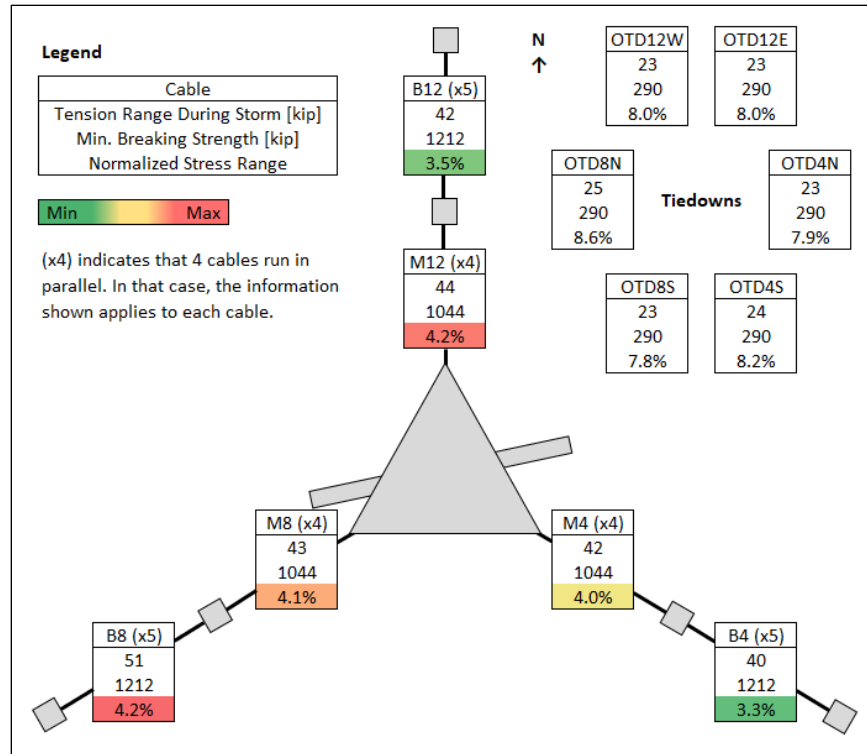
Figure 31: Maximum normalized stress range in cables of original structure in hurricane conditions.

Figure 31 shows the maximum normalized stress range experienced by each cable during the hurricane. The maximum normalized stress range is the ratio of the maximum tension range (difference between

maximum and minimum tension experienced) to the cable’s minimum breaking strength. The maximum normalized stress range is between three and five percent in the mains and backstays.

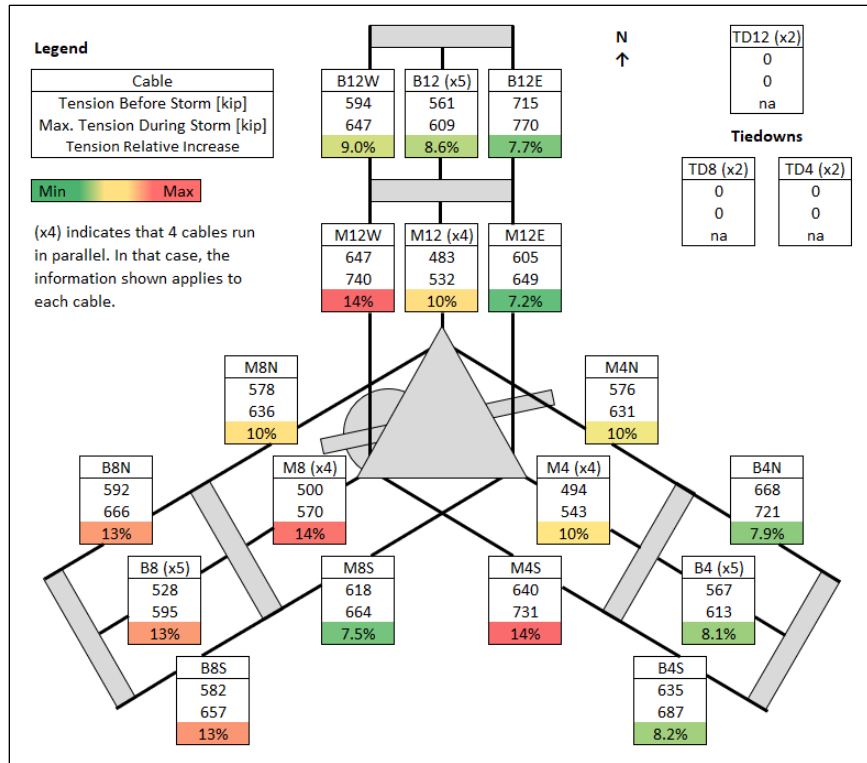
Figure 33: Maximum cable tension increase in upgraded structure in hurricane conditions.

Figure 33 shows the maximum tension increase in each cable during the hurricane as a percentage of the pre-hurricane tension. The maximum tension increase is 14 percent and occurs in the three mains that support the corner of the platform where the Gregorian is stowed (M8, M4S, M12W). This is due to the significant drag-down force that the wind induces on the Gregorian. The maximum tension increase in cable M4N (where the first failure occurred in August 2020) is 10 percent.

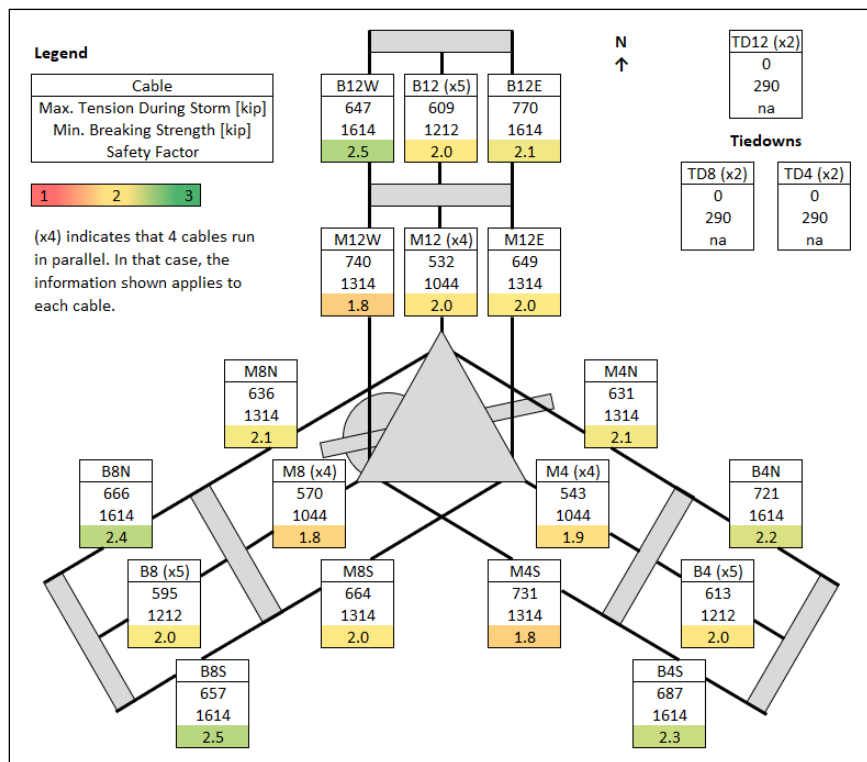
Figure 34: Maximum cable tension and corresponding safety factor in upgraded structure in hurricane conditions.

Figure 34 shows the lowest safety factor reached in each cable during the hurricane. The lowest safety factor is the ratio of the highest cable tension experienced during the hurricane to the cable’s minimum breaking strength. The lowest safety factor in cable M4N is 2.1.
