Arecibo Telescope Collapse Forensic Investigation

Thornton Tomasetti

July 25, 2022

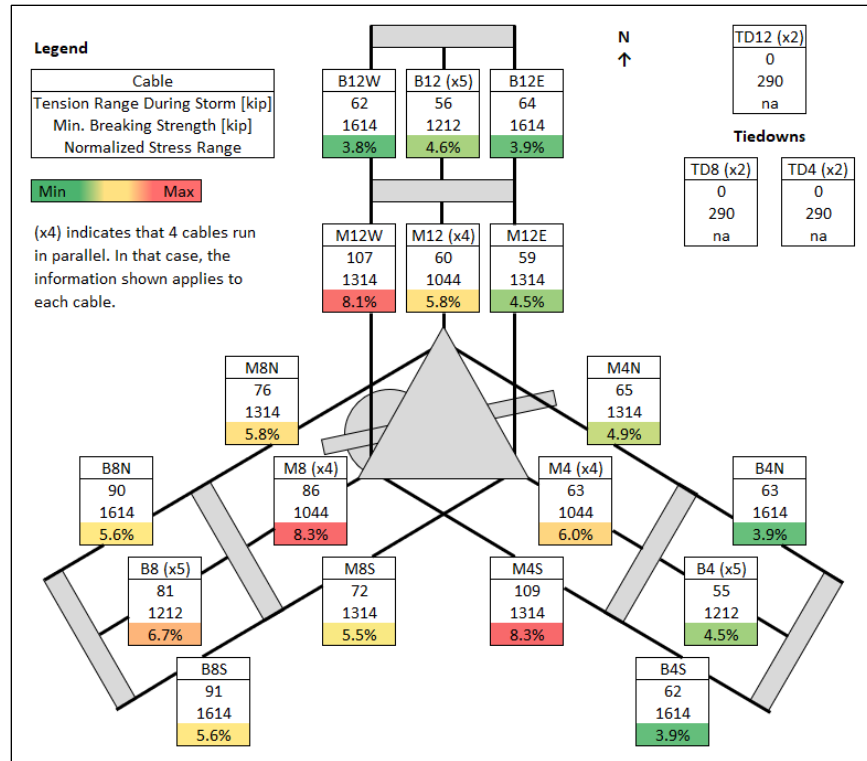
Figure 35: Maximum normalized stress range in cables of upgraded structure in hurricane conditions.

Figure 35 shows the maximum normalized stress range experienced by each cable during the hurricane. The maximum normalized stress range is the ratio of the maximum tension range (difference between maximum and minimum tension experienced) to the cable’s minimum breaking strength. The maximum normalized stress range is around eight percent in the three cables that experience the maximum tension increase due to the drag-down force on the Gregorian.

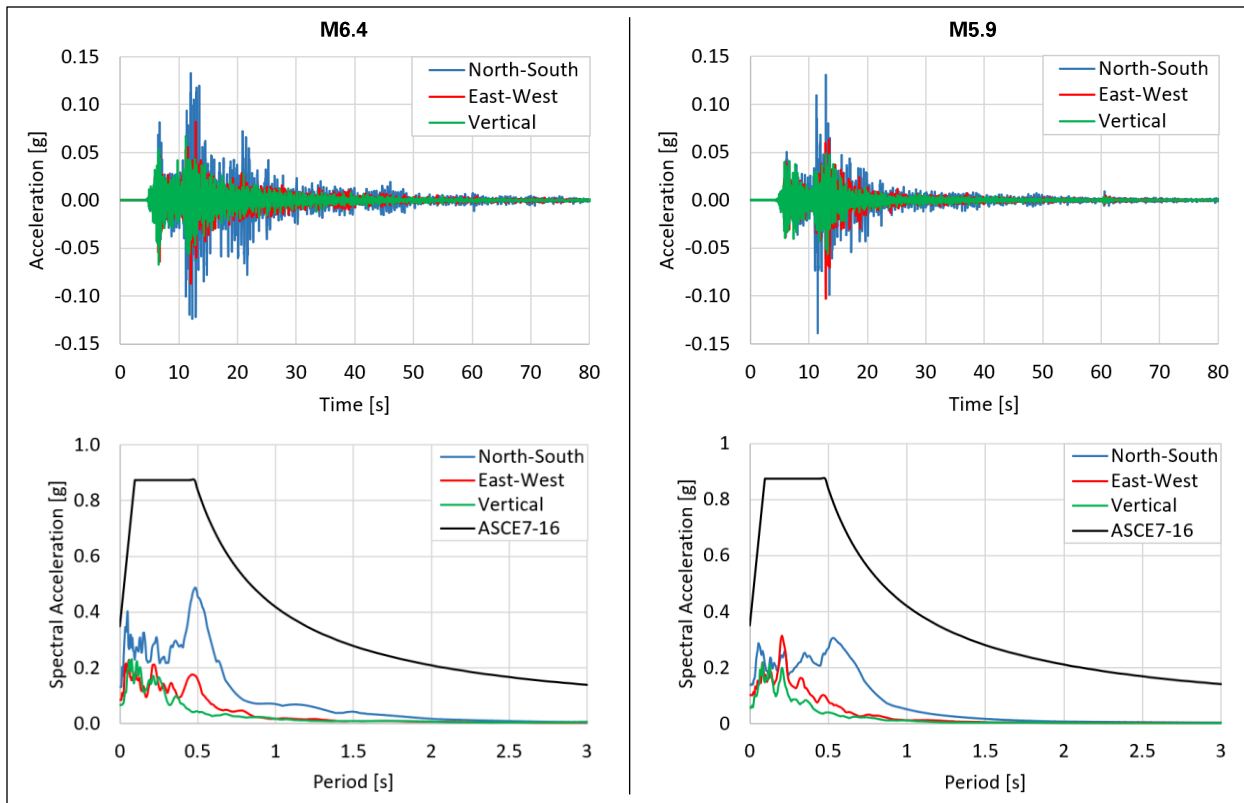
Figure 1: Ground acceleration time histories and five percent damping response spectra for M6.4 and M5.9 earthquakes.

Figure 1 shows the acceleration time histories at the AOPR station for M6.4 and M5.9, with the corresponding acceleration response spectra. Also shown in the figure is the Design Earthquake (DE) response spectrum per the ASCE 7-16 standard¹ at the AO site for an assumed site class C. All spectra are based on five percent damping. The DE spectrum is about two times larger at shorter periods and about five times larger at moderate to long periods than the M6.4 earthquake. The 2020 earthquakes were therefore significantly less severe than the current design earthquake for the AO site.

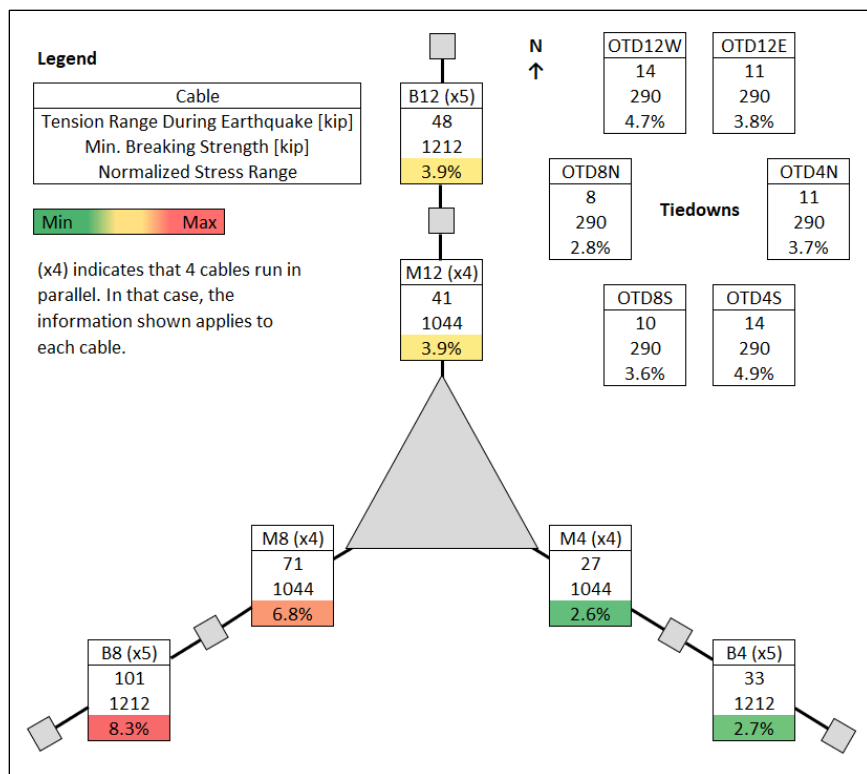
Figure 6: Maximum normalized stress range in cables of original structure due to 2020 earthquakes.

Figure 6 shows the maximum normalized stress range experienced by each cable during the earthquake. The maximum normalized stress range is the ratio of the maximum tension range (difference between the maximum and minimum tension experienced) to the cable’s minimum breaking strength. The maximum normalized stress range is between two and nine percent in the mains and backstays.

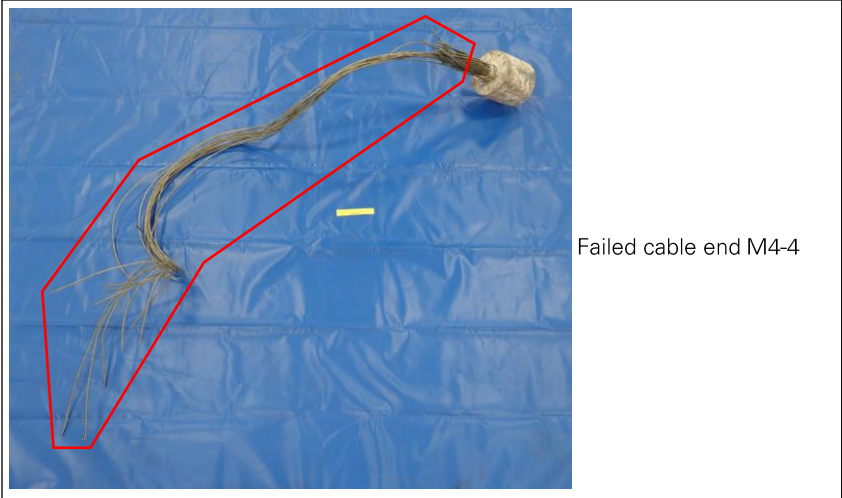
Another M4 cable, M4-4, failed three weeks before the collapse. Some of the cable's wires fractured within socket M4-4_T, while others fractured outside of the socket. Socket M4-4_T was recovered and sent to Socotec's laboratory for analysis, and the fractured wires still attached to the socket are considered as *failed cable end M4-4* in this appendix (Figure 2).

Figure 2: Socket M4-4_T with multiple M4-4 wires fractured outside of socket (photo: Socotec).

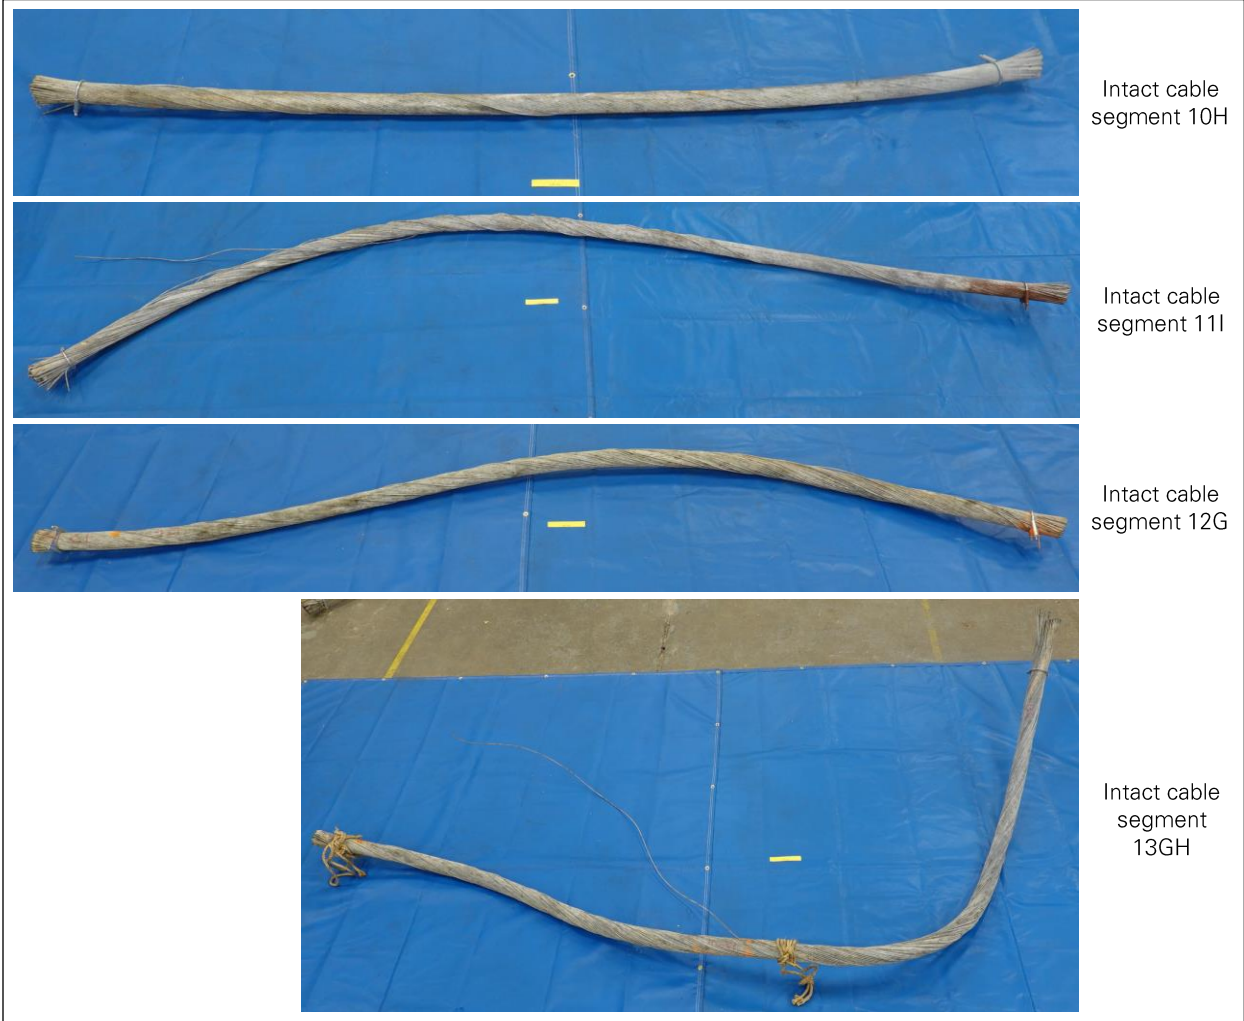
An additional segment was cut from each of the four M4 cables and sent to Socotec's laboratory for analysis (Figure 3). Each segment was cut away from the cable failure point and had no visible wire break. These samples are referred to *intact cable segment 10H*, *11I*, *12G* and *13GH* in this appendix.

Figure 3: Intact segments of four M4 cables (photos: Socotec).

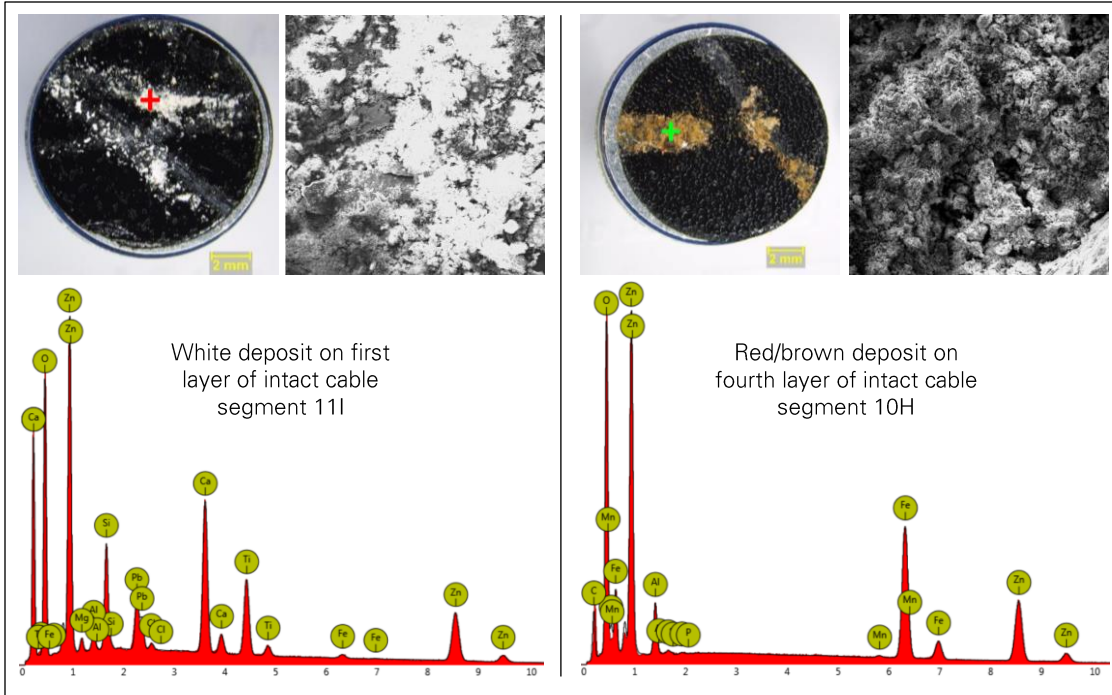
Four samples of corrosion deposits were analyzed with energy dispersive x-ray spectroscopy (EDS) to determine their chemical composition (Figure 5, Table 1). The white deposits consist primarily of oxygen of zinc, and contain very little iron. This confirms that the white deposits are due to corrosion of the galvanizing zinc, while the wires' steel remained protected. The red/brown deposits, however, consist primarily of oxygen, zinc, and iron. This confirms that at the locations of the red/brown deposits, the wires' steel started to corrode.

Figure 5: Representative EDS spectra from white and red/brown deposits (photos and figures: Socotec).

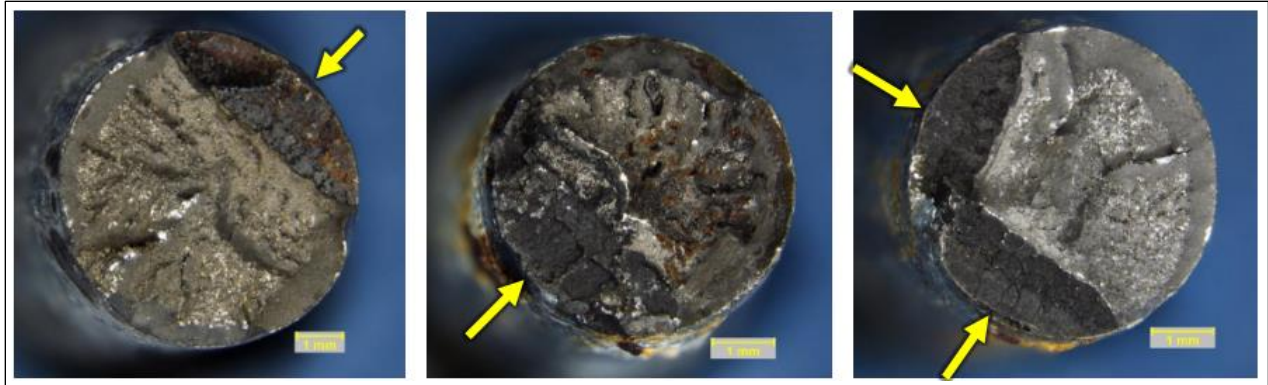
Visual examination of the four intact cable segments revealed three fractured wires in the second layer of one segment (11I). The wire fracture surfaces are flat transverse planes with thumbnail-shaped regions covered with a dark layer of oxide deposit (Figure 6). Scanning electron microscopy (SEM) of the fracture surfaces shows a morphology with micro void coalescence indicative of ductile overstress fracture (Figure 7). Additional stereomicroscopic examination revealed multiple cracks on the surface of two of the fractured wires parallel to the fracture surface. Finally, a cross-section through the length of the wire cutting through the crack revealed multiple branched cracks parallel to the primary fractured surface (Figure 8). This indicates that the wires fractured to stress-corrosion cracking.

Figure 6: Stereomicroscopic images of three fractured wires of intact cable segment 111, showing thumbnail-shaped areas covered with an oxide layer (photos: Socotec).

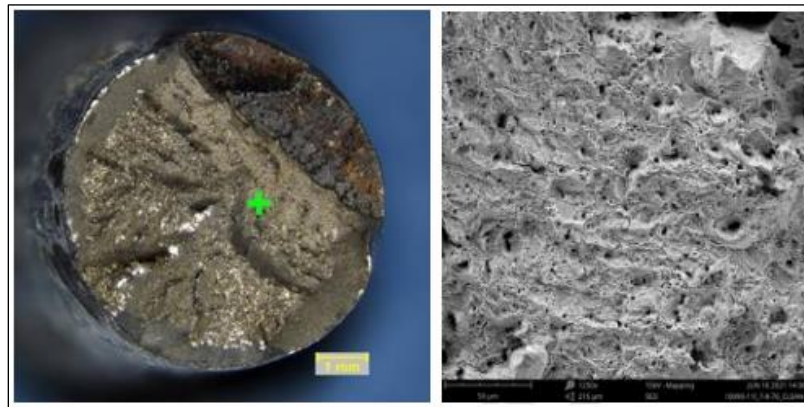
Figure 7: SEM image of a fractured wire of intact cable segment 111, showing fracture morphology consistent with microvoid coalescence (photos: Socotec).

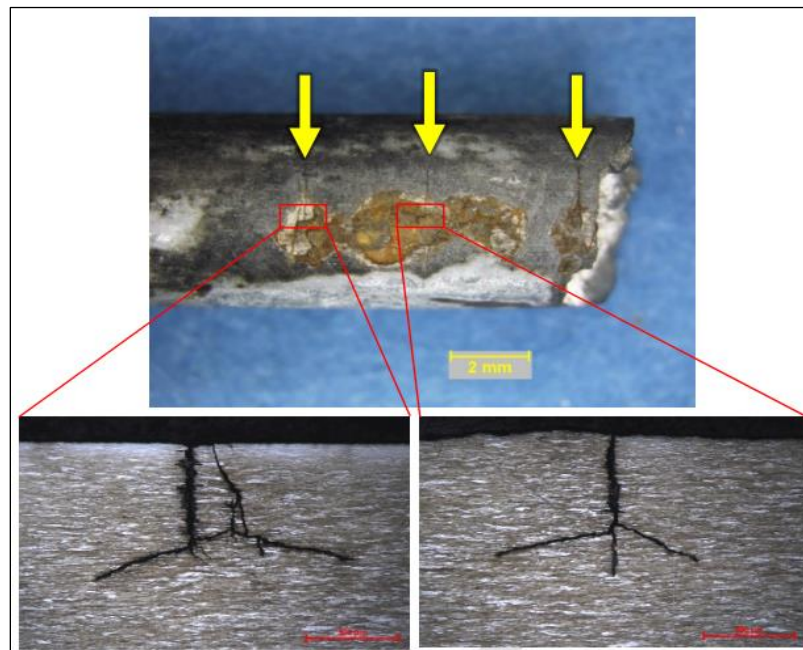
Figure 8: Metallographic images of branched cracks near fracture point of a wire of intact cable segment 111 (photos: Socotec).

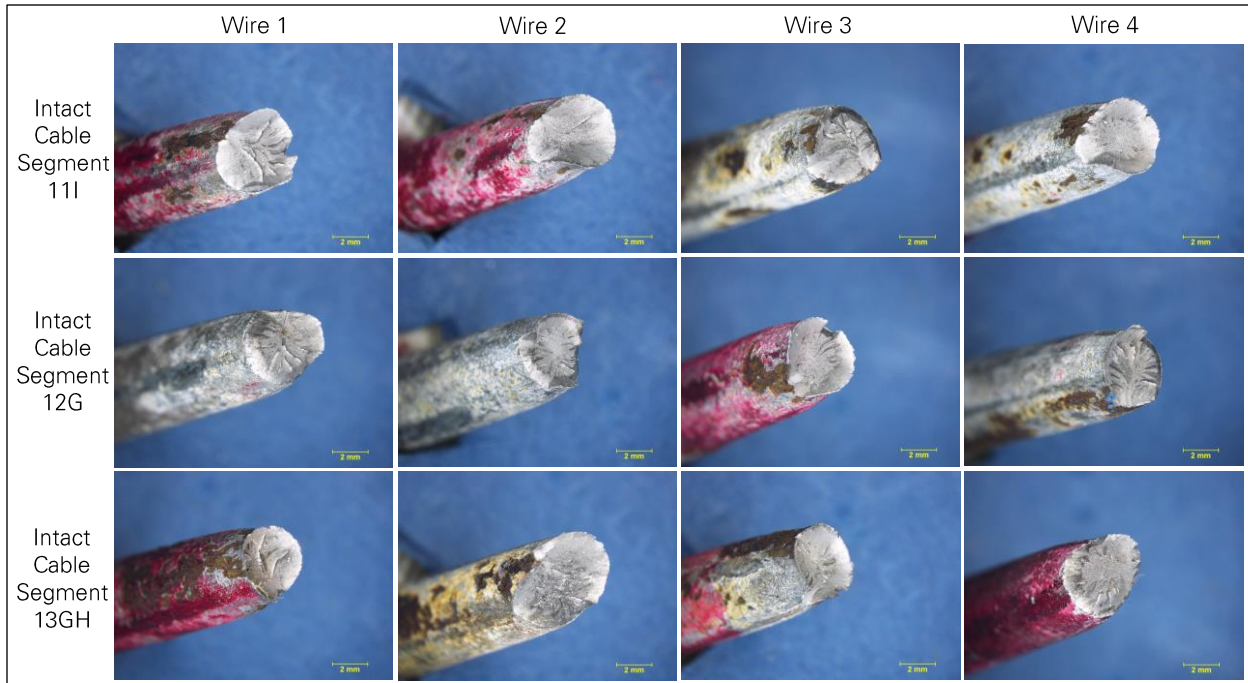
A total of 12 wire samples taken from three intact cable segments were tested to failure in conformance with the ASTM A586 standard.³ Per the original structural drawings of the telescope, these wires were required to have an ultimate tensile strength of at least 220 ksi. The test results indicate that every tested wire meets this requirement (Table 5). Moreover, every tested wire meets the strength and ductility requirements of ASTM A586, which was prescribed for the auxiliary cables installed in 1997. Photographs of the fracture surface of each tested wire are provided in Figure 9.

Figure 9: Fracture surfaces after wire tensile tests (photos: Socotec).

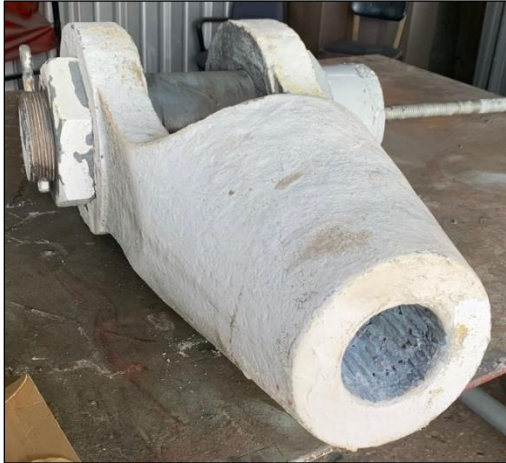
Figure 2: Socket M4N_T recovered from Tower 4 after M4N failure (photo: WJE).

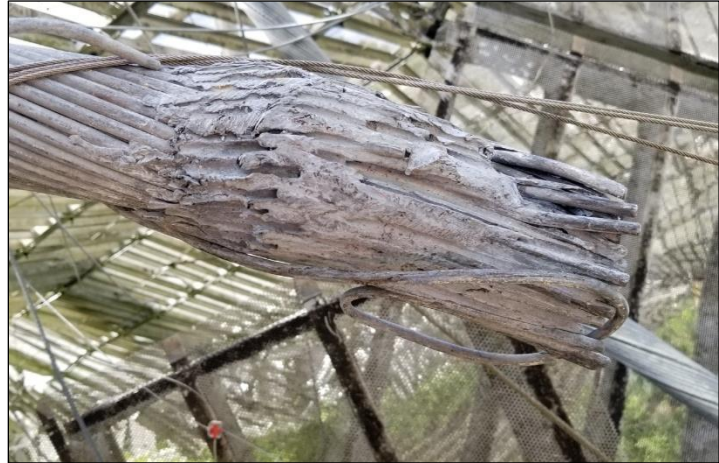
Figure 3: Cable end pulled out of socket M4N_T.

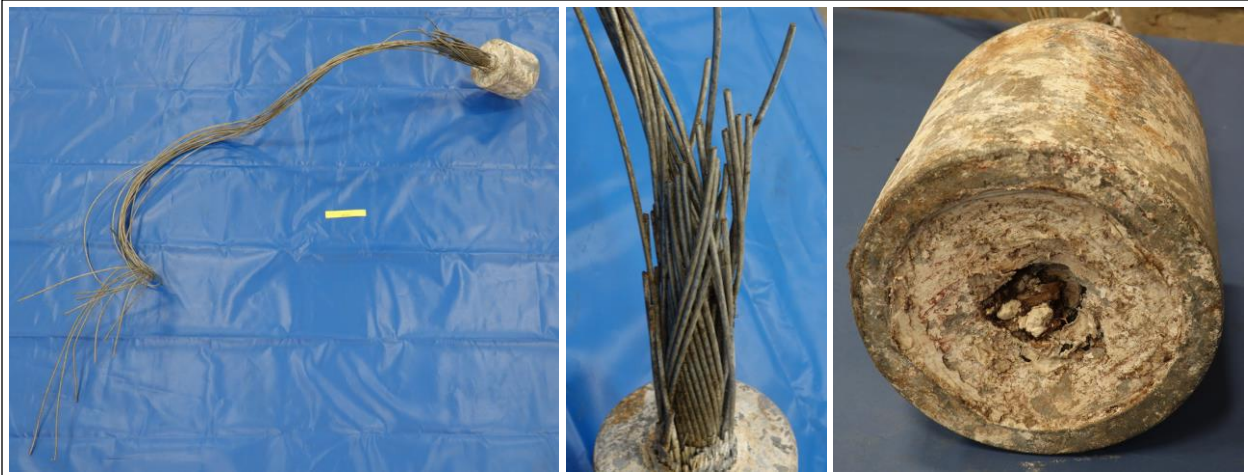
Figure 4: Socket M4-4_T (photos: Socotec).

- The back surface of every casting is deformed, with a dip towards the socket's axis.
- In the castings of sockets B4S_G (failed during load test), B12W_G (maximum cable slip) and M4-4_T (failed on November 6, 2020), fracture planes developed at the back of the casting and a central core shifted in the direction of the cable pull.
- In the casting of socket B12W_G (maximum cable slip), several wires slipped with respect to the zinc outside of the displaced core.
- In the casting of M4-4_T (failed on November 6, 2020), several wires fractured inside the casting.

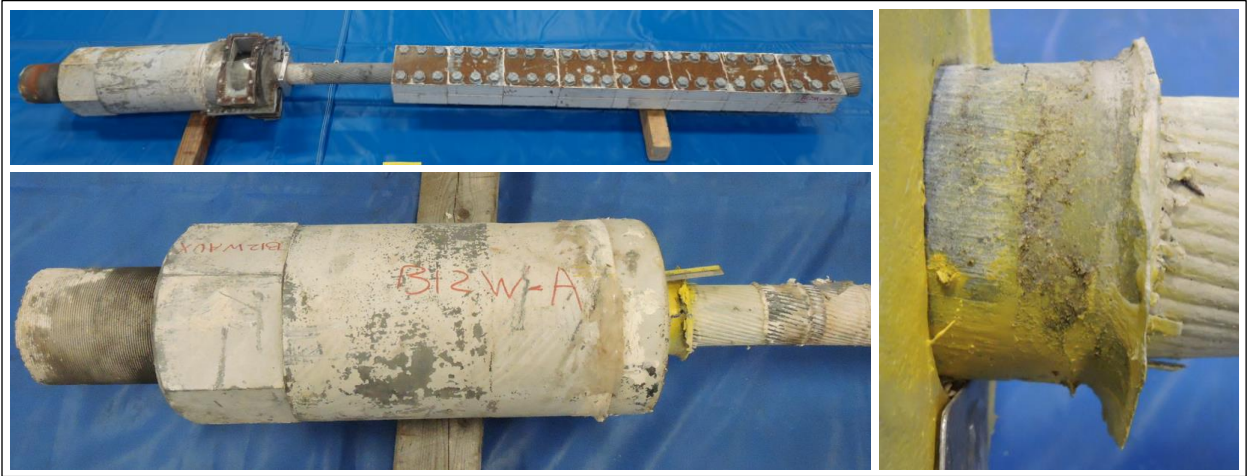
Figure 5: Socket B12W_G (photos: Socotec).

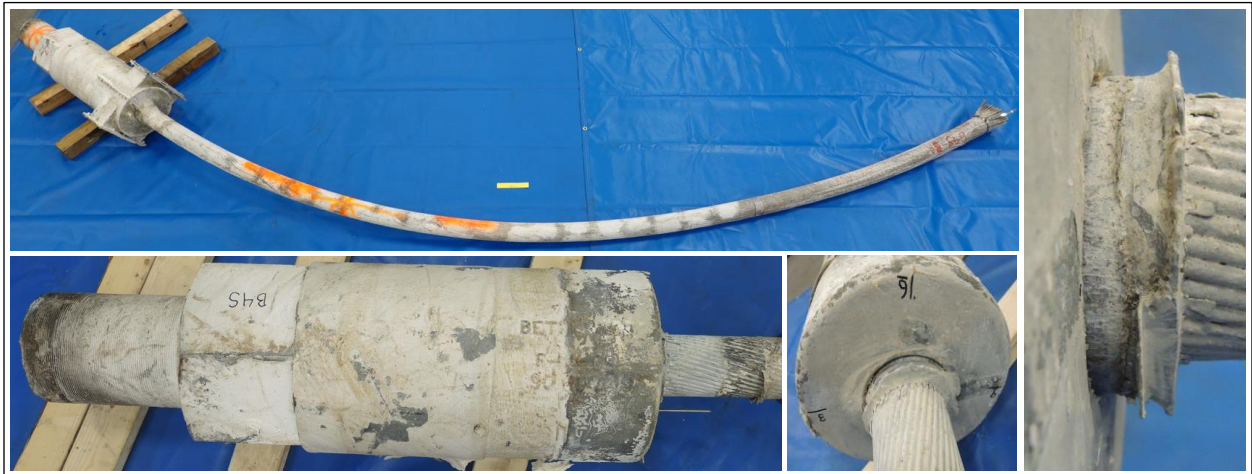
Figure 8: Socket B4S_G (photos: Socotec).

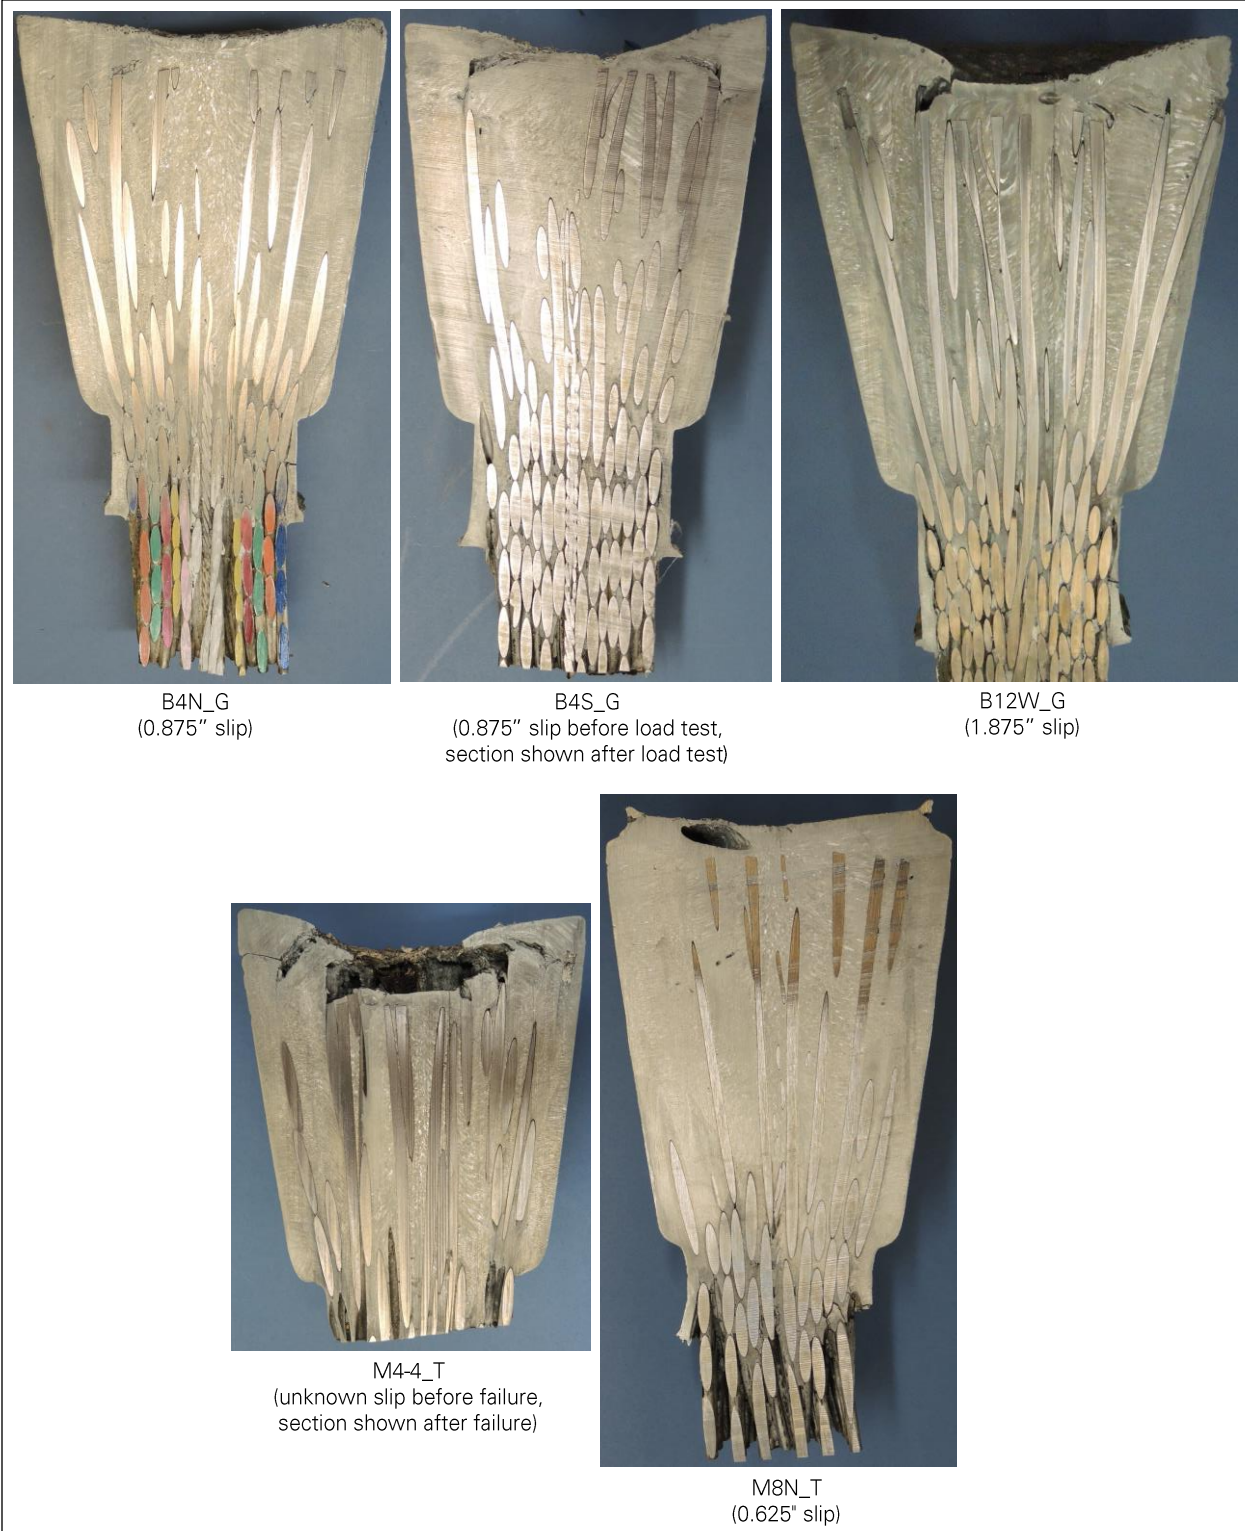
Figure 11: Macro-etched transverse sections of socket zinc castings (photos: Socotec).

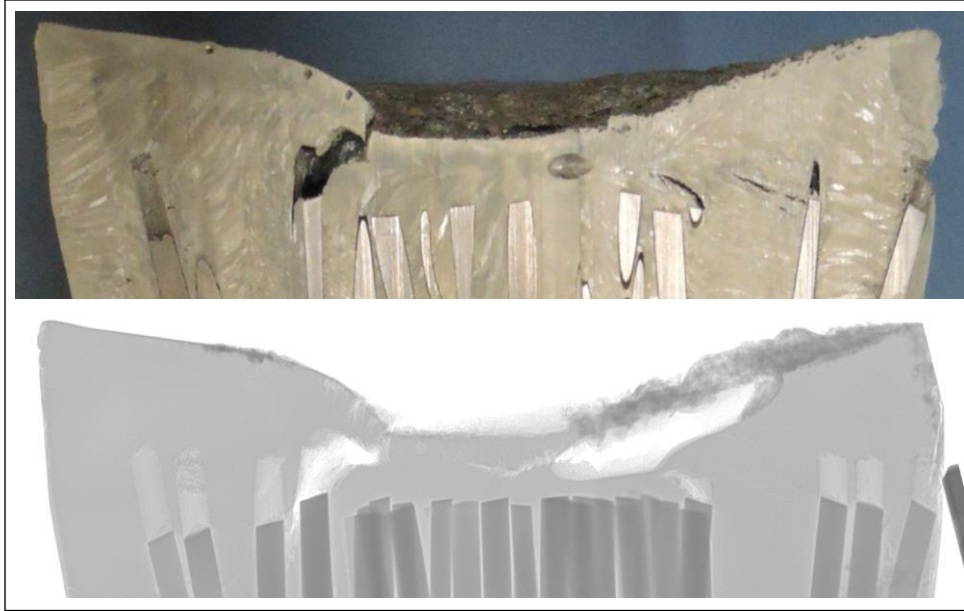
The largest cable slip was observed on socket B12W_G, and the longitudinal sectioning of that socket's zinc casting revealed that several cable wires had slipped within the casting. To determine the extent of the wire slips, we performed a neutron radiography of a one inch-thick longitudinal slice of the casting (Figure 12). The radiograph is shown in Figure 13 and reveals that within the slice considered, every wire end located outside of the displaced casting core has slipped. The wire slip distances varies from 0.4 to 0.8 inch. For comparison, we performed the same radiography on a one inch-thick slice of casting of socket M8N_T, which exhibits the smallest cable slip among the sockets considered in the laboratory studies. The radiograph is shown in Figure 14, and we observe a wire slip on only two wires, with a slip distance of less than 0.05 inch.

Figure 13: Neutron imaging of back of one inch-thick slice of B12W_G (1.875" slip) casting (top photo: Socotec; bottom radiograph: Adrian Brügger, Columbia University - Oak Ridge National Laboratory).

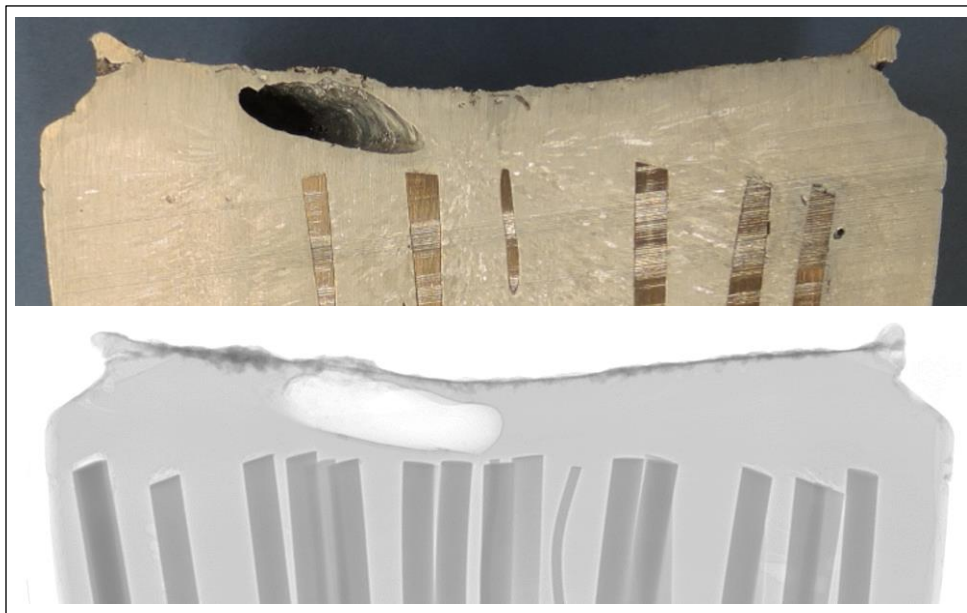
Figure 14: Neutron imaging of back of one inch-thick slice of M8N_T (0.625" slip) casting (top photo: Socotec; bottom radiograph: Adrian Brügger, Columbia University - Oak Ridge National Laboratory).

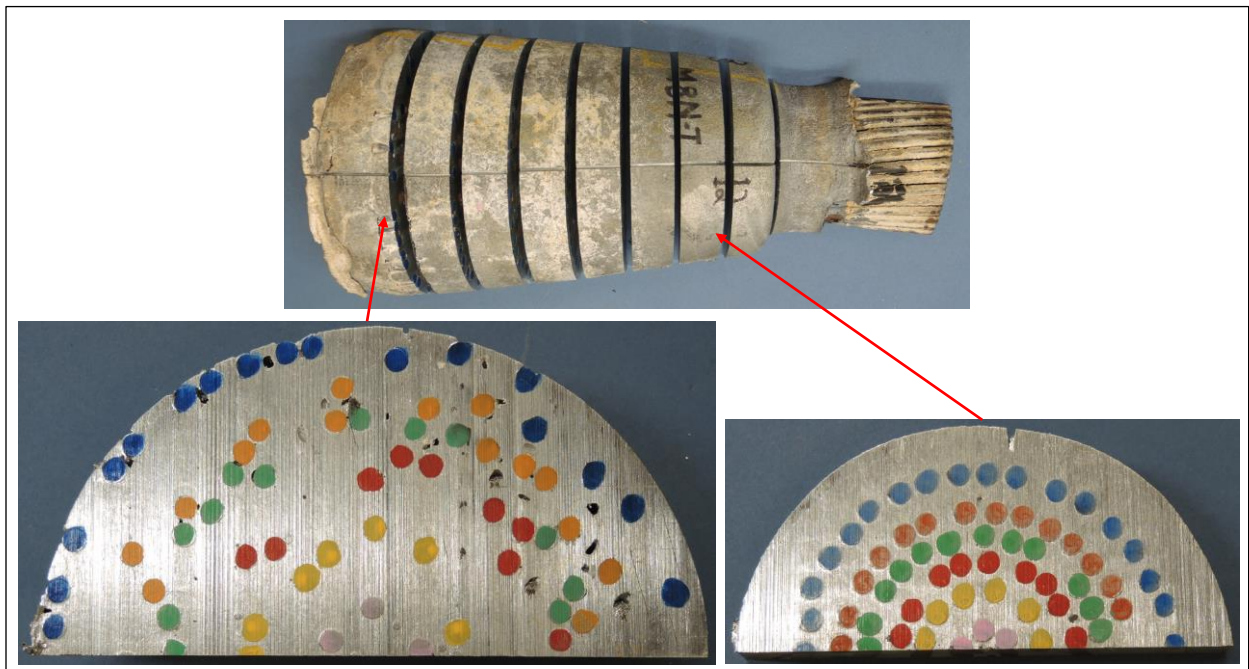
In every socket considered, the wire broom is irregular and does not follow any consistent pattern. General differences are immediately visible between the wire brooms in the sections close to the wire ends. For instance, most of the outer layer of wires is fully broomed out in socket M8N_T (Figure 17), while no wire is fully broomed-out in socket B12W_G (Figure 19). Then, the wire broom of M4-4_T (Figure 16) appears to be relatively uniform, while there is a significant zinc area with no embedded wire in socket B4N_G (Figure 18).

Figure 17: M8N_T (0.625" slip) transverse sections (photos: Socotec).

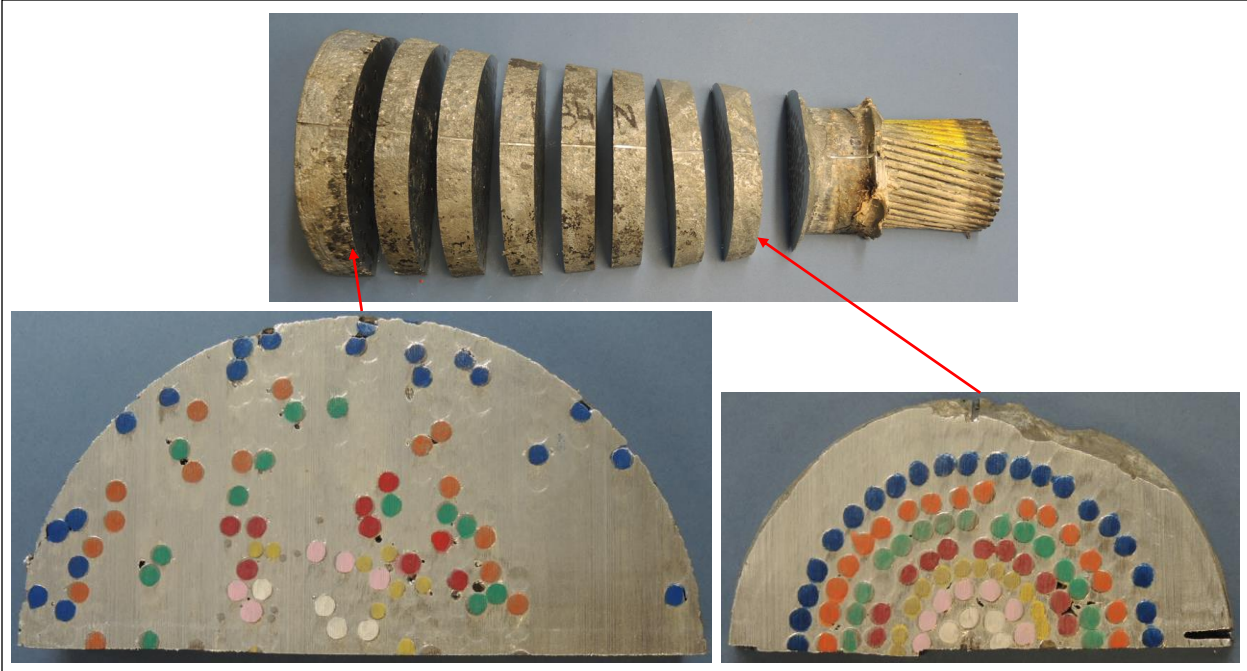
Figure 18: B4N_G (0.875" slip) transverse sections (photos: Socotec).

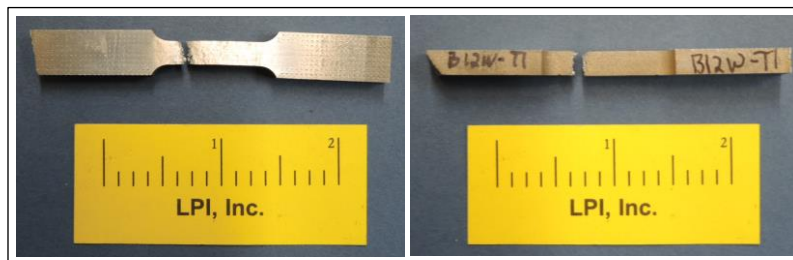
Figure 27: Zinc sample B12W_G-F after tensile testing to failure (photos: Socotec).

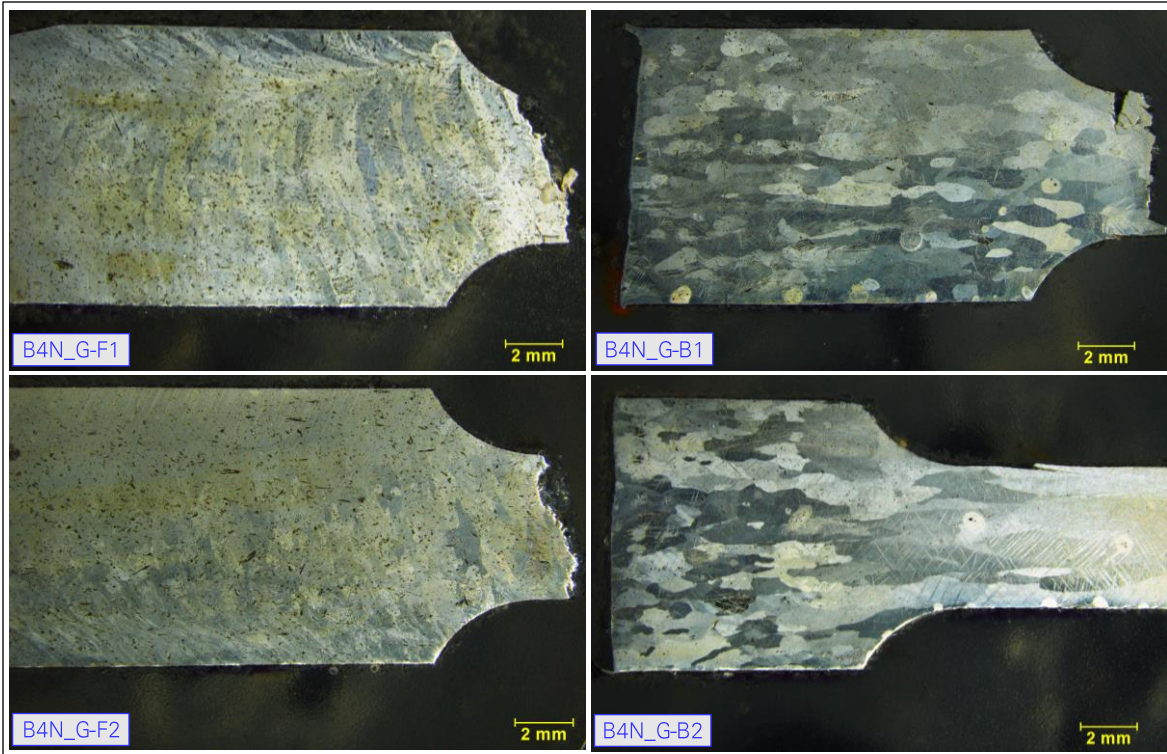
The zinc specimens cut from the socket castings and tested in tension were prepared for metallographic observation. The results are shown in Figure 30 to Figure 33, with each figure comparing the grain structure of the sample(s) taken at the front and back of a given casting. In every casting, the grains are smaller at the front of the casting and larger at the back. This is consistent with the tensile test results, where higher yield and ultimate tensile stresses were measured at the front of the casting. The smaller grain size is likely due to the faster cooling of the molten zinc at the front of the casting during the socketing process.

Figure 30: Grain size comparison between tensile specimens of socket B4N_G (photos: Socotec).

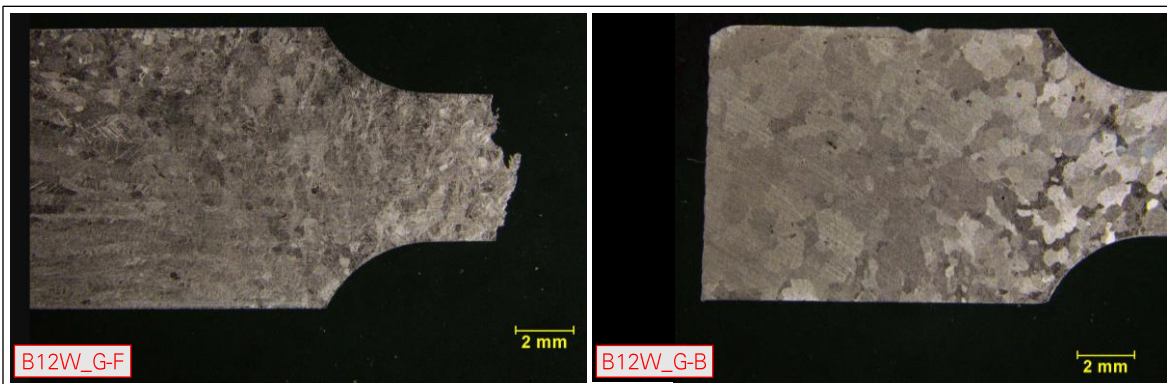
Figure 31: Grain size comparison between tensile specimens of socket B12W_G (photos: Socotec).

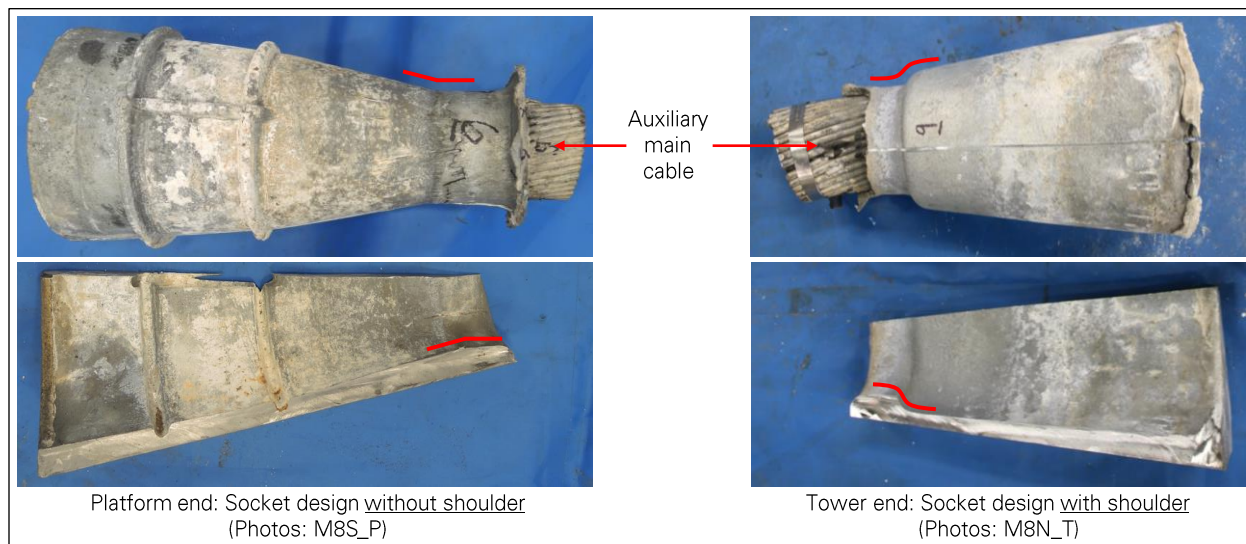
The laboratory studies revealed that these three socket designs featured a shoulder. As shown in Figure 34, the shoulder is a discontinuity in the slope of the socket's cavity near the front of the socket. However, as also shown in Figure 34, not all of the telescope's sockets had a shoulder design. The platform-end socket of an auxiliary main cable, M8N_P, was cut open by Socotec and found to not have a shoulder. The impact of the presence of a shoulder on the short-term and long-term behavior of the socket is studied in Appendix P.

Figure 34: Socket designs with and without shoulder (photos: Socotec).

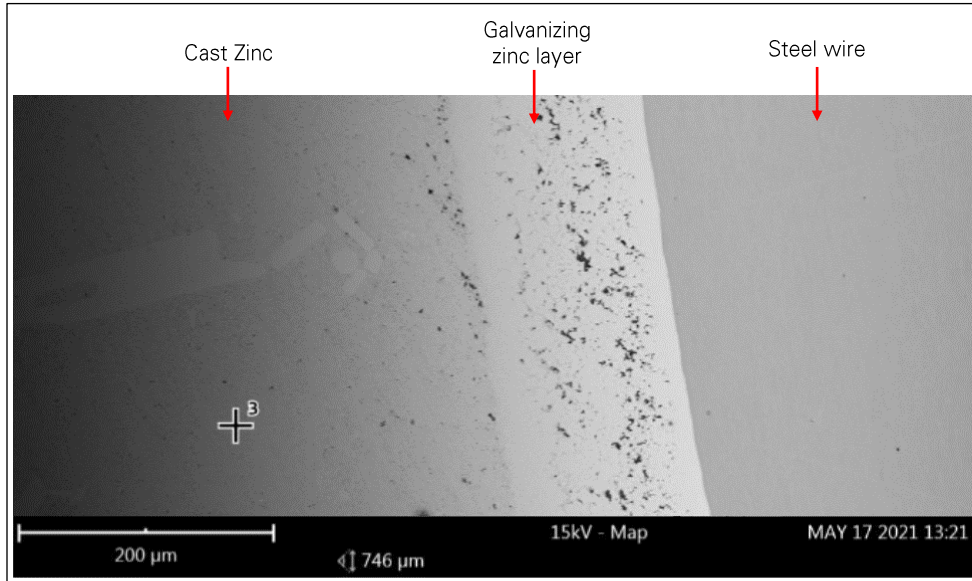
The drawings specify the cables to be galvanized structural strands based on ASTM A586, class A which requires a minimum zinc coating weight of one ounce per square foot (equivalent to a thickness of 43 micrometer). During metallographic examination of the casting of socket B4N_G, it was observed that the zinc coating had not been removed from the wires prior to socketing (Figure 35). This observation is consistent with current socketing practice.

Figure 35: Galvanizing zinc layer on wires within zinc casting (photo: Socotec).

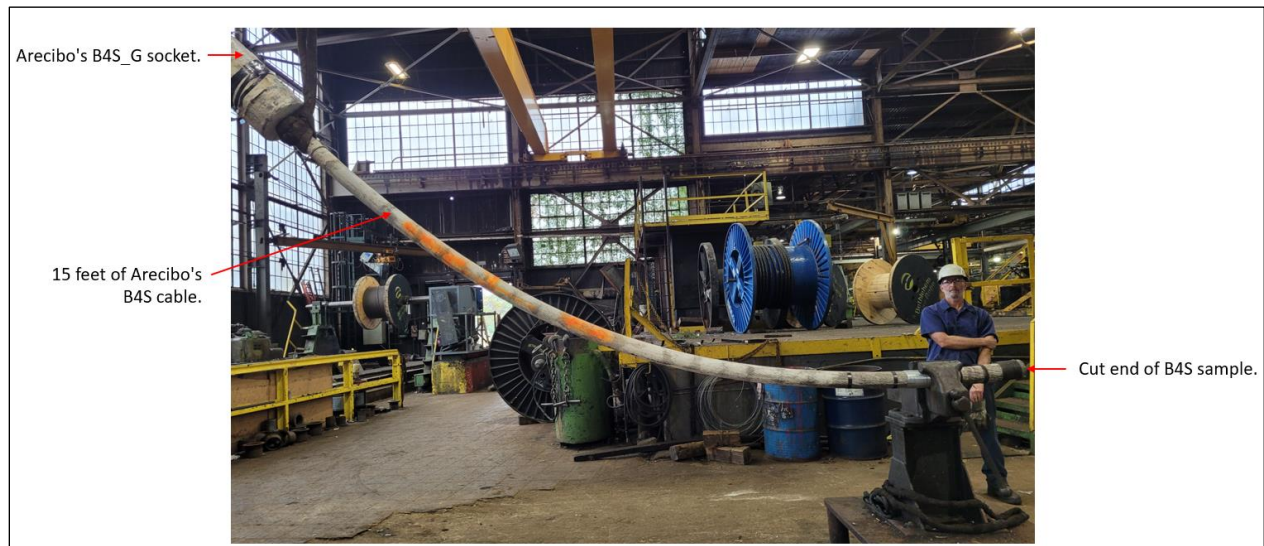
The socket selected for the load test is B4S_G, which was recovered from the ground end of an auxiliary backstay stabilizing Tower 4. On December 1, 2020, the collapse started with the failure of multiple main cables at the top of Tower 4, which caused an immediate force release in the Tower 4 backstays. As a result, socket B4S_G did not experience any impact loading during the collapse. The socket was in good general condition, had no visible wire breaks, and exhibited a cable slip of 0.875 inch. This cable slip is intermediate compared to the other auxiliary sockets of the telescope, where cable slips between 0.375 inch and 1.875 inch were observed. Like the first two sockets that failed (M4N_T and M4-4_T), socket B4S_G had a shoulder. B4S_G was recovered with 15 feet of cable B4S still attached (Figure 1).

Figure 1: Recovered B4S_G cable-socket assembly.

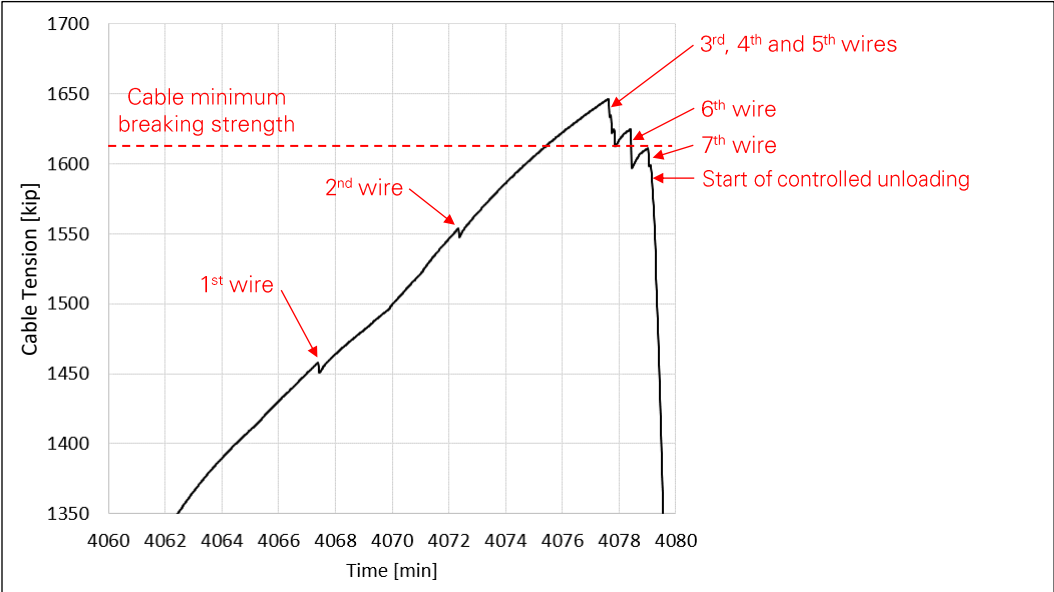
As the cable was being loaded to failure, several wires fractured inside the B4S_G socket. As shown in Figure 16, the first two fractures occurred at cable tensions of 1,454 kip and 1,552 kip. The cable tension was then increased past the minimum breaking strength of 1,614 kip, and reached a maximum of 1,647 kip before three wires fractured simultaneously. As the testing machine attempted to increase the load again, two more wires fractured at cable tensions lower than the maximum previously reached. This suggested that a complete failure of the cable-socket assembly was imminent, and the test was therefore terminated by rapidly unloading the cable.

Figure 16: Cable tension drops due to wire fractures.

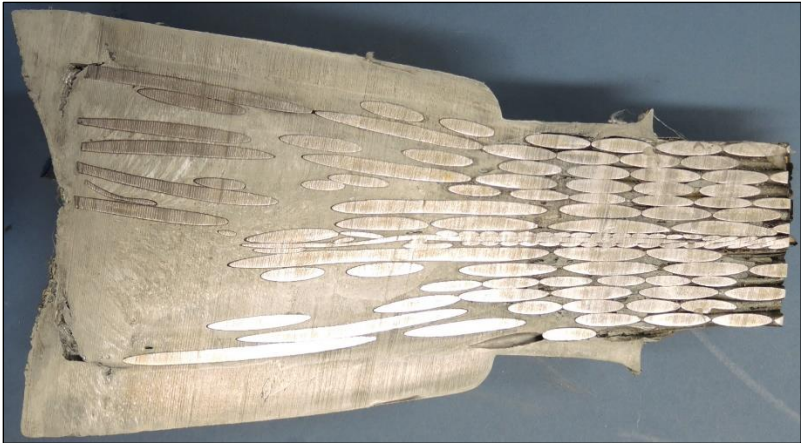
The condition of the specimen at the end of the test is shown in Figure 17. The seven fractured wires exhibit a cup-cone failure surface characteristic on tensile overload, and all of the fracture occurred within the B4S_G socket. The specimen was later moved to Socotec's laboratory, where the zinc casting of socket B4S_G was cut open for analysis. As shown in Figure 18, a central core has shifted with respect to the rest of the casting. The laboratory test results are covered in M.

Figure 18: B4S_G casting cut open after load test to (photo: Socotec).

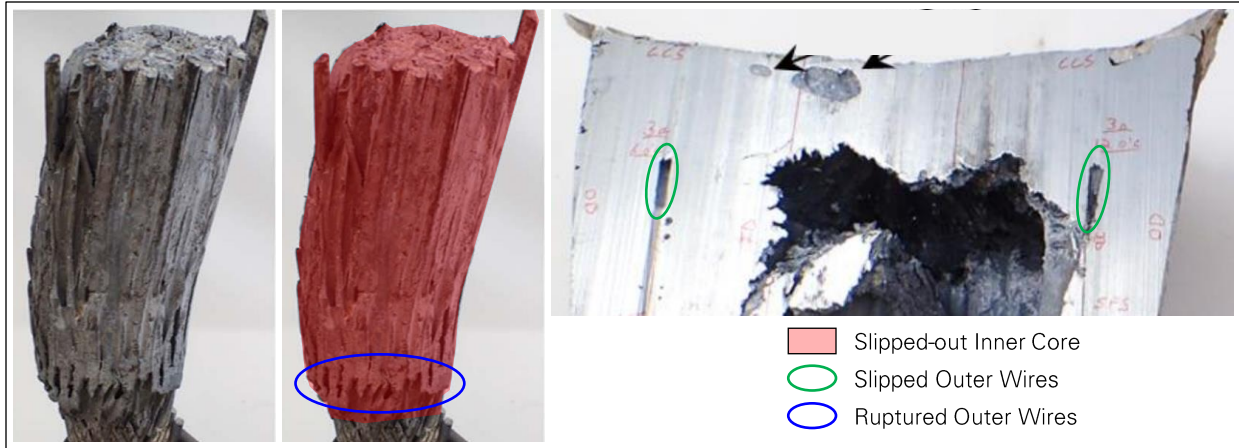
Socket **M4N_T** (Figure 1) was the first socket to fail, on August 10, 2020. In this case, an inner core of the casting slipped out of the socket entirely, and multiple outer wires ruptured. The socket and slipped-out core and cable end were analyzed by Wiss, Janney, Elstner Associates (WJE) and the NASA Engineering and Safety Center (NESC), and their findings were provided in a report¹. Among these findings, it was observed that some wire located outside the core had slipped with respect to the cast zinc.

Figure 1: Slipped-out inner core, and ruptured and slipped outer wires in socket M4N_T (photos: WJE).
