Arecibo Telescope Collapse Forensic Investigation

Thornton Tomasetti

July 25, 2022

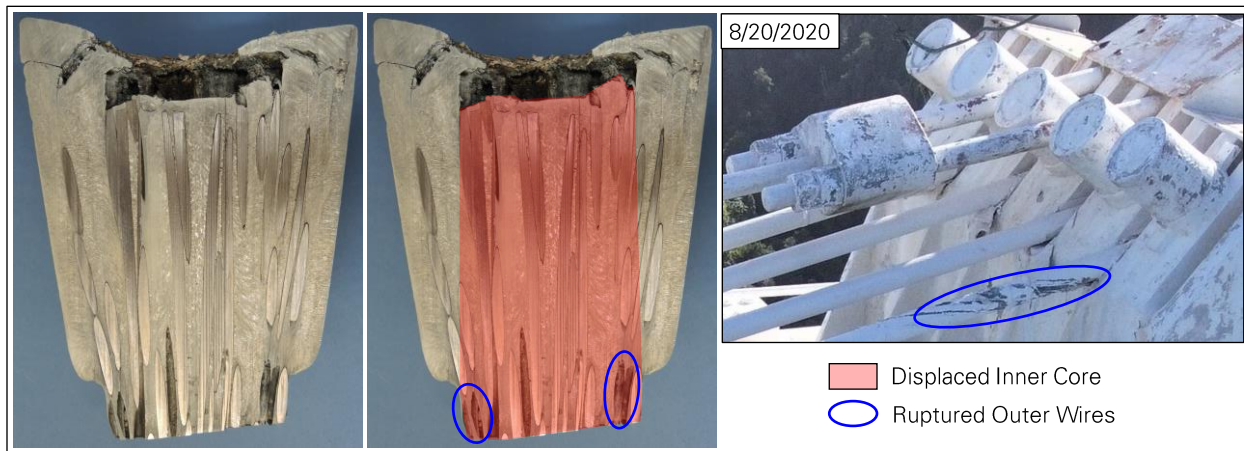
Socket **M4-4_T** (Figure 2) failed on November 6, 2020, approximately three months after the first socket failure (M4N_T). The first socket failure had caused four outer wires to rupture in M4-4_T. The socket's casting was cut open after the collapse, and on the cut surface we observe the significant displacement of an inner core.

Figure 2: Displaced inner core and ruptured outer wires in socket M4-4_T (left and center photos: Socotec, right photo: NAIC Arecibo Observatory, a facility of the NSF).

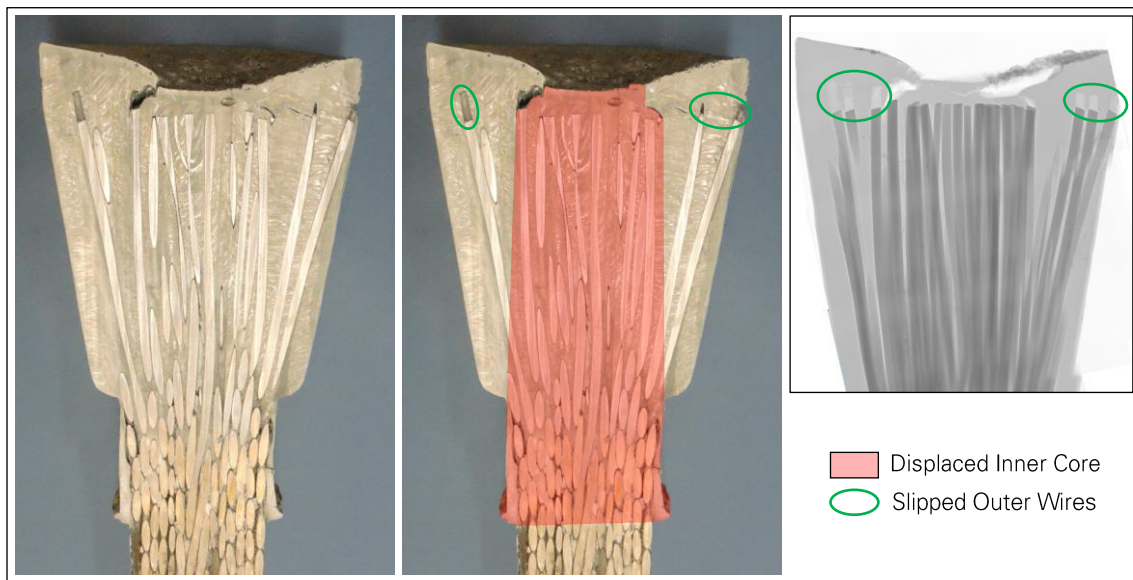
Socket **B12W_G** (Figure 4) exhibited the largest cable slip among the telescope's sockets before the collapse. The casting was cut open after the collapse, and on the cut surface we observe that an inner core has displaced within the casting, with cracks opening at the back of the core. We also observe that the wire ends located outside of the core have slipped with respect to the cast zinc. A one-inch-thick slice of the casting was radiographed with neutron imaging, and the radiograph reveals that every wire end located outside of the core has slipped.

Figure 4: Displaced inner core and slipped outer wires in socket B12W_G (left and center photos: Socotec; right photo: Adrian Brügger, Columbia University - Oak Ridge National Laboratory).

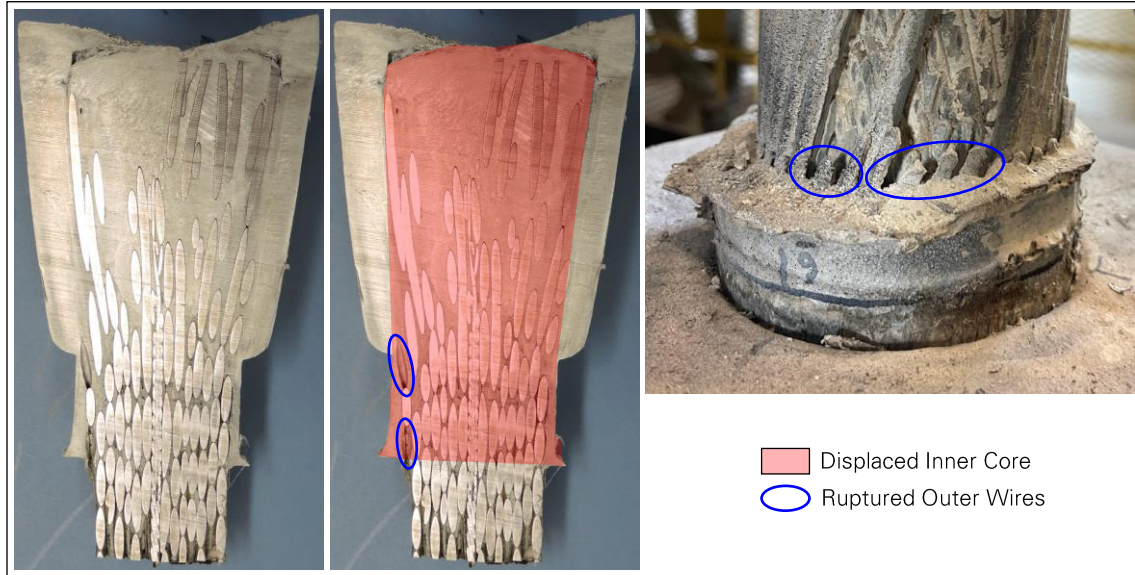
Socket **B4S_G** (Figure 5) did not fail before or during the telescope's collapse, but was recovered from the site and load-tested to failure as part of the investigation (Appendix O). The load test was ended after seven outer wires ruptured inside the socket. When the seventh wire ruptured, the cable tension was

two percent higher than the cable's Minimum Breaking Strength. The socket's casting was cut open after the test. On the cut surface, we observe that an inner core has displaced within the casting, with cracks opening at the back of the core. The seven ruptured wires are outer wires that used to extend across the core surface towards the socket wall.

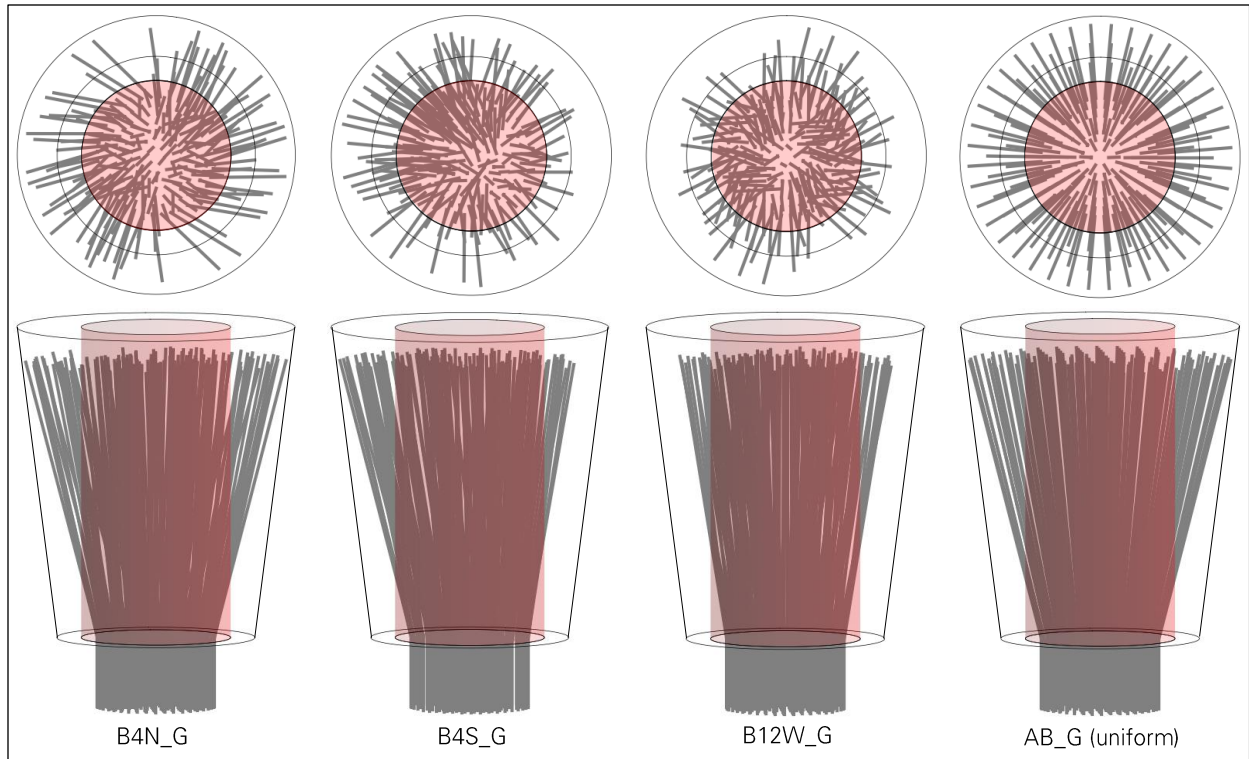
The actual and uniform wire brooms of auxiliary backstay ground-end sockets are shown in Figure 18. Socket B4S_G was tested to failure at Lehigh University, and socket B12W_G exhibited the largest cable slip across the entire telescope structure, with 1.875 inch. The broom of socket B12W_G is visually narrower than for the other sockets, with wires crossing the core surface closer to the wire ends, resulting on relatively short embedment lengths in the perimeter zinc.

Figure 18: Auxiliary backstay ground-end socket brooms.
The maximum diameter core is highlighted in red.

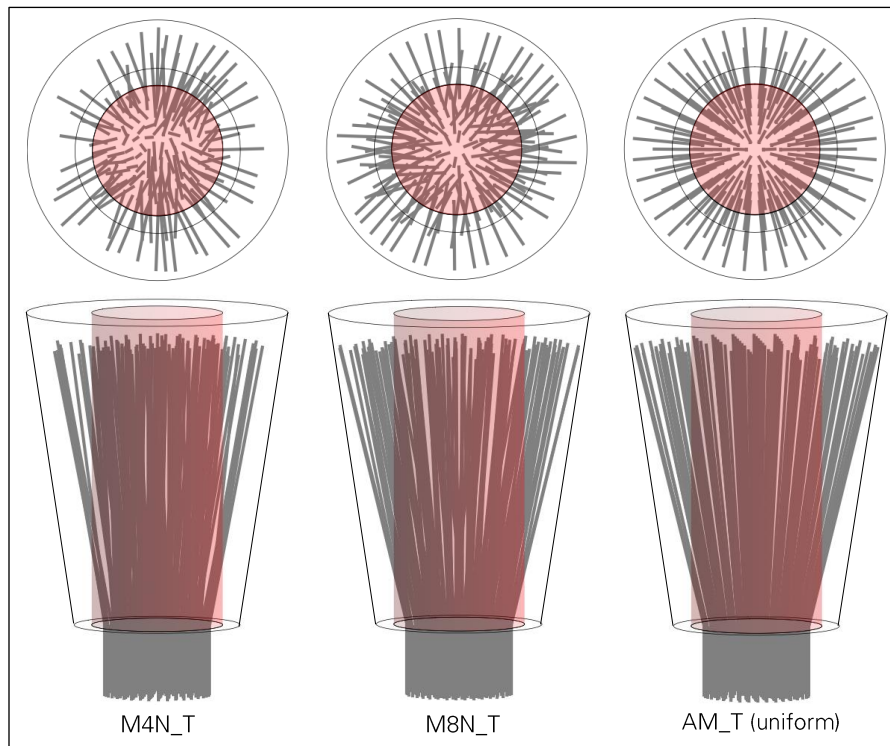
The actual and uniform wire brooms of auxiliary main tower-end sockets are shown in Figure 19. Socket M4N_T is where the first cable failure occurred on August 10, 2020, and socket M8N_T exhibited a relatively small cable slip of 0.625 inch.

Figure 19: Auxiliary main tower-end socket brooms.
The maximum diameter core is highlighted in red.

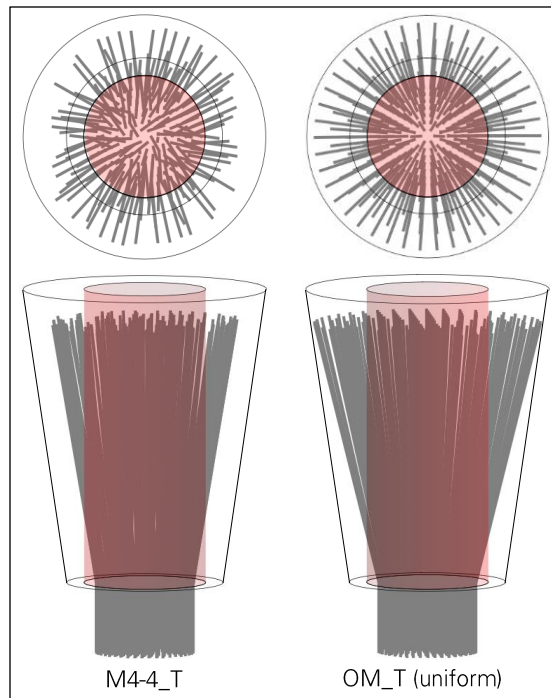
The actual and uniform wire brooms of original main tower-end sockets are shown in Figure 20. Socket M4-4_T is where the second cable failure occurred on November 6, 2020.

Figure 20: Original main tower-end socket brooms.

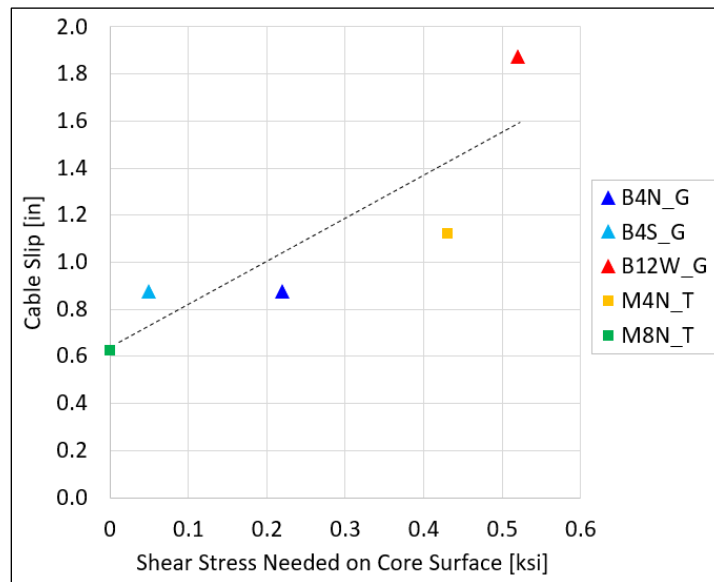
Figure 22: Cable slip vs. core shear needed in auxiliary sockets under gravity loads before M4N failure.

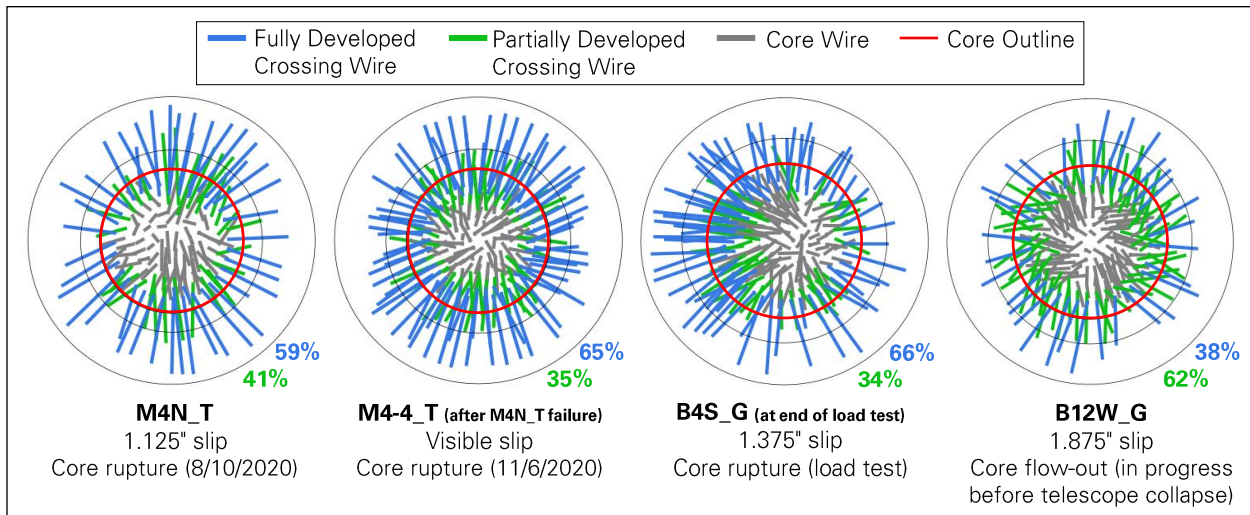
Figure 25: Fully and partially developed crossing wires in failed and failing sockets.

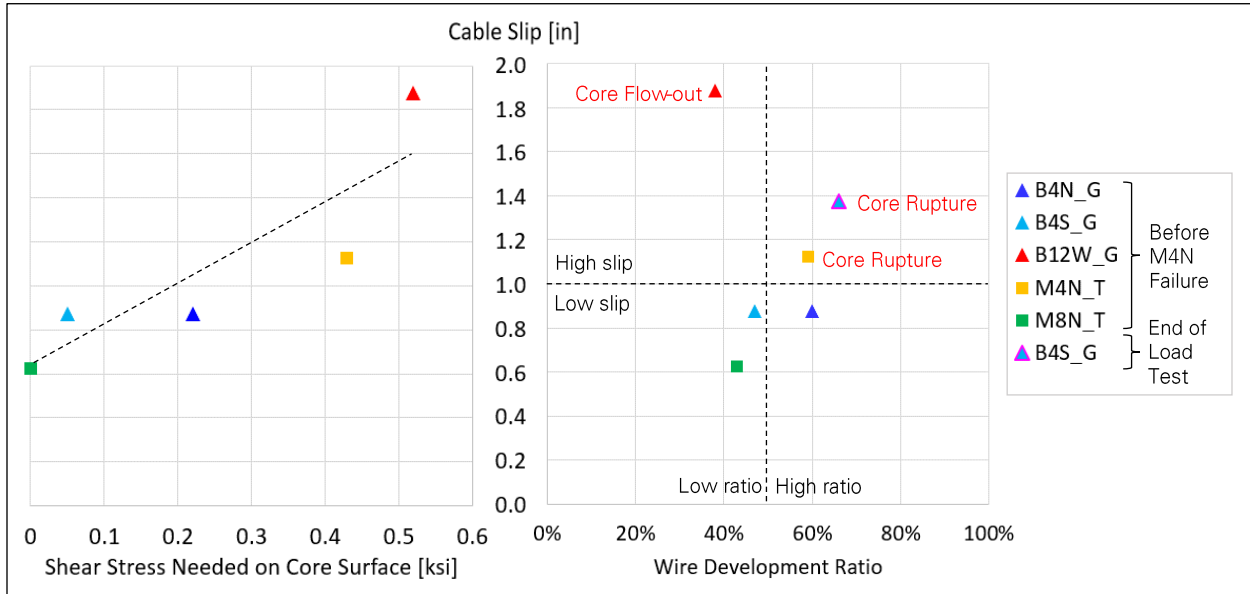
By applying the proposed mathematical model to the six telescope sockets of known wire broom, we observed correlations between core shear, wire development ratio, cable slip and socket failure mode. These correlations are summarized in Figure 28 for the auxiliary sockets. The original socket (M4-4_T) is not included because its cable slip is not known. The left side of Figure 28 shows that the cable slip observed in the field increases with the core shear needed to resist the cable tension under gravity loads (same as Figure 22 page 22). This core shear depends on the collective capacity of the crossing wires to resist the cable tension: if the crossing wires capacity is lower, the core shear needed is higher. The right side of Figure 28 shows that failure occurs in the sockets exhibiting the largest cable slips, with a failure mode that depends on the wire development ratio: the socket experiences core rupture if its crossing wires tend to rupture before slipping (high ratio), and core flow-out if its wires tend to slip before

Figure 28: Correlation between core shear, wire development ratio, cable slip, and socket failure.

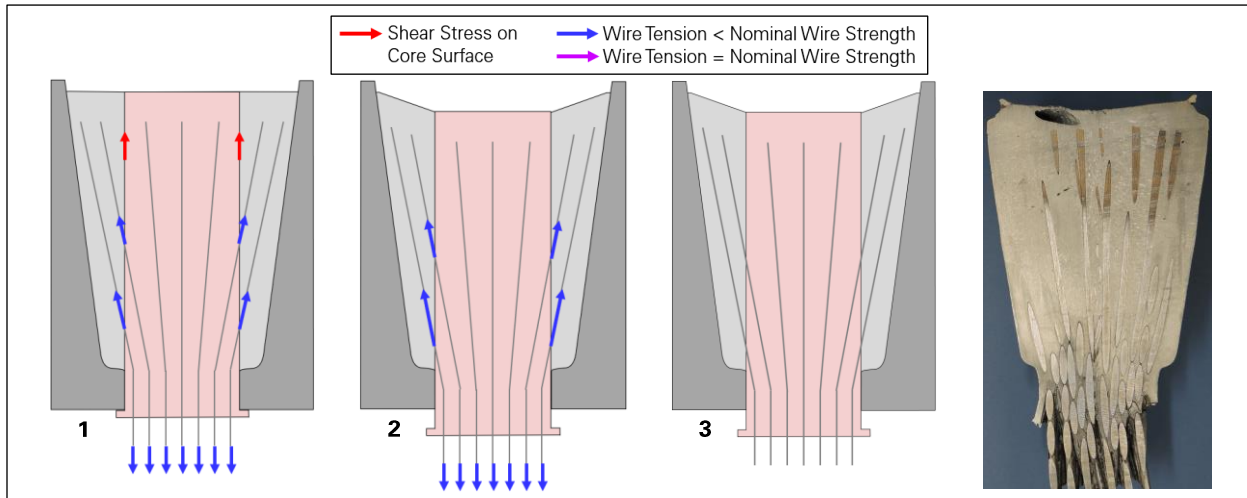
1. As the socket is initially loaded, the cable tension is resisted by a combination of core shear and crossing wire tension.
2. Core shear causes zinc flow, which increases crossing wire tension and decreases core shear. The crossing wires capacity (752 kip) is greater than the cable tension (602 kip), so the core shear eventually drops to zero and zinc flow stops.

Figure 30: Behavior of socket M8N_T (photo: Socotec).

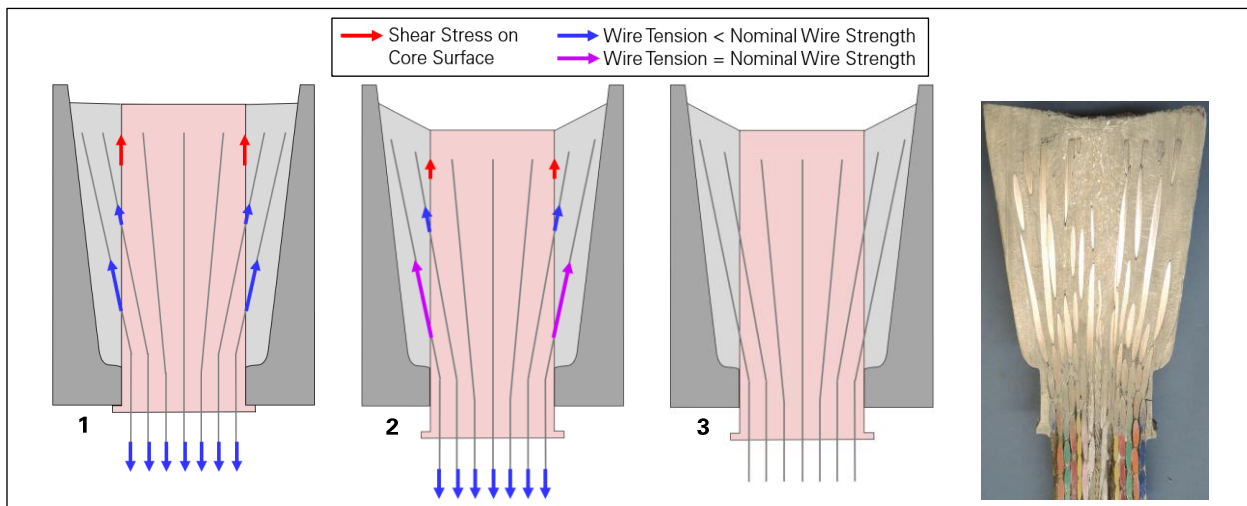
1. As the socket is initially loaded, the cable tension is resisted by a combination of core shear and crossing wire tension.
2. Core shear causes zinc flow, which increases crossing wire tension and decreases core shear. The crossing wires capacity (671 kip) is less than the cable tension (698 kip), so core shear (0.22 ksi) is still needed to resist the cable tension after the crossing wires reach their capacity.
3. The core shear needed is relatively low, so zinc flow is slow, and the socket does not fail before the telescope's collapse.

Figure 31: Behavior of socket B4N_G (photo: Socotec).

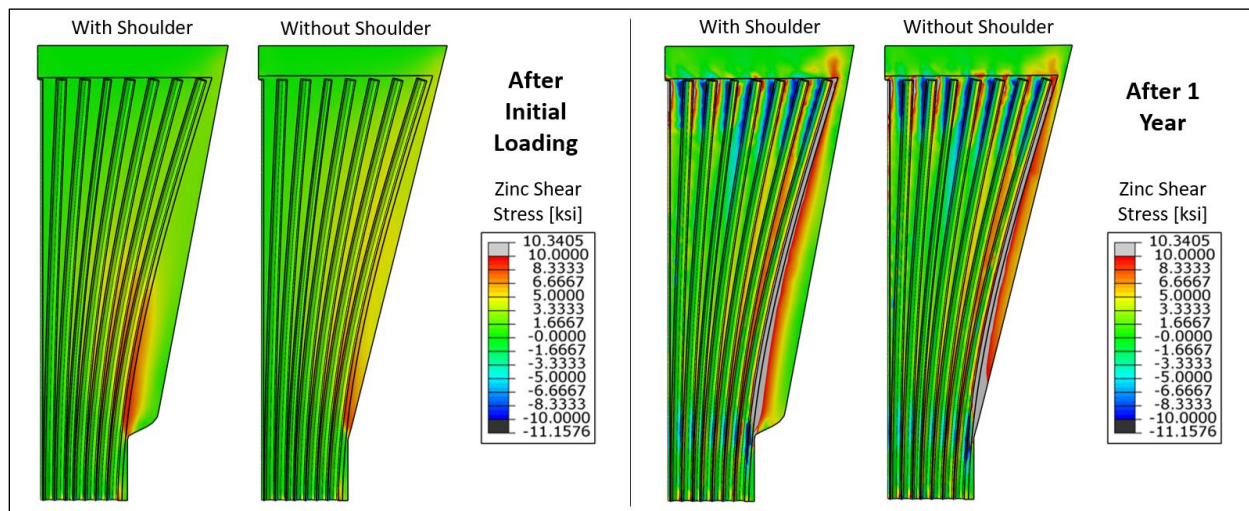
Figure 8: Zinc casting shear stress with and without shoulder.

As shown in Figure 8, when the socket is initially loaded, the shoulder causes higher shear stress at the front of the zinc casting because the casting bears on the shoulder. However, after allowing the zinc to creep for a year, the shear stress distribution is similar in the models with and without a shoulder.

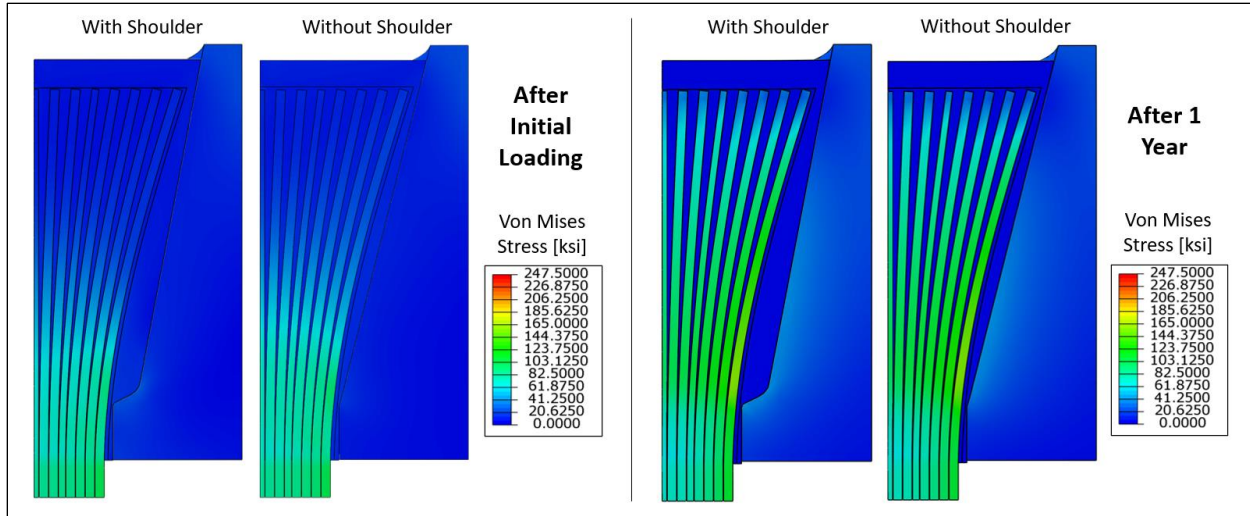
Figure 9: cable slip and wire stress with and without shoulder.

Similarly, the wire stress and cable slip are almost equivalent between the creep models with and without shoulders (Figure 9). The shoulder does not appear to have a significant impact on the long-term behavior of the socket.

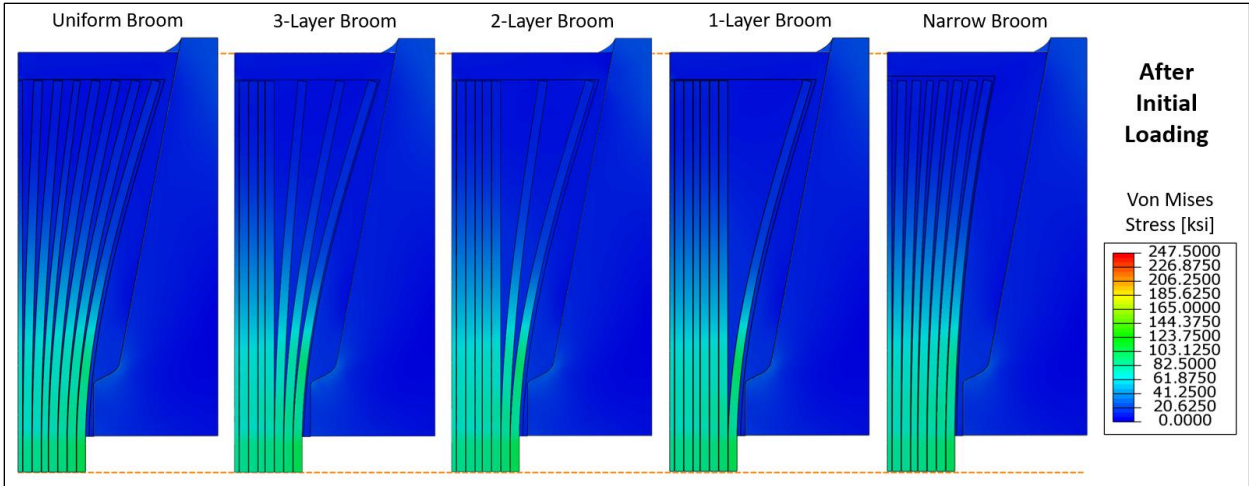
Figure 10: Wire tensile stress for different wire brooms after initial loading.

The wire stresses and cable slips are equivalent in every broom when the socket is initially loaded (Figure 10), with the casting bearing on the shoulder. Zinc flow over time causes a stress redistribution resulting in the broomed-out wires carrying most of the cable's tension (Figure 11, Figure 12). In the socket with a single layer of wires broomed out, those wires rupture after just three years of zinc flow (Figure 11), causing failure of the socket. The sockets with at least two layers of wires broomed out do not fail after 25 years, and at that point the broomed-out layers carry most of the cable tension.

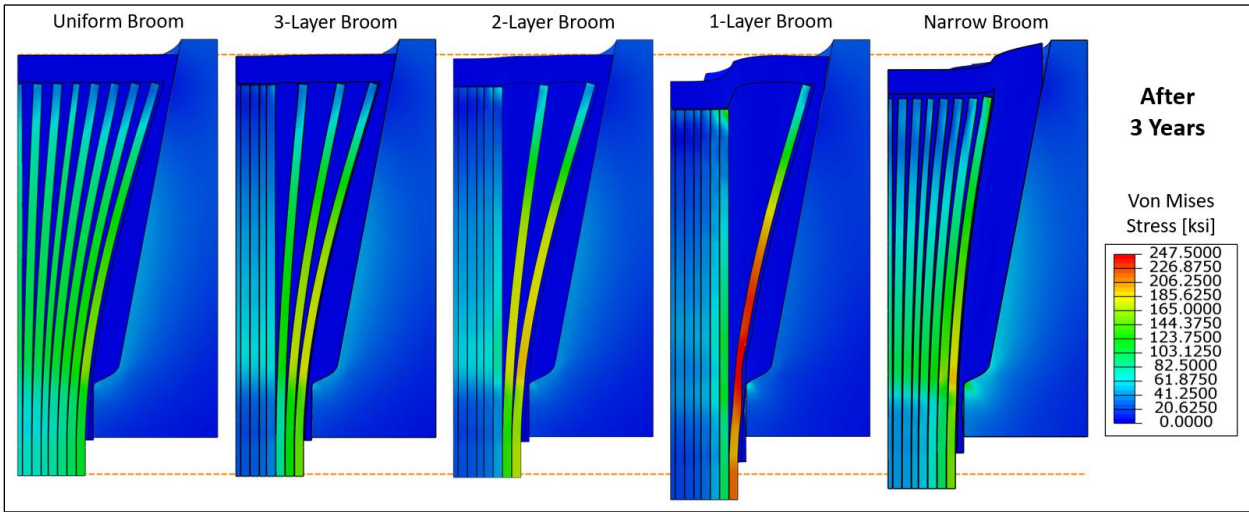
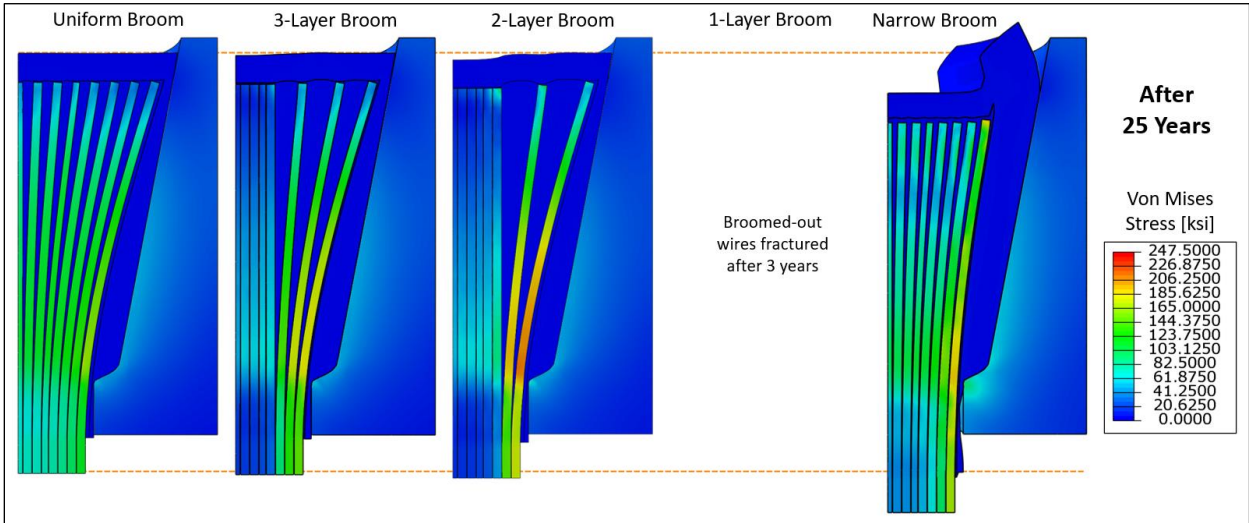
Figure 11: Wire tensile stress for different wire brooms after 3 years of zinc flow.

Figure 12: Wire tensile stress for different wire brooms after 25 years of zinc flow.

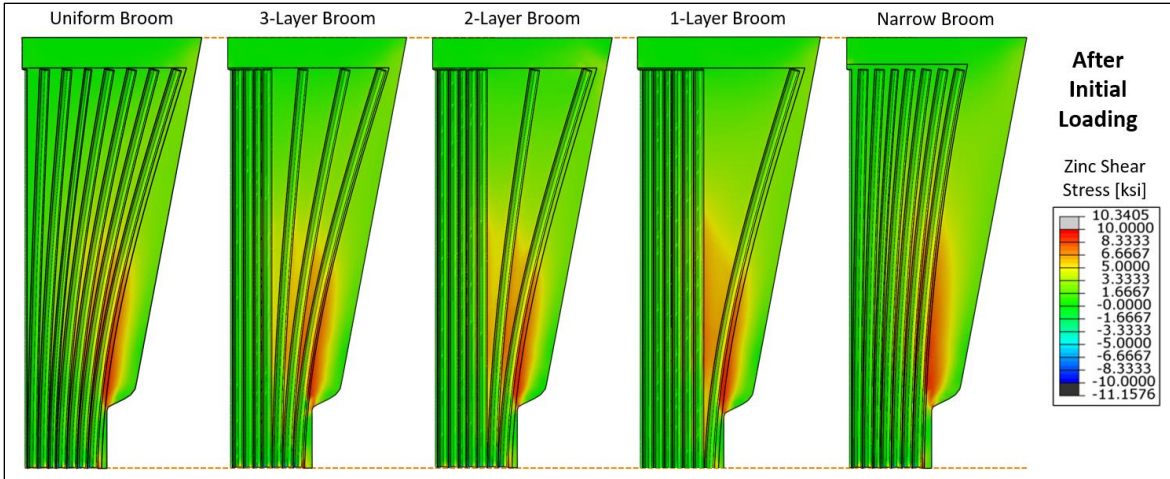
Figure 13: Zinc shear stress for different wire brooms after initial loading.

The shear stress in the zinc is also equivalent in every socket after the initial loading (Figure 13), and changes over time as zinc flows (Figure 14, Figure 15). The shear stress is higher within a zone located on the outer side of each wire layer, where the wires transfer their load to the zinc. For the socket with a single layer of wires broomed out, a broad zone of high shear stress is present around the central bundle of wires, which are not broomed out. This causes those un-broomed wires to gradually pull out of the socket, stretching and eventually rupturing the single layer of broomed-out wires.

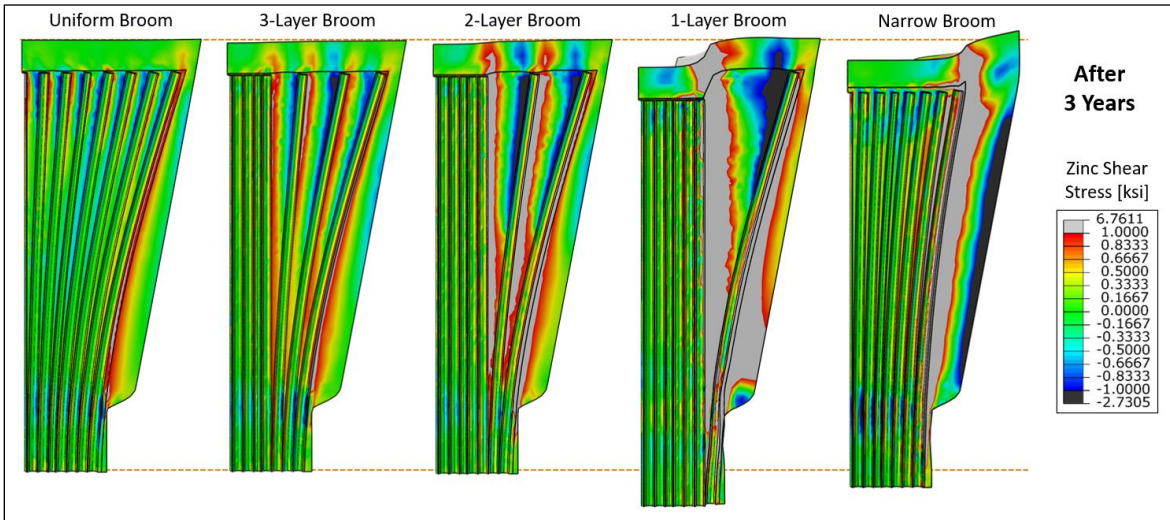
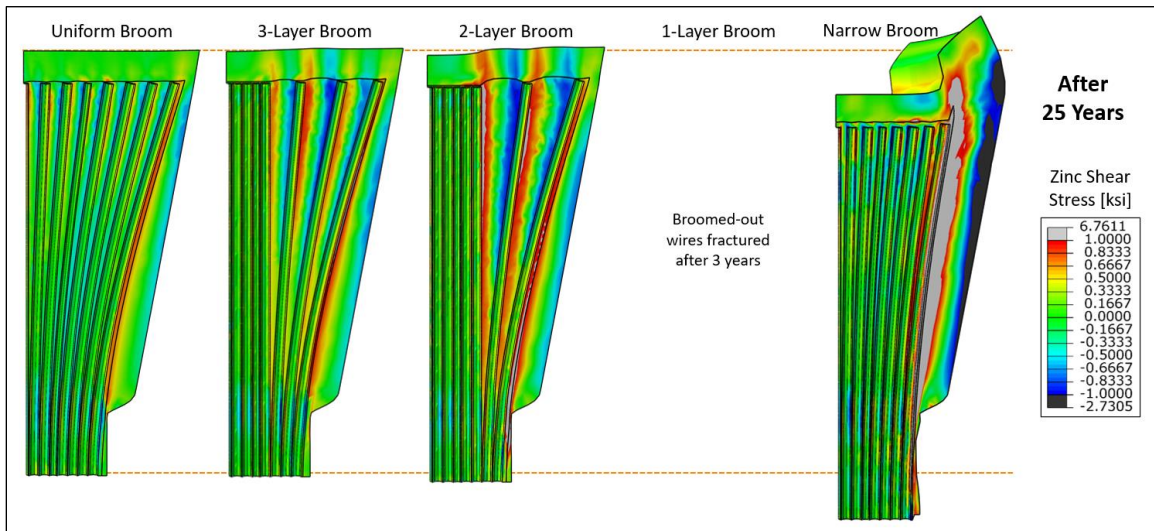
Figure 14: Zinc shear stress for different wire brooms after 3 years of zinc flow.

Figure 15: Zinc shear stress for different wire brooms after 25 years of zinc flow.
